Report: TAB REPORT
Function: Test, Adjust, & Balance
Date: 02/05/2024

01-22-24 KRISPY KREME METARRAIRE, LA

825 Clearview Parkway

Client
Krispy Kreme

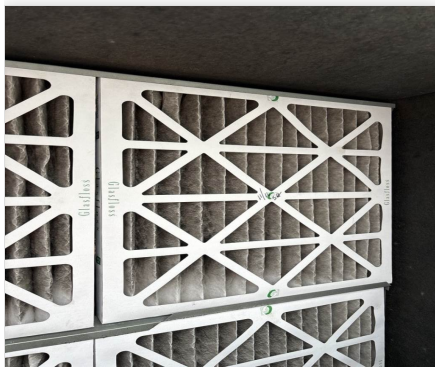
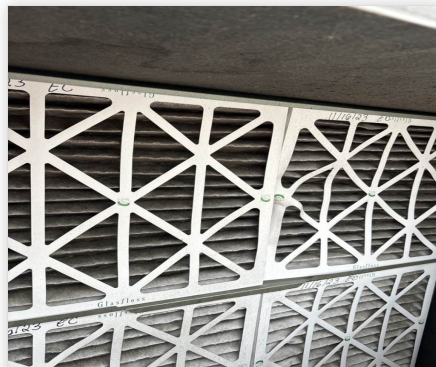
FILTERS1
01/25/2024

Issue Name : Dirty RTU Filters
Description : Filters for all RTU's are dirty. Recommend to replace.
Created By : National TAB **Assigned To :** National TAB - Antonio Flores-De La Cruz
Status : Open
Priority : Urgent **Asset Tag :**
Originated Date : 01/25/2024 - Antonio Flores-De La Cruz - National TAB

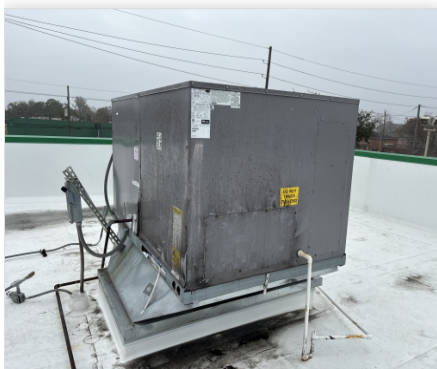
RTU-1(1)
01/25/2024

Issue Name : RTU-1 Not operational
Description : The unit was turned off at the disconnect to obtain data from inside the motor compartment. After gathering data, unit was turned back on again and the unit operated for a couple seconds before coming to a complete stop. It was observed that the unit was rotating Clockwise and Rotation should be Counterclockwise. Unit does not turn on anymore. Further investigation is required.

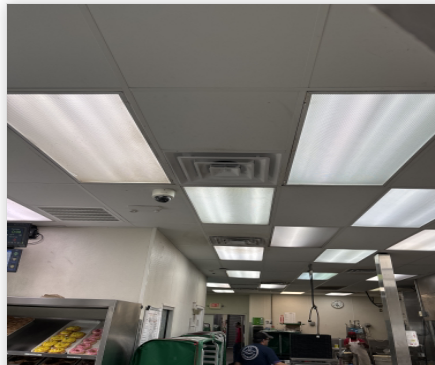
Flex
01/25/2024

Issue Name : RTU-2 diffuser flex duct not installed
Description : Flex duct is not properly installed and sitting on top of the diffuser.
Created By : National TAB **Assigned To :** National TAB - Antonio Flores-De La Cruz
Status : Open
Priority : Urgent **Asset Tag :**
Originated Date : 01/25/2024 - Antonio Flores-De La Cruz - National TAB

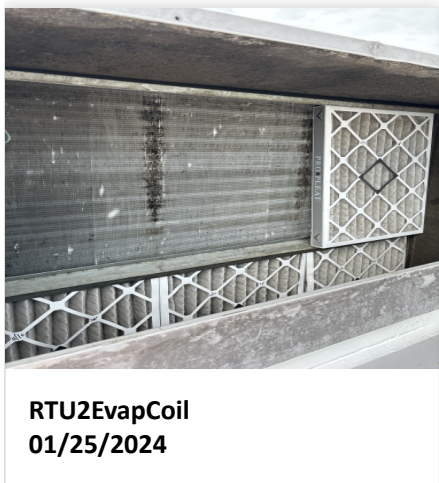
Issue Name : RTU-2 Dirty Evaporator Coil
Description : The evaporator coil is dirty. Recommend cleaning to help improve airflow
Created By : National TAB **Assigned To :** National TAB - Antonio Flores-De La Cruz
Status : Open
Priority : Urgent **Asset Tag :**
Originated Date : 01/25/2024 - Antonio Flores-De La Cruz - National TAB

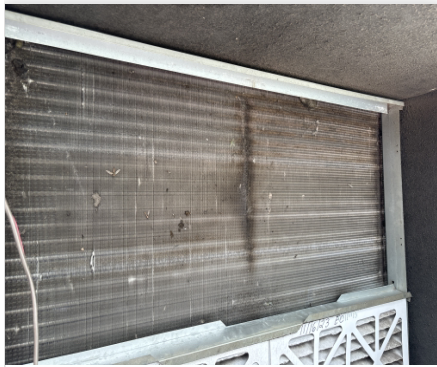
RTU3EVAPCoil
01/25/2024

Issue Name : RTU-3 Dirty Evaporator Coil
Description : The Evaporator Coil is dirty and has debris. Recommend cleaning to help improve airflow.
Created By : National TAB **Assigned To :** National TAB - Antonio Flores-De La Cruz
Status : Open
Priority : Urgent **Asset Tag :**
Originated Date : 01/25/2024 - Antonio Flores-De La Cruz - National TAB

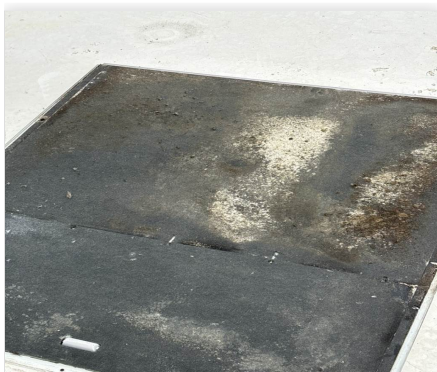
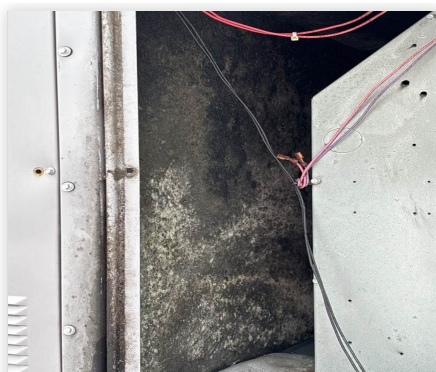
RTU3MOLD1
01/25/2024

Issue Name : RTU-3 Mold inside Motor Compartment
Description : Mold has been found on the walls and the panel of the motor compartment.
Created By : National TAB **Assigned To :** National TAB - Antonio Flores-De La Cruz
Status : Open
Priority : Urgent **Asset Tag :**
Originated Date : 01/25/2024 - Antonio Flores-De La Cruz - National TAB
