**Report: Test and Balance
Date: 5/18/2018**

**PROJECT
RED ROBIN - BARTONSVILLE, PA (REVIVE)**

250 Route 611, Crossroads Mall
BARTONSVILLE, PA 18321

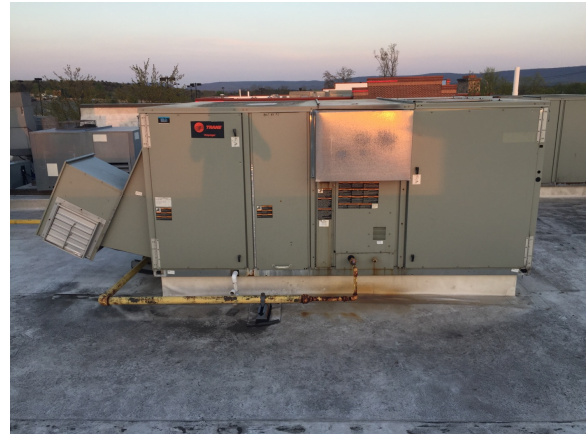
RTU 2

<p>required and described below:</p>
Recommendation (Clean/Repair/Replace/Info)	
REPAIR - NEEDS IMMEDIATE ATTENTION	<p>Attempted to speed RTU-2 up and doing so caused the motor to stop running. Slowed the unit back down and found the motor RPM was only 2909 out of rating of 3450 RPM. The motor is degrading and needs to be replaced.</p>
REPAIR - HIGH PRIORITY	<p>RTU 2 has a damaged tension pulley. Recommend repairing</p>
CLEAN - HIGH PRIORITY	<p>Recommend cleaning blowers for all RTU's. Evaluate the evaporator coils to determine if they require cleaning (not verified by NTAB while on site)</p>
REPAIR - HIGH PRIORITY	<p>Motor sheave for MUA-1 is seized with rust and could not be adjusted. Recommend breaking free with pipe wrench so that adjustment during final balancing is possible. If not salvagable, then recommend replacing with identical pulley (2VP42 x 1-1/8")</p>
REPAIR - HIGH PRIORITY	<p>Motor sheave for RTU-3 (kitchen) needs to be replaced with a VP44 x 7/8" pulley in order to increase motor speed as close to FLA rating as possible.</p>

Notes: Starting RPM: 598
 Starting OA: 1506
 Damaged tension pulley
 Motor RPM 2909 see issues list for details.

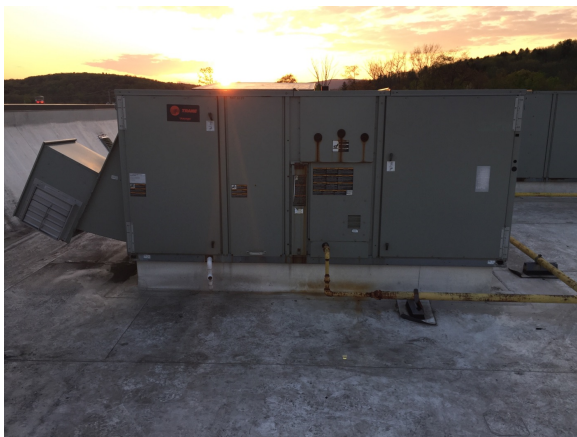
RTU 3

Notes: Starting RPM: 713
 Sheave is maximized and frozen with rust
 Starting OA: 2230 CFM
 Motor RPM: 1729
 OA Damper is closed as far as the actuator will allow without closing to 0%.

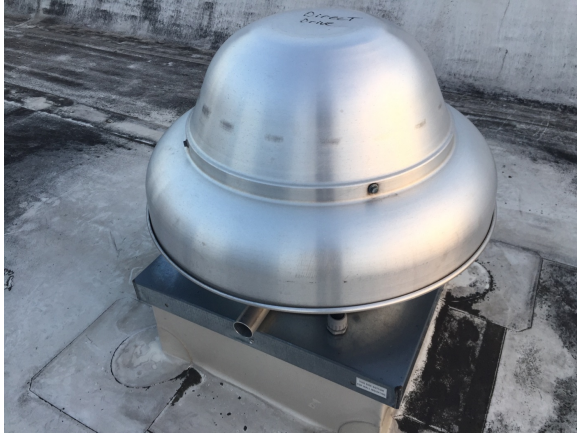
Notes: Duct system is dirty and needs to be cleaned to restore system performance.

REPAIR - HIGH PRIORITY	<p>RTU-1 economizer is not functional and is propped open by a magnet. Recommend repairing so that OA can be properly set.</p>
CLEAN - LOW PRIORITY	<p>Restroom exhaust fan EF 5 duct system is dirty and needs to be cleaned to restore system performance.</p>

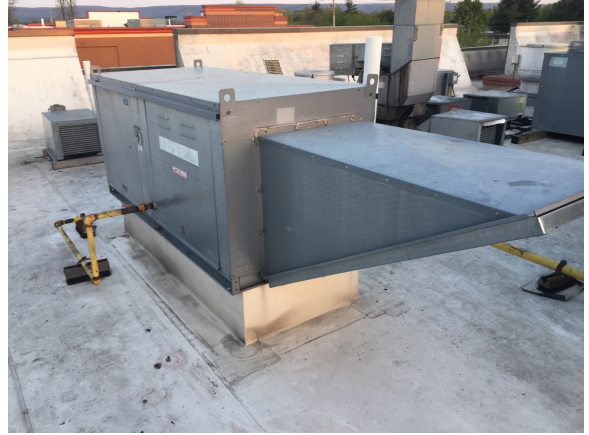
MUA

Notes: Sheave is frozen with rust.

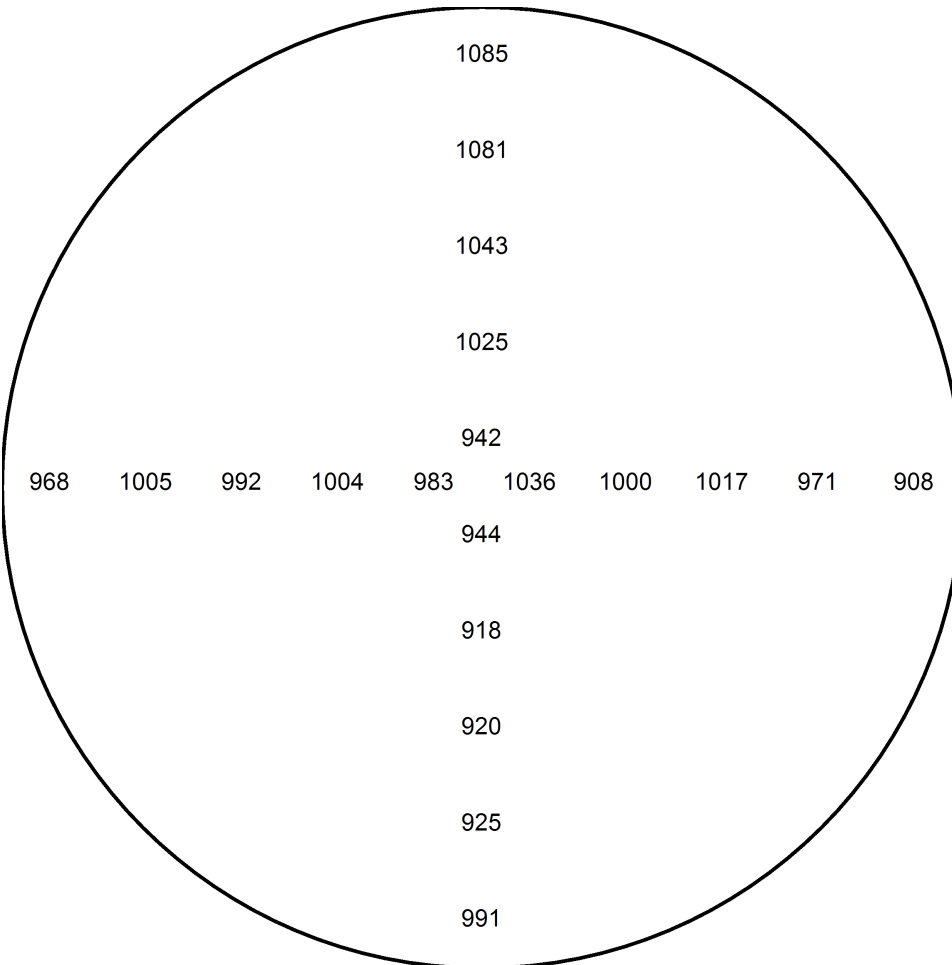
Duct Traverse Data Points

Duct	Design	Actual
Diameter: 26 Readings: 10	SCFM:	SCFM:
Area: 3.69	FPM: 1220	FPM: 988
S.P.: Temp:	CFM: 4505	CFM: 3643

This traverse is used to develop a K for the open dining room diffusers. Total Velocity: 2568 K=1.42
