Report: TAB REPORT
Function: Test, Adjust, & Balance
Date: 07/16/2025
Completed By: National TAB

PROJECT
07-14-25 CHIPOTLE #5446 CHARDON, OH

Project: 07-14-25 CHIPOTLE #5446 CHARDON, OH

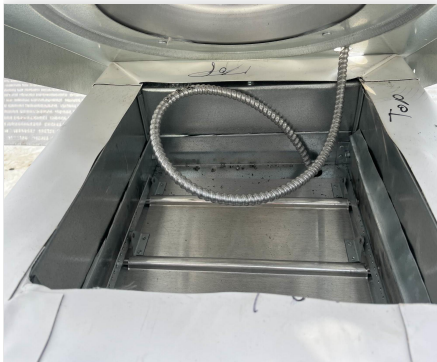
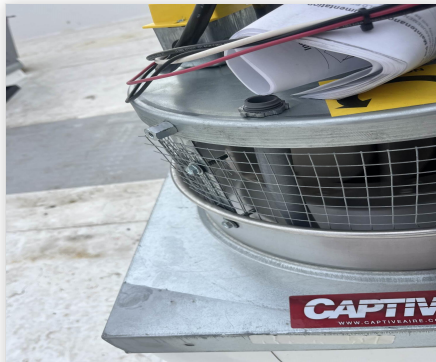
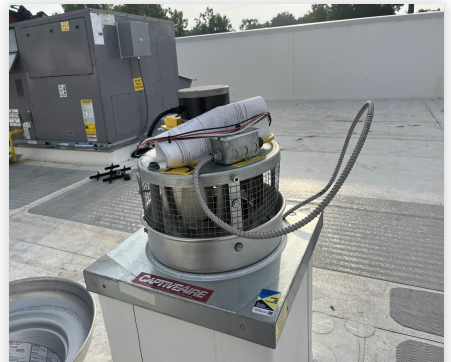
Issue Name : EF-2 Backdraft Damper
Description : Electrical conduit for EF-2 is not run through provided raceway. Conduit was bunched above backdraft damper and preventing damper from opening. NTAB pulled conduit through drilled hole to free damper. Recommend conduit is run through provided raceway and cut to length.
Created By : National TAB **Assigned To :** National TAB - Michael McDonnell
Status : Open
Priority : Medium **Asset Tag :**
Originated Date : 07/16/2025 - Michael McDonnell - National TAB

Electrical conduit was inhibiting operation of damper. Pulled conduit through, it needs to be run through the provided raceway and cut to proper length. SEE ISSUE.

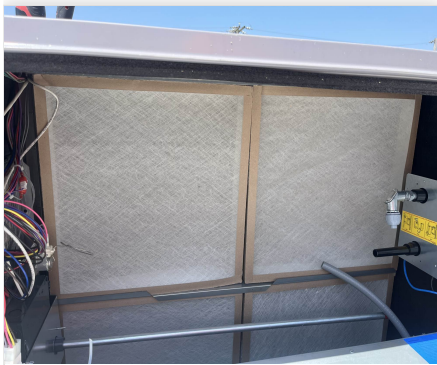
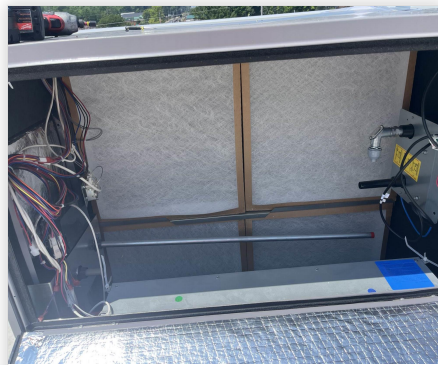
Issue Name : RTU Final Filters
Description : Construction filters are installed. Recommend pleated final filters are installed.
Created By : National TAB **Assigned To :** National TAB - Michael McDonnell
Status : Open
Priority : Low **Asset Tag :**
Originated Date : 07/15/2025 - Michael McDonnell - National TAB

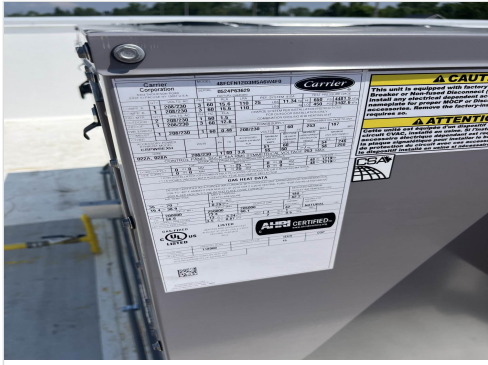
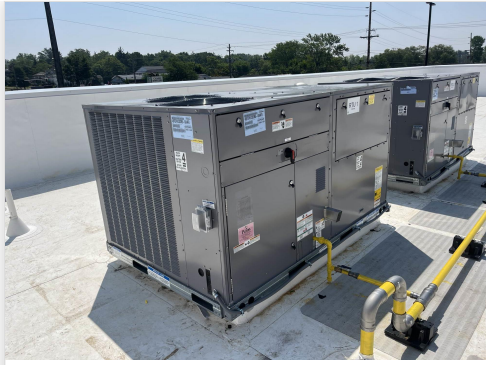
[1] DIFFUSERS SUM TO 3400 CFM. RTU SCHEDULE CALLS FOR 3800 CFM. PROPORTIONALLY INCREASED DIFFUSER VALUES TO MATCH SCHEDULE. RTU IS OPERATING AT 372 CFM/TON.

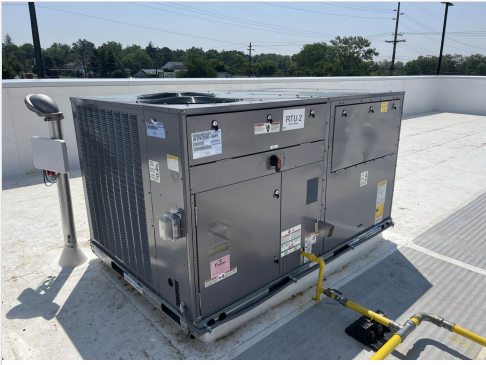
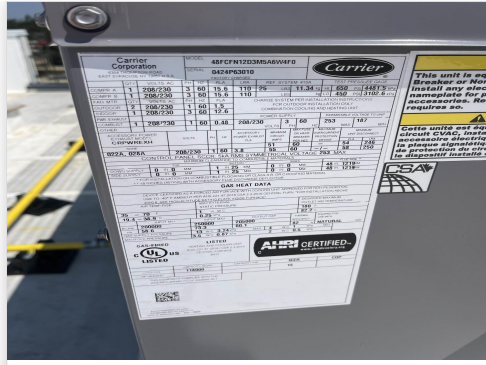
[1] RTU-2 SUPPLY AND RETURN DROPS DEVIATE FROM DESIGN DUE TO TRUSS INSTALLATION. SEVERAL TRANSITIONS AND TURNING VANES INSTALLED IN RETURN. SUPPLY AND RETURN ARE CRAMMED TOGETHER AT DROP. SEE PHOTOS

Slightly elevated dining room noise from RTU-2. Suspect deviations in drop ductwork is contributing to issue. When store is in full operation, not anticipated to be noticeable or cause any issue.

[2] HIGHER THAN NORMAL NOISE FROM UNIT IN SPACE. SUSPECT INSTALLATION OF RTU DROP IS CAUSE, SEE ISSUE.

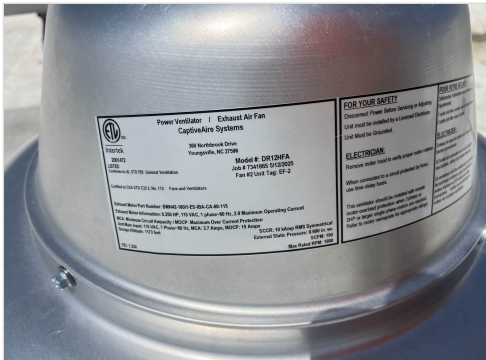
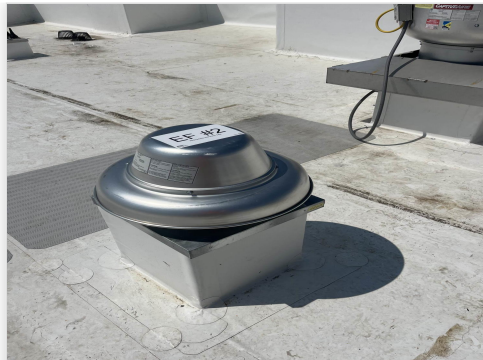
Test Data		
	Design	Actual
CFM	150	149
Fan RPM	1304	1307
Fan Rotation	-	CCW, CORRECT
Motor RPM	-	1307
System SetPt	-	66%
RL Voltage	-	119
RL Amperage	-	1.7
Total ESP	.60"	0.32"
Fan Inlet SP	-	-0.32"
Fan Discharge SP	-	ATM
