Report: TAB REPORT
Function: Test, Adjust, & Balance
Date: 08/28/2025
Completed By: National TAB

PROJECT
08-25-25 CHIPOTLE #5659 PEKIN, IL

Project Summary

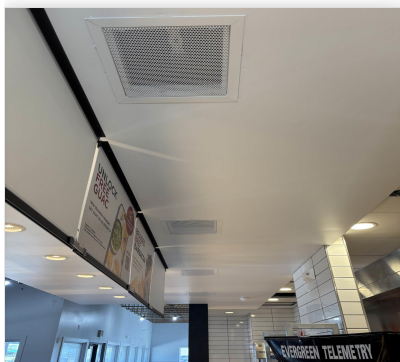
Deflector plates are removed from 1x1 diffusers on the serve line (double check that this is specified on the diffuser schedule first)	Yes
--	-----

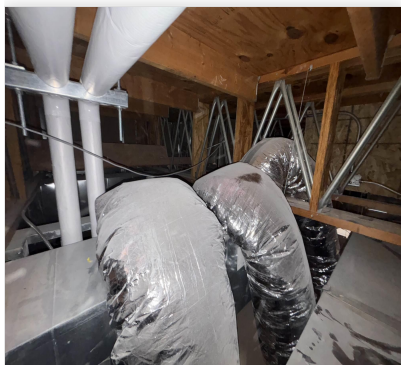
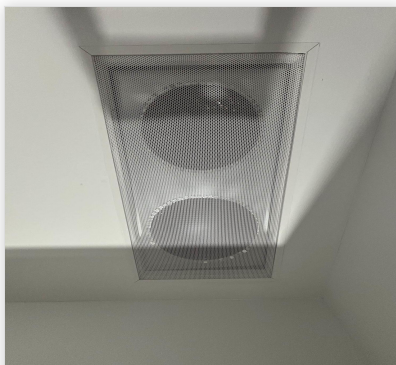
Note Photos

[1] RTU Returns are ducted with two 16" flex runs. Plans indicate hard duct should be installed at full size indicated. [2] ACPSP ducting comes off top of duct with flex and is pinched in some instances, plenum at design.

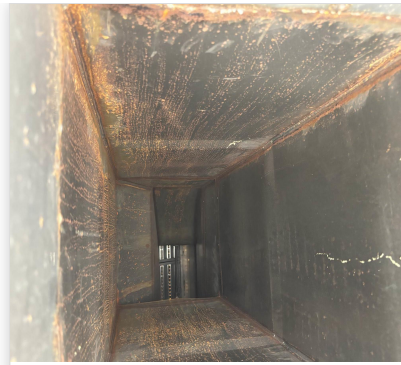
Lean fan back. Is grease duct installation adequate and is duct ran all the way to the base of the fan?	Yes
--	-----

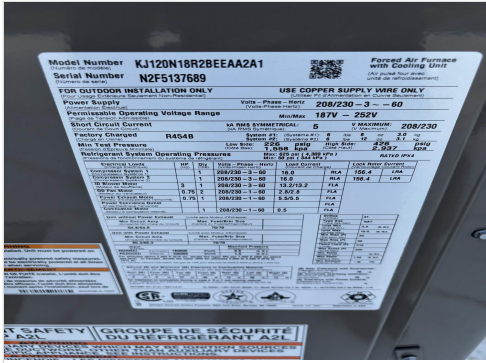
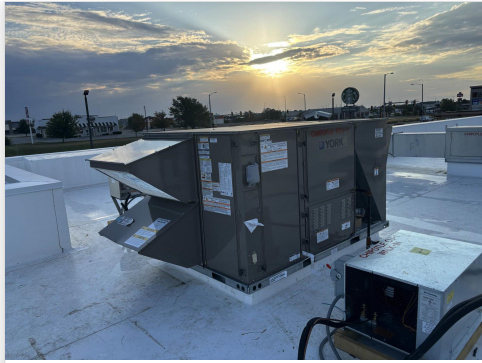
Unit Data - PHOTO LOG

Unit Data		
	Design	Actual
MFG	YORK	YORK
Serial Num	-	N2F5137689
Model Num	KJ120	KJ120
Type	RTU	RTU
Configuration	VERTICAL	VERTICAL
Num OA Filters 1	-	1
OA Filter Size 1	-	21X29
Num Final Filter 1	-	4
Final Filter Size 1	-	20X24X2

Test Data		
	Design	Actual
SF CFM	4000	3882
SF RPM	-	996
RA CFM	3500	3364
OA CFM	500	518
RL Voltage	-	206/206/208
RL Amperage	-	8.1/8.3/8.5
SF Rotation	-	CW, CORRECT
SF System SetPt	-	60 HZ
RA Damper Position	-	MECHANICALLY LINKED
Min OA Damper Position	-	17%
Min OA Damper Type	-	ECONOMIZER

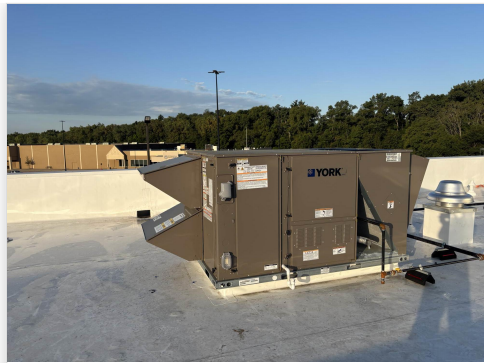
Unit Data - PHOTO LOG

Unit Data		
	Design	Actual
MFG	YORK	YORK
Serial Num	-	N2F5129273
Model Num	KJ120	KJ120
Type	RTU	RTU
Configuration	VERTICAL	VERTICAL
Num OA Filters 1	-	1
OA Filter Size 1	-	21X29
Num Final Filter 1	-	4
Final Filter Size 1	-	20X24X2

Test Data		
	Design	Actual
SF CFM	3600	3764
SF RPM	-	936
RA CFM	2600	2721
OA CFM	1000	1043
RL Voltage	-	206/208/26
RL Amperage	-	7.9/7.9/8.1
SF Rotation	-	CW, CORRECT
SF System SetPt	-	60 HZ
RA Damper Position	-	MECHANICALLY LINKED
Min OA Damper Position	-	17%
Min OA Damper Type	-	ECONOMIZER

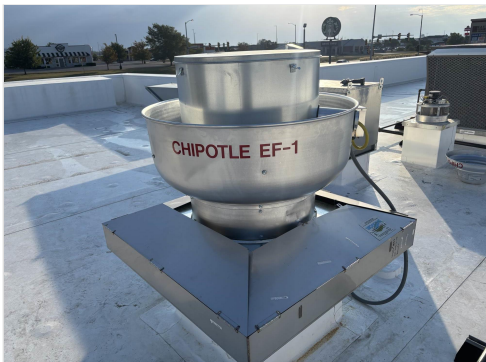
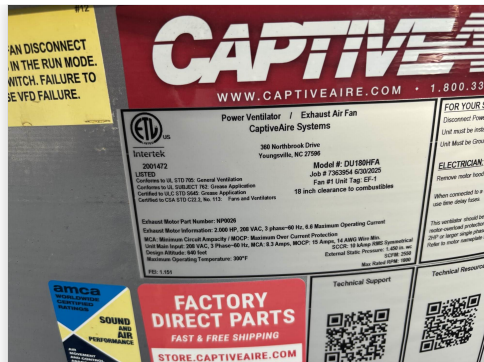
Unit Data - PHOTO LOG

Unit Data		
	Design	Actual
MFG	CAPTIVE-AIRE	CAPTIVE-AIRE
Model Num	DU180HFA	DU180HFA
Serial Num	-	7363954
Type	UPBLAST	UPBLAST
Configuration	VERTICAL	VERTICAL

Test Data		
	Design	Actual
CFM	2550	2610
Fan RPM	1229	1035
Fan Rotation	-	CCW, CORRECT
Motor RPM	-	1035
System SetPt	-	53.1 HZ
RL Voltage	-	108 @ VFD
RL Amperage	-	4.8 @ VFD
Total ESP	1.450"	0.82"
Fan Inlet SP	-	-0.82"
Fan Discharge SP	-	ATM

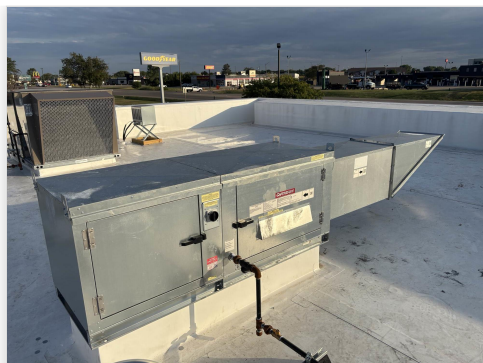
Unit Data - PHOTO LOG

Unit Data		
	Design	Actual
MFG	CAPTIVE-AIRE	CAPTIVE-AIRE
Model Num	A1-D.250-15D	A1-D.250-15D
Serial Num	-	7363954
Type	MAU	MAU
Configuration	VERTICAL	VERTICAL

Test Data		
	Design	Actual
CFM	1300	1328
SF RPM	1555	1314
Motor RPM	-	1314
SF System SetPt	-	45.3 HZ
RL Voltage	-	108 @ VFD
RL Amperage	-	2.2 @ VFD
Total ESP	-	0.46"
Fan Discharge SP	-	0.46"
