Report: TAB Report
Function: Test, Adjust, & Balance
Date: 04/01/2026
Completed By: National TAB

PROJECT
03-30-26 QT #1052 CHARLOTTE, NC

3206 EASTWAY DR

QUIKTRIP
4705 SOUTH 129TH EAST AVENUE
TULSA, OK 74134

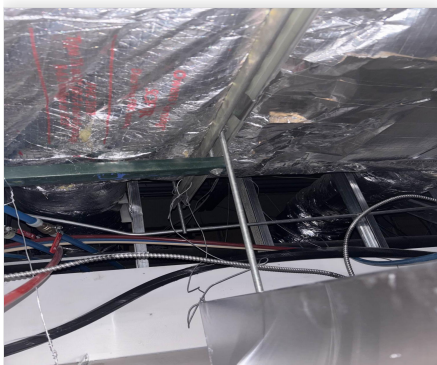
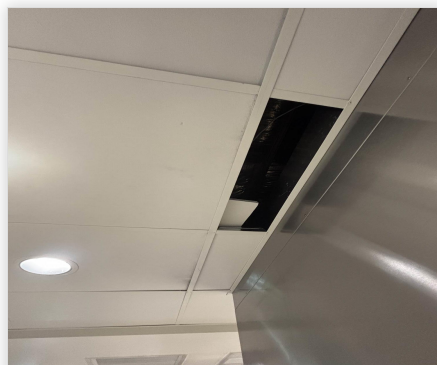
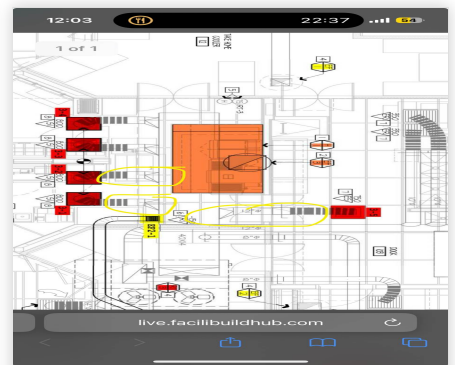
Issue Name : Cannot access dampers
Description : SGRD 1,2 and 5's dampers on RTU3 cannot be reached. The only ceiling tiles able to be moved are too thin and far from the dampers to be able to reach them. SGRD 5's damper is also on top of the duct making it farther to reach.
Created By : National TAB **Assigned To :** National TAB - Brianna Biggs
Status : Open
Priority : Urgent **Asset Tag :** RT-3
Originated Date : 04/01/2026 - Christian Moller - National TAB

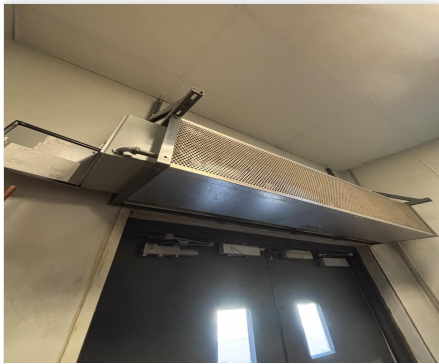
Issue Name : Door fan not running
Description : The bug fan above the back door was left with its mechanical compartment door open and wires dangling. The fan does not turn on when the door is opened.
Created By : National TAB **Assigned To :** National TAB - Brianna Biggs
Status : Open
Priority : InfoOnly **Asset Tag :**
Originated Date : 04/01/2026 - Christian Moller - National TAB

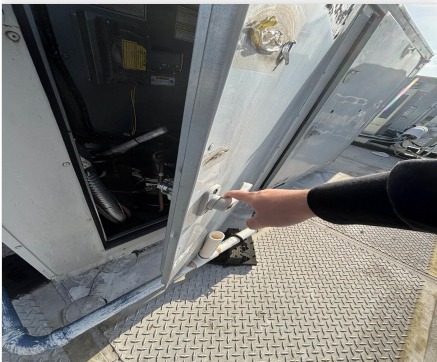
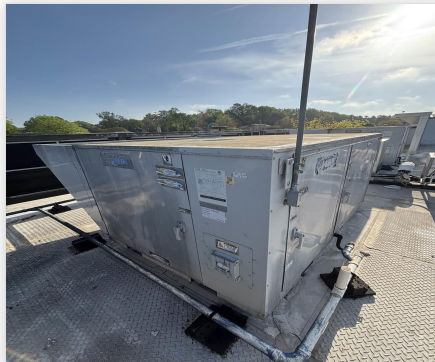
Issue Name : RTU 3 compressor door obstructed
Description : The condensate drain pipe is obstructing the compressor access door from opening fully.
Created By : National TAB **Assigned To :** National TAB - Brianna Biggs
Status : Open
Priority : Medium **Asset Tag :** RT-3
Originated Date : 04/01/2026 - Christian Moller - National TAB

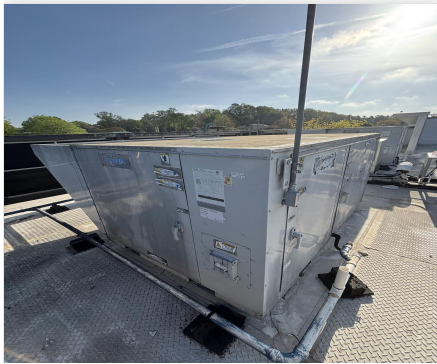
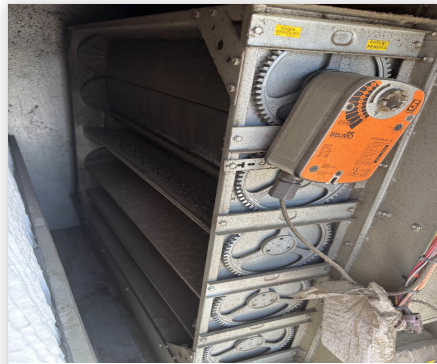
Issue Name : RTU 3 Econ not working
Description : The economizer on RTU 3 does not respond to the Emerson board nor the manual dial on the actuator itself. With its position the screws could not be taken out to manually set outside air.
Created By : National TAB **Assigned To :** National TAB - Brianna Biggs
Status : Open
Priority : Urgent **Asset Tag :** RT-3
Originated Date : 04/01/2026 - Christian Moller - National TAB

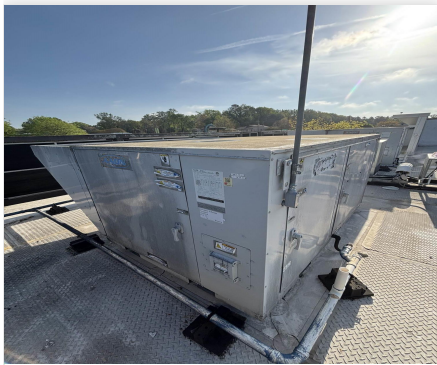
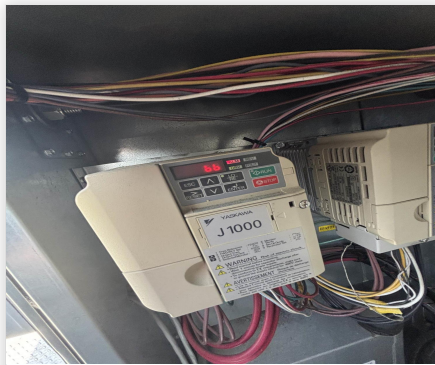
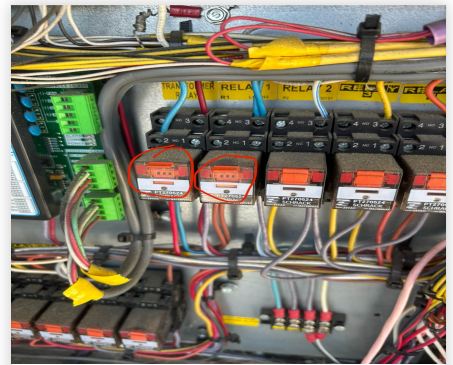
Issue Name : RTU 3 in alarm
Description : Upon arrival RTU 3 was in alarm, the VFD was flashing a 'bb' alarm. This means there is a communication issue, either telling the fan to not run or not sending a signal. The unit was put into override for balancing using the tstat and R1 relays, but set back to alarm once finished. The kitchen is getting very hot without this unit being on.
Created By : National TAB **Assigned To :** National TAB - Brianna Biggs
Status : Open
Priority : Urgent **Asset Tag :** RT-3
Originated Date : 04/01/2026 - Christian Moller - National TAB

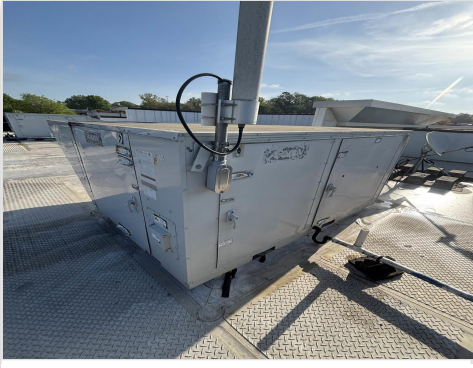
Asset: RT-1

Unit Data	
	Actual
MFG	AAON
Serial Num	201407-ANEK10595
Model Num	RN-013-8-0-EA0A-152
Num OA Filters 1	1
OA Filter Size 1	45X24
Num Final Filter 1	2
Final Filter Size 1	56X45

Test Data		
	Design	Actual
SF CFM	4200	4166
SF RPM	-	DD
OA CFM (Hoods On)	800	822
OA CFM (Hoods Off)	350	367
RL Voltage	-	209/208/207
RL Amperage	-	6.7/6.2/6.5
VFD Max SetPt	-	37Hz
VFD Min SetPt	-	24Hz
OA Damper Position (Hoods On)	-	46%
OA Damper Position (Hoods Off)	-	34%

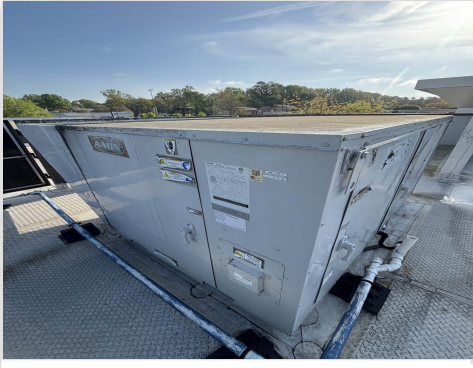
Asset: RT-2

Unit Data	
	Actual
MFG	AAON
Serial Num	201407-ANEK10596
Model Num	RN-013-8-0-EA0A
Num OA Filters 1	1
OA Filter Size 1	45X24
Num Final Filter 1	2
Final Filter Size 1	56X45

Test Data		
	Design	Actual
SF CFM	4200	4308
SF RPM	-	DD
OA CFM (Hoods On)	800	768
OA CFM (Hoods Off)	350	339
RL Voltage	-	207/208/207
RL Amperage	-	6.6/5.9/5.5
VFD Max SetPt	-	36Hz
VFD Min SetPt	-	24Hz
OA Damper Position (Hoods On)	-	46%
OA Damper Position (Hoods Off)	-	34%

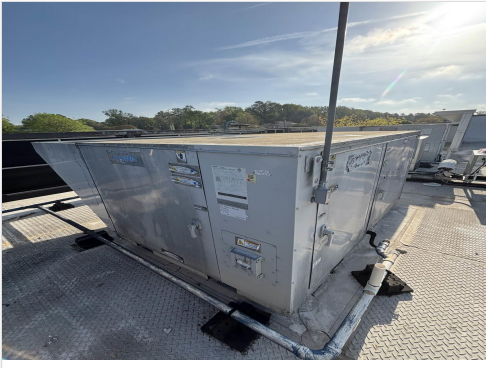
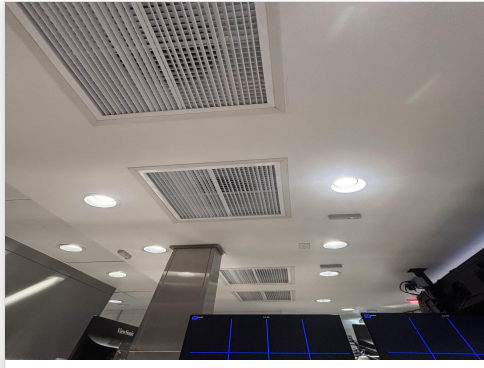
Asset: RT-3

Unit Data	
	Actual
MFG	AAON
Serial Num	201407-ANEK10597
Model Num	RN-013-8-0-EA0A-152
Num OA Filters 1	1
OA Filter Size 1	45X24
Num Final Filter 1	2
Final Filter Size 1	56X45

Test Data		
	Design	Actual
SF CFM	4200	4019
SF RPM	-	DD
OA CFM (Hoods On)	800	0
OA CFM (Hoods Off)	350	0
RL Voltage	-	205/207/206
RL Amperage	-	7.8/7.5/8.1
VFD Max SetPt	-	40.8Hz
VFD Min SetPt	-	24Hz
OA Damper Position (Hoods On)	-	0%
OA Damper Position (Hoods Off)	-	0%

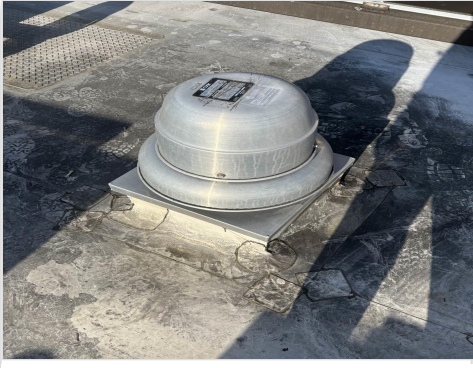
Asset: EF1

Unit Data		
	Design	Actual
MFG	NA	COOK
Model Num	NA	90 ACEH 90C15DH
Serial Num	-	410SE13845- 00/0005505
Type	-	DOWNBLAST
Configuration	-	VERTICAL

Test Data		
	Design	Actual
CFM	225	213
Fan RPM	-	DD
Fan Rotation	-	CORRECT
Motor RPM	-	DD
System SetPt	-	SPEED CONTROLLER / MEDIUM SPEED
RL Voltage	-	113
RL Amperage	-	1.2
Total ESP	-	0.21"
Fan Inlet SP	-	-0.21"
Fan Discharge SP	-	ATM

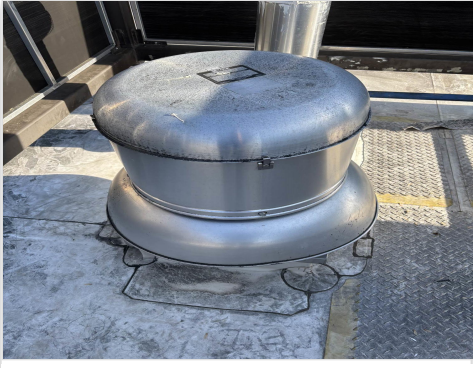
Asset: EF2

Unit Data		
	Design	Actual
MFG	NA	COOK
Model Num	NA	120 ACE 120C15D
Serial Num	-	410SE152**-00/0007202
Type	-	DOWNBLAST
Configuration	-	VERTICAL

Test Data		
	Design	Actual
CFM	525	457
Fan RPM	-	DD
Fan Rotation	-	CORRECT
Motor RPM	-	DD
System SetPt	-	SPEED CONTROLLER / MEDIUM SPEED
RL Voltage	-	111
RL Amperage	-	2.6
Total ESP	-	0.56"
Fan Inlet SP	-	-0.56
Fan Discharge SP	-	ATM

** IN THE SERIAL NUMBER ARE OBSTRUCTED NUMBERS

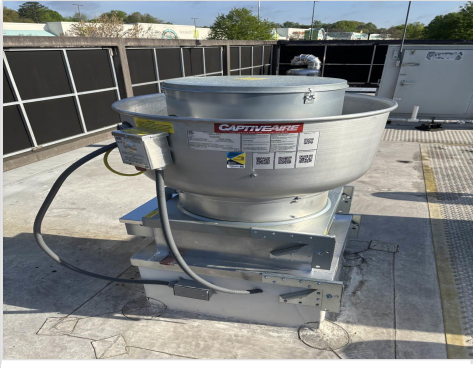
Asset: EF3

Unit Data		
	Design	Actual
MFG	NA	CAPTIVEAIRE
Model Num	NA	DU50HFA
Serial Num	-	8262110
Type	UPBLAST	UPBLAST
Configuration	VERTICAL	VERTICAL

Test Data		
	Design	Actual
CFM	1350	1372
Fan RPM	-	DD
Fan Rotation	-	CORRECT
Motor RPM	-	DD
System SetPt	-	HMI / 54.8Hz
RL Voltage	-	210
RL Amperage	-	3.2
Total ESP	0.75"	0.81"
Fan Inlet SP	-	-0.81"
Fan Discharge SP	-	ATM

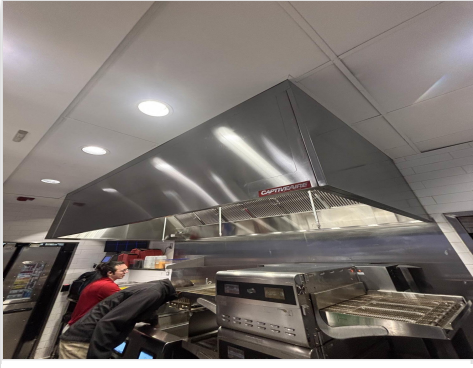
Asset: HD1

Unit Data		
	Design	Actual
MFG	CAPTIVEAIRE	CAPTIVEAIRE
Model Num	6030ND-2-F	6030ND-2
Job / Serial Num	-	8262110
Type	TYPE I CANOPY	TYPE I CANOPY
Hood length	108"	108"
Hood Width	60"	60"

Test Data Exhaust		
	Design	Actual
Filter Type	CAPTRATE SOLO FILTER	BAFFLE FILTERS
Filter Size 1	20X16	20X16
Filter Qty 1	6	6
Filter AK factor size 1	2.08	2.08
Filter Total AK Area	12.48	12.48
Filter1 FPM	-	104
Filter2 FPM	-	116
Filter3 FPM	-	128
Filter4 FPM	-	108
Filter5 FPM	-	105
Filter6 FPM	-	104
Filter Ave FPM(corr)	-	110
CFM	1350	1372
