Report: TAB Report
Function: Test, Adjust, & Balance
Date: 06/24/2025
Completed By: National TAB

06-09-25 CHIPOTLE #5491 WINCHESTER, KY

550 BULLION BLVD

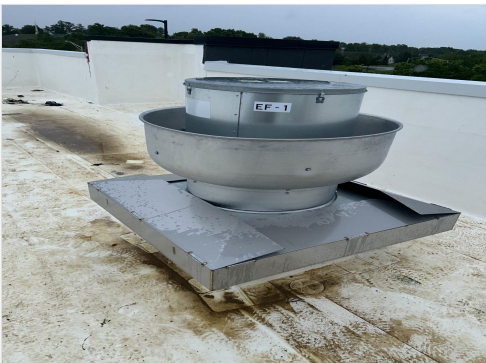
Unit Data - PHOTO LOG

Asset: EF1

Unit Data		
	Design	Actual
MFG	CAPTIVEAIRE	CAPTIVEAIRE
Model Num	DU180HFA	DU180HFA
Serial Num	-	7196239
Type	UPBLAST	UPBLAST
Configuration	VERTICAL	VERTICAL

Test Data		
	Design	Actual
CFM	2550	2609
Fan RPM	-	NA
Fan Rotation	-	CCW
Motor RPM	-	NA
RL Voltage	-	209
RL Amperage	-	4.9
Total ESP	1.45"	NA
Fan Inlet SP	-	NA
Fan Discharge SP	-	ATM

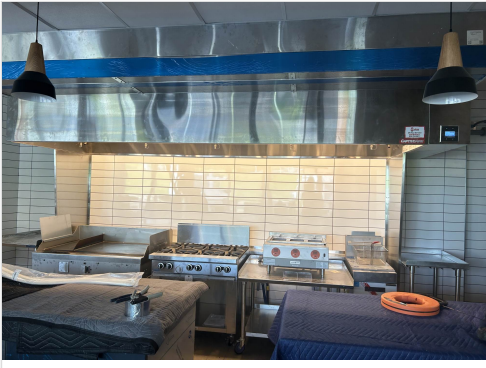
Unit Data - PHOTO LOG

Asset: HD1

Unit Data		
	Design	Actual
MFG	CAPTIVEAIRE	CAPTIVEAIRE
Model Num	5424 ND-2-ACPSP-F	5424 ND-2-ACPSP-F
Job / Serial Num	-	7196239
Type	CANOPY	TYPE I CANOPY
Hood length	153"	153"
Hood Width	54"	54"
Supply Plenum Type	-	ACPSP
Supply Plenum Width	9"	9"
Supply Plenum Length	165"	165"

Test Data Exhaust		
	Design	Actual
Filter Type	CAPTRATE SOLO FILTER	CAPTRATE SOLO FILTER
Filter Size 1	16X16"	16X16"
Filter Qty 1	9	9
Filter AK factor size 1	1.62	1.62
Filter Total AK Area	14.58"	14.58"
Filter1 FPM	-	166
Filter2 FPM	-	157
Filter3 FPM	-	177
Filter4 FPM	-	186
Filter5 FPM	-	191
Filter6 FPM	-	203
Filter7 FPM	-	180
Filter8 FPM	-	172
Filter9 FPM	-	179
Filter Ave FPM(corr)	-	179
CFM	2550	2609

Test Data Supply		
	Design	Actual
Total Area	10.31"	10.31"
Kv factor (Vel)	0.81"	0.81"
Num of Readings	-	9
Reading1 FPM	-	179
Reading2 FPM	-	123
Reading3 FPM	-	143
Reading4 FPM	-	175
Reading5 FPM	-	143
Reading6 FPM	-	171
Reading7 FPM	-	184
Reading8 FPM	-	163
Reading9 FPM	-	234
Ave FPM(corr)	-	168
CFM	1300	1402
