**Report: TAB Report**  
**Function: Test, Adjust, & Balance**  
**Date: 06/24/2025**  
**Completed By: National TAB**

**06-09-25 CHIPOTLE #5491 WINCHESTER, KY**

550 BULLION BLVD

Chipotle Mexican Grill  
610 Newport Center Drive, Suite 1100  
Newport Beach, CA 92660

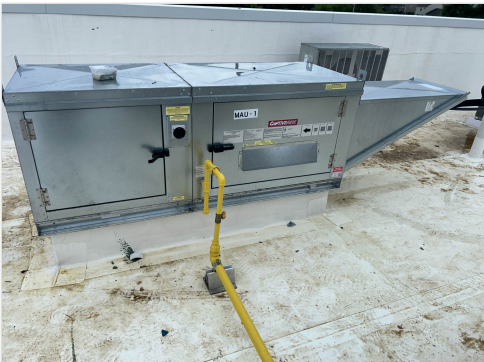
### Unit Data - PHOTO LOG

Unit Data		
	Design	Actual
MFG	CAPTIVEAURE	CAPTIVEAURE
Model Num	A1-D.250-15D	A1-D.250-15D
Serial Num	-	7196239
Type	MAU	MAU
Configuration	HORIZONTAL	HORIZONTAL

Test Data		
	Design	Actual
CFM	1300	1402
SF RPM	-	1690
SF System SetPt	-	60HZ
RL Voltage	-	208
RL Amperage	-	2.7
Fan Discharge SP	-	0.09
