**Report: TAB Report**  
**Function: Test, Adjust, & Balance**  
**Date: 06/24/2025**  
**Completed By: National TAB**

**06-09-25 CHIPOTLE #5491 WINCHESTER, KY**

550 BULLION BLVD

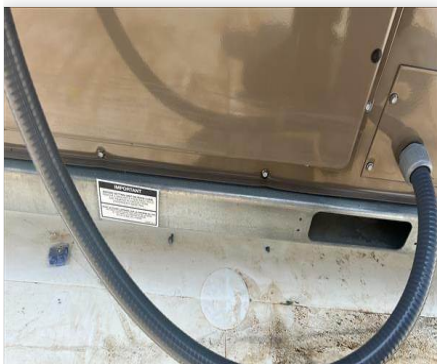
**Issue Name :** RTU-1 leakage / low on flow  
**Description :** RTU-1 is 85% of design with the motor operating at FLA. There is a leak at the base of the RTU near the discharge panel that needs to be sealed on the roof. Recommend re-testing once sealed  
**Created By :** National TAB                      **Assigned To :** National TAB - Dan Hertenstein  
**Status :** Open  
**Priority :** **Urgent**                                      **Asset Tag :**  
**Originated Date :** 06/10/2025 - Aaron Cosby - National TAB

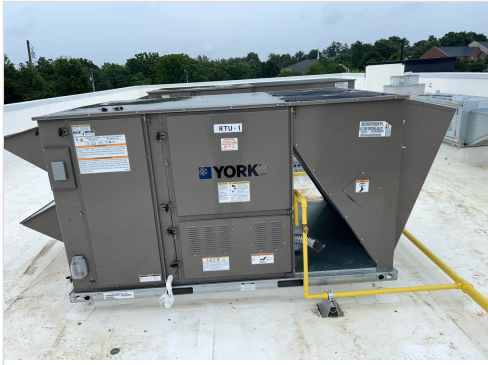
## Unit Data - PHOTO LOG

Asset: RTU1

Unit Data		
	Design	Actual
MFG	YORK	YORK
Serial Num	-	N2D5589653
Model Num	ZJ120	ZJ120
Type	RTU	RTU
Configuration	VERTICAL	VERTICAL
Num OA Filters 1	-	1
OA Filter Size 1	-	29X20"
Num Final Filter 1	-	4
Final Filter Size 1	-	20X24X2"

General	
	Actual
Fan Rotation Correct	GOOD
Unit Filters Clean	NO
Condensate Drain Installed	YES

Notes:  
Unit was slowed down to 57hz as it was running above FLA

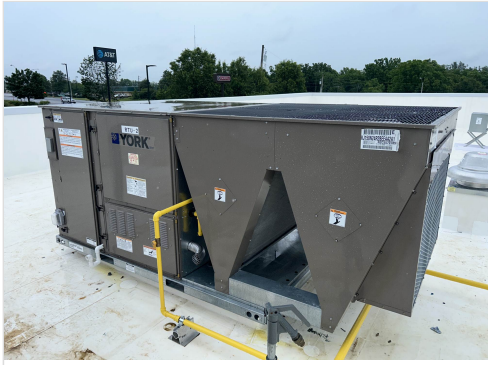
## Unit Data - PHOTO LOG

Asset: RTU2

Unit Data		
	Design	Actual
MFG	YORK	YORK
Serial Num	-	N2C5570789
Model Num	ZJ120	ZJ120
Type	RTU	RTU
Configuration	VERTICAL	VERTICAL
Num OA Filters 1	-	1
OA Filter Size 1	-	29X20"
Num Final Filter 1	-	4
Final Filter Size 1	-	20X24X2"

General	
	Actual
Fan Rotation Correct	GOOD
Unit Filters Clean	NO
Condensate Drain Installed	YES

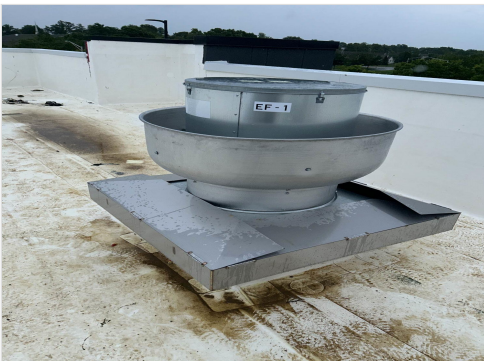
### Unit Data - PHOTO LOG

Asset: EF1

Unit Data		
	Design	Actual
MFG	CAPTIVEAIRE	CAPTIVEAIRE
Model Num	DU180HFA	DU180HFA
Serial Num	-	7196239
Type	UPBLAST	UPBLAST
Configuration	VERTICAL	VERTICAL

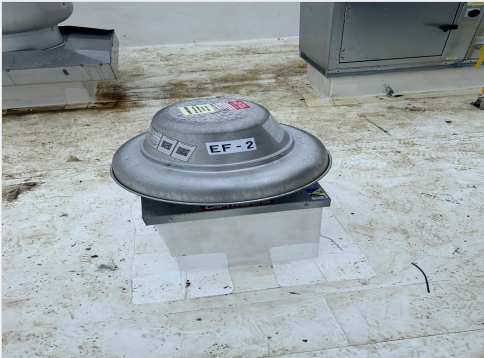
### Unit Data - PHOTO LOG

Asset: EF2

Unit Data		
	Design	Actual
MFG	CAPTIVEAIRE	CAPTIVEAIRE
Model Num	DR12HFA	DR12HFA
Serial Num	-	7196239
Type	DOWNBLAST	DOWNBLAST
Configuration	VERTICAL	VERTICAL

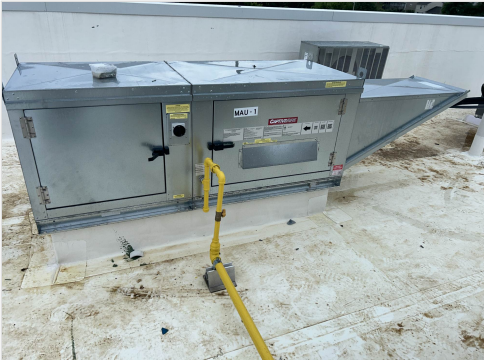
### Unit Data - PHOTO LOG

Asset: MAU1

Unit Data		
	Design	Actual
MFG	CAPTIVEAURE	CAPTIVEAURE
Model Num	A1-D.250-15D	A1-D.250-15D
Serial Num	-	7196239
Type	MAU	MAU
Configuration	HORIZONTAL	HORIZONTAL

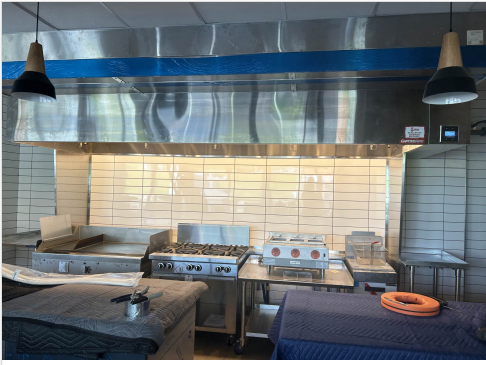
## Unit Data - PHOTO LOG

Asset: HD1

Unit Data		
	Design	Actual
MFG	CAPTIVEAIRE	CAPTIVEAIRE
Model Num	5424 ND-2-ACPSP-F	5424 ND-2-ACPSP-F
Job / Serial Num	-	7196239
Type	CANOPY	TYPE I CANOPY
Hood length	153"	153"
Hood Width	54"	54"
Supply Plenum Type	-	ACPSP
Supply Plenum Width	9"	9"
Supply Plenum Length	165"	165"
