Report: TAB Report

Function: Test, Adjust, & Balance

06-09-25 CHIPOTLE #5491 WINCHESTER, KY

Chipotle Mexican Grill

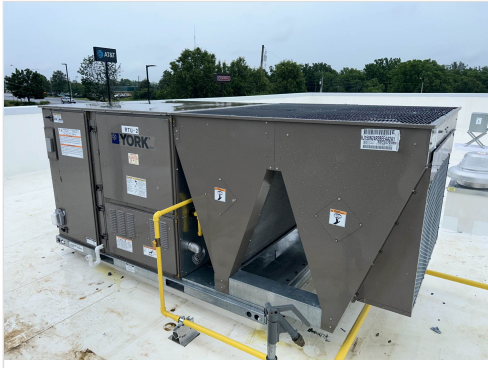
Unit Data - PHOTO LOG

Asset: RTU2

AREA:DINING

Unit Data		
	Design	Actual
MFG	YORK	YORK
Serial Num	-	N2C5570789
Model Num	ZJ120	ZJ120
Type	RTU	RTU
Configuration	VERTICAL	VERTICAL
Num OA Filters 1	-	1
OA Filter Size 1	-	29X20"
Num Final Filter 1	-	4
Final Filter Size 1	-	20X24X2"

General	
	Actual
Fan Rotation Correct	GOOD
Unit Filters Clean	NO
Condensate Drain Installed	YES

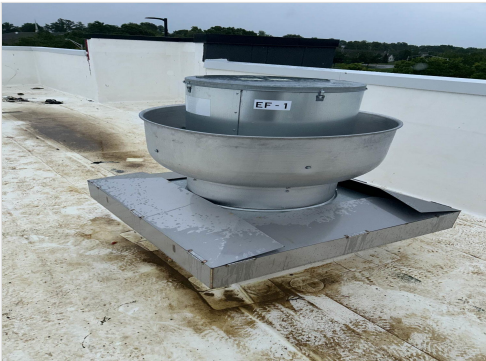
Unit Data - PHOTO LOG

Asset: EF1

AREA:HOOD #1

Unit Data		
	Design	Actual
MFG	CAPTIVEAIRE	CAPTIVEAIRE
Model Num	DU180HFA	DU180HFA
Serial Num	-	7196239
Type	UPBLAST	UPBLAST
Configuration	VERTICAL	VERTICAL

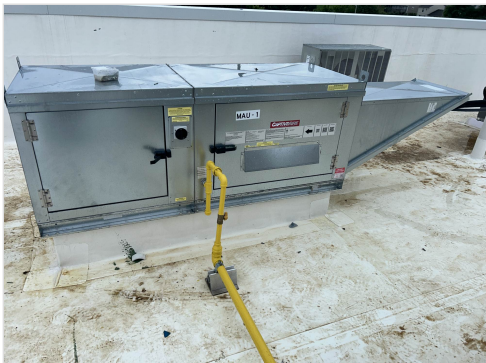
Unit Data - PHOTO LOG

Asset: MAU1

AREA:HOOD #1

Unit Data		
	Design	Actual
MFG	CAPTIVEAURE	CAPTIVEAURE
Model Num	A1-D.250-15D	A1-D.250-15D
Serial Num	-	7196239
Type	MAU	MAU
Configuration	HORIZONTAL	HORIZONTAL
