**Report: TAB Report**  
**Function: Test, Adjust, & Balance**  
**Date: 06/24/2025**  
**Completed By: National TAB**

**06-09-25 CHIPOTLE #5491 WINCHESTER, KY**

550 BULLION BLVD

WINCHESTER, KY 40391

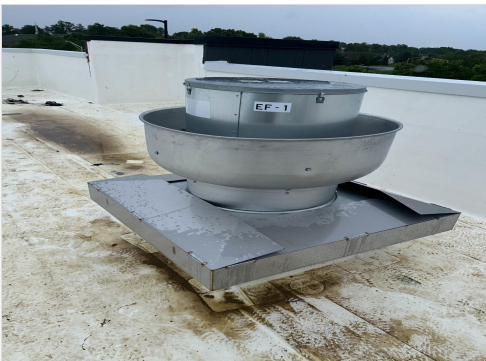
### Unit Data - PHOTO LOG

Asset: EF1

Unit Data		
	Design	Actual
MFG	CAPTIVEAIRE	CAPTIVEAIRE
Model Num	DU180HFA	DU180HFA
Serial Num	-	7196239
Type	UPBLAST	UPBLAST
Configuration	VERTICAL	VERTICAL

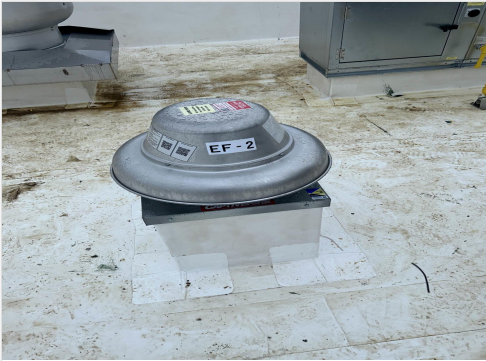
### Unit Data - PHOTO LOG

Asset: EF2

Unit Data		
	Design	Actual
MFG	CAPTIVEAIRE	CAPTIVEAIRE
Model Num	DR12HFA	DR12HFA
Serial Num	-	7196239
Type	DOWNBLAST	DOWNBLAST
Configuration	VERTICAL	VERTICAL

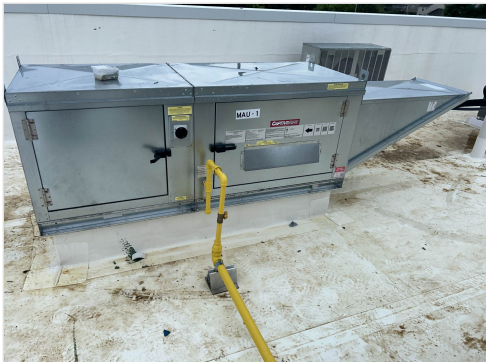
### Unit Data - PHOTO LOG

Asset: MAU1

Unit Data		
	Design	Actual
MFG	CAPTIVEAURE	CAPTIVEAURE
Model Num	A1-D.250-15D	A1-D.250-15D
Serial Num	-	7196239
Type	MAU	MAU
Configuration	HORIZONTAL	HORIZONTAL
