**Report: TAB Report**  
**Function: Test, Adjust, & Balance**  
**Date: 06/02/2025**  
**Completed By: National TAB**

**06-02-25 CHIPOTLE #4119 MERCERVILLE, NJ**

249 ROUTE 33

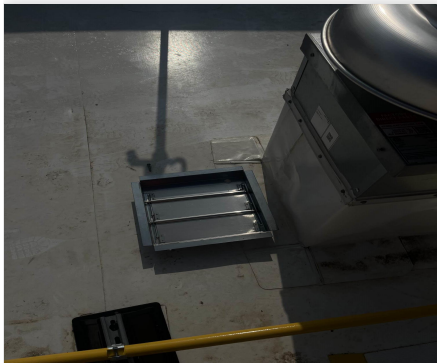
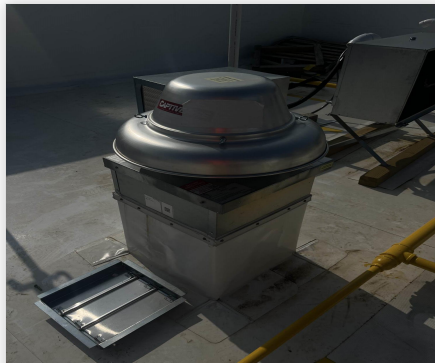
**Issue Name :** EF-2 Backdraft damper  
**Description :** EF-2 Backdraft damper is not installed. Damper needs to be installed so OA and pest can not enter the space when the fan is off.  
**Created By :** National TAB                      **Assigned To :** National TAB - Dan Hertenstein  
**Status :** Open  
**Priority :** Low                                      **Asset Tag :**  
**Originated Date :** 06/02/2025 - Tyler Youells - National TAB

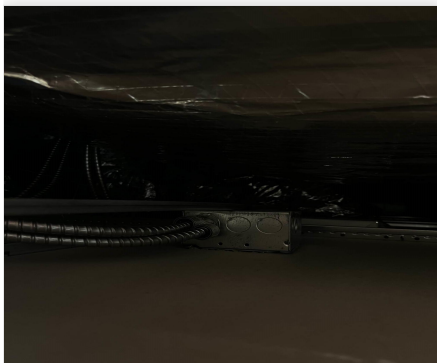
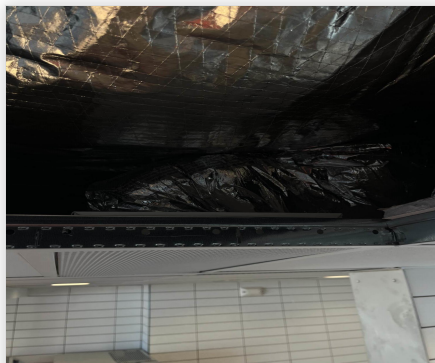
**Issue Name :** Low Flow Diffusers 1-4 to 1-7  
**Description :** Diffusers 1-4 thru 1-7 are all low on flow. Approximately 60-70% flow due to the flex duct being pinched underneath of RTU-2 supply duct. Hood ACSP left high on flow to try to account for missing air on the serve line.  
**Created By :** National TAB                      **Assigned To :** National TAB - Dan Hertenstein  
**Status :** Open  
**Priority :** High                                      **Asset Tag :**  
**Originated Date :** 06/02/2025 - Tyler Youells - National TAB

Asset	Notes	Date	Written By
SGRD4	[1] FLEX DUCT IS PINCHED BETWEEN DIFFUSER AND RTU-2 CSUPPLY DUCT. DESIGN FLOW NOT ACHIEVABLE.	06/02/2025	Tyler Youells
SGRD5	[1] FLEX DUCT IS PINCHED BETWEEN DIFFUSER AND RTU-2 CSUPPLY DUCT. DESIGN FLOW NOT ACHIEVABLE.	06/02/2025	Tyler Youells
SGRD6	[1] FLEX DUCT IS PINCHED BETWEEN DIFFUSER AND RTU-2 CSUPPLY DUCT. DESIGN FLOW NOT ACHIEVABLE.	06/02/2025	Tyler Youells
SGRD7	[1] FLEX DUCT IS PINCHED BETWEEN DIFFUSER AND RTU-2 CSUPPLY DUCT. DESIGN FLOW NOT ACHIEVABLE.	06/02/2025	Tyler Youells
SGRD10	[1]BALANCED ABOVE DESIGN FLOW TO ACCOUNT FOR MISSING CFM FROM DIFFUSER S 4-7	06/02/2025	Tyler Youells

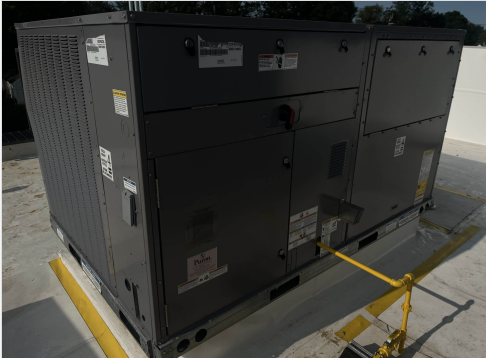
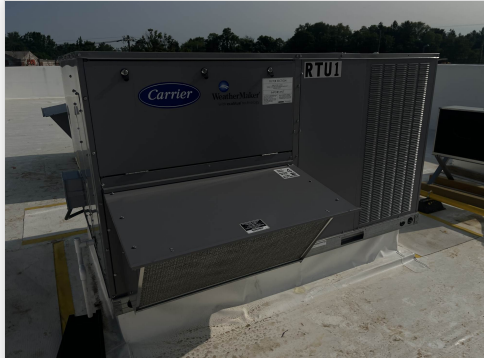
## Unit Data - PHOTO LOG

Asset: RTU1

Unit Data		
	Design	Actual
MFG	CARRIER	CARRIER
Serial Num	-	1923P60236
Model Num	48HC_D09	48FCDM09A3M5A6W4C0
Type	RTU	RTU
Configuration	VERTICAL	VERTICAL
Num OA Filters 1	-	1
OA Filter Size 1	-	36X20
Num Final Filter 1	-	4
Final Filter Size 1	-	20X20X2

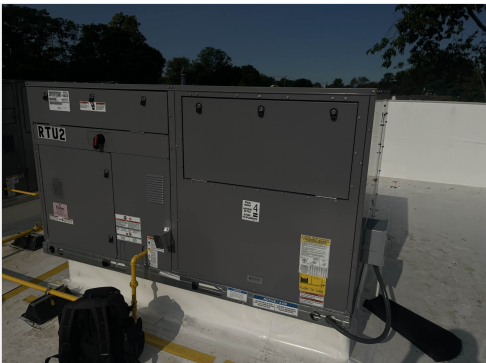
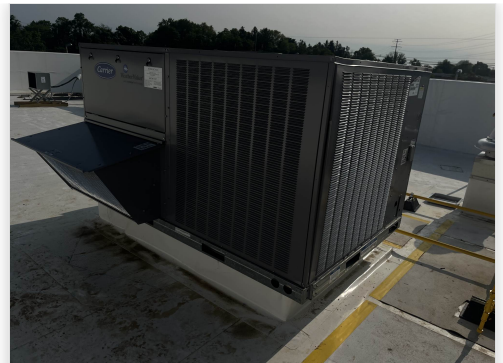
## Unit Data - PHOTO LOG

Asset: RTU2

Unit Data		
	Design	Actual
MFG	CARRIER	CARRIER
Serial Num	-	1823P79275
Model Num	48HC_D11	48FCEM12A3M5A6W4C0
Type	RTU	RTU
Configuration	VERTICAL	VERTICAL
Num OA Filters 1	-	1
OA Filter Size 1	-	36X20
Num Final Filter 1	-	4
Final Filter Size 1	-	20X20X2

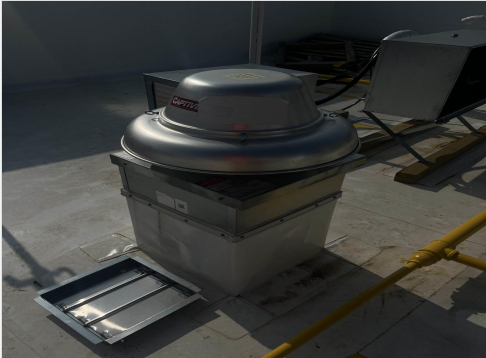
## Unit Data - PHOTO LOG

NOT INSTALLED

Asset: EF2

Unit Data		
	Design	Actual
MFG	CAPTIVEAIRE	CAPTIVEAIRE
Model Num	DR12HFA	DR12HFA
Serial Num	-	5689583
Type	DOWNBLAST	DOWNBLAST
Configuration	VERTICAL	VERTICAL

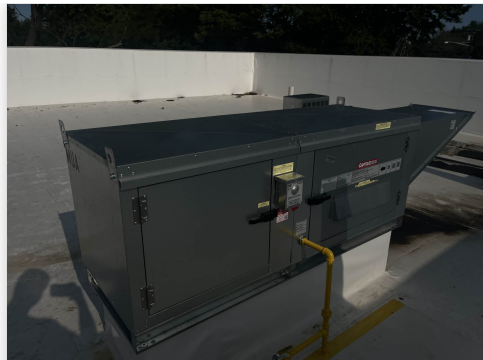
### Unit Data - PHOTO LOG

Asset: MAU1

Unit Data		
	Design	Actual
MFG	CAPTIVEAIRE	CAPTIVEAIRE
Model Num	A1-D.250-G10	A1-D.250-G10
Serial Num	-	5689583
Type	MAU	MUA
Configuration	VERTICAL	VERTICAL

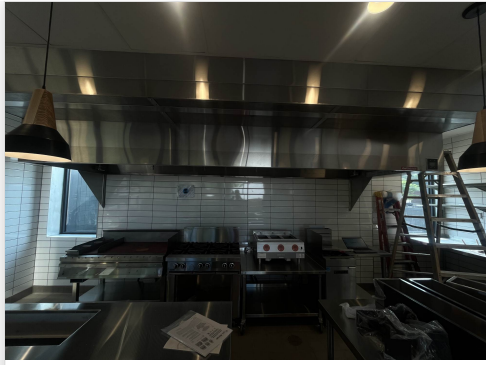
## Unit Data - PHOTO LOG

Asset: HD1

Unit Data		
	Design	Actual
MFG	CAPTIVEAIRE	CAPTIVEAIRE
Model Num	5424 ND-2-ACPSP-F	5424 ND-2-ACPSP-F
Job / Serial Num	-	5689583
Type	CANOPY	CANOPY
Hood length	171"	171"
Hood Width	54"	54"
Supply Plenum Type	-	ACPSP
Supply Plenum Width	12"	12"
Supply Plenum Length	183"	183"
