**Report: FINAL TAB REPORT
Function: Test, Adjust, & Balance
Date: 10/03/2022**

**PROJECT
09-26 NIKE - CARLSBAD, CA**

Project: 09-26 NIKE - CARLSBAD, CA

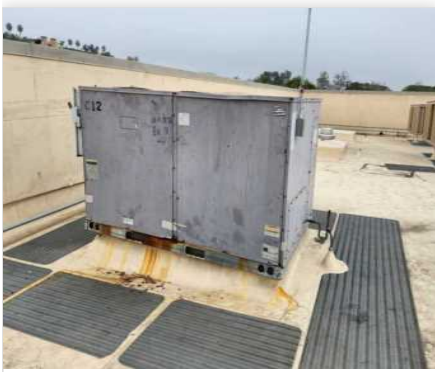
rtu3.png

Issue Name : RTU-3 ECONOMIZER NOT INSTALLED

Description : OA ECONOMIZER NOT INSTALLED

Notes: No economizers installed
