**National TAB  
1329 E. KEMPER ROAD  
SUITE 4210  
CINCINNATI, OH 45246**

**Report: FINAL TAB REPORT  
Function: Test, Adjust, & Balance  
Date: 10/03/2022**

**PROJECT  
09-26 NIKE - CARLSBAD, CA**

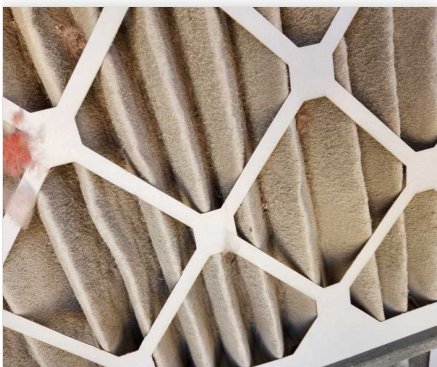
20220926\_121606.jpg

**Issue Name :** Dirty filters  
**Description :** Most RTU'S have significant filter loading  
**Created By :** National TAB                      **Assigned To :** National TAB - Will Turnbough  
**Status :** Open  
**Originated Date :** 09/27/2022 - Zack Eismin - National TAB

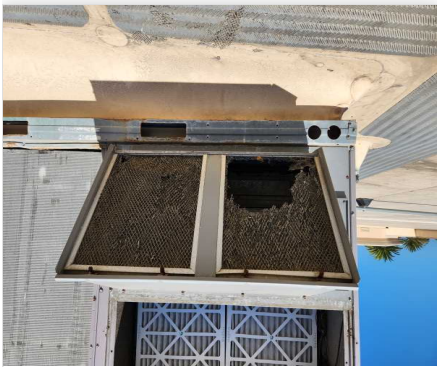
20220926\_123617.jpeg

**Issue Name :** RTU-2 OA FILTER CONDITION  
**Description :** OA filter is damaged replacement needed  
**Created By :** National TAB                      **Assigned To :** National TAB - Will Turnbough  
**Status :** Open  
**Originated Date :** 09/27/2022 - Zack Eismin - National TAB

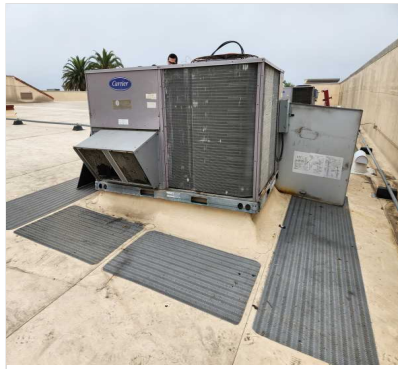
| <b>Description :</b> | RTU-2 has a blown fuse. Replacement required | | |
