**Report: FINAL TAB REPORT  
Function: Test, Adjust, & Balance  
Date: 10/03/2022**

**PROJECT  
09-26 NIKE - CARLSBAD, CA**

# National TAB

Project: 09-26 NIKE - CARLSBAD, CA

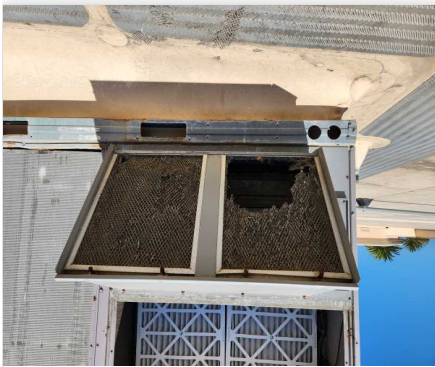
20220926\_123617.jpeg

**Issue Name :** RTU-2 OA FILTER CONDITION

**Description :** OA filter is damaged replacement needed

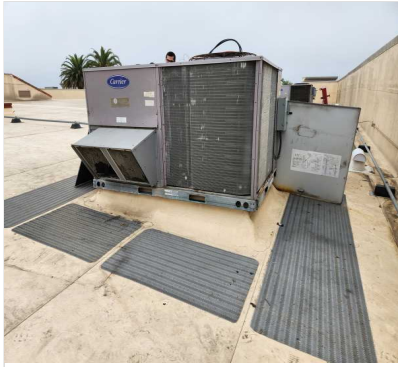
**Description :** RTU-2 has a blown fuse. Replacement required
