Report: FINAL TAB REPORT
Function: Test, Adjust, & Balance
Date: 10/03/2022

PROJECT
09-26 NIKE - CARLSBAD, CA

Project: 09-26 NIKE - CARLSBAD, CA

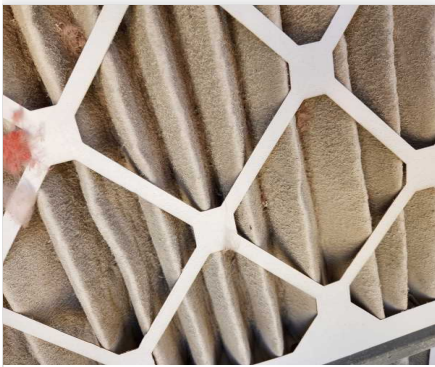
20220926_121606.jpg

Issue Name : Dirty filters

Description : Most RTU'S have significant filter loading

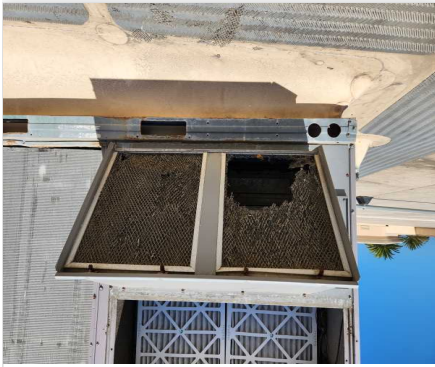
20220926_123617.jpeg

Issue Name : RTU-2 OA FILTER CONDITION

Description : OA filter is damaged replacement needed
