**Report: Renew
Date: 2/23/2022**

**PROJECT
FREDDY'S - CREVE COEUR MO - RENEW 4B (4)**

Project: FREDDY'S - CREVE COEUR MO - RENEW 4B (4)

Project Summary

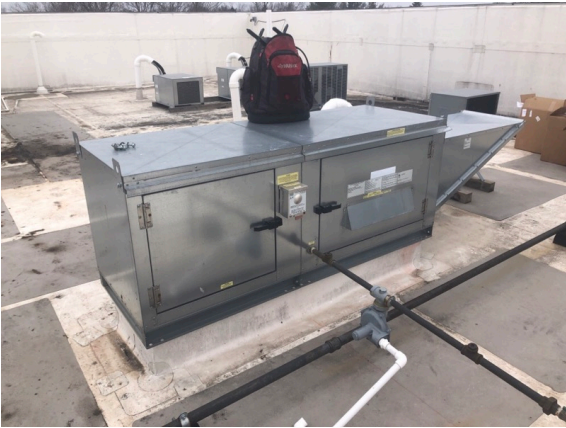
MAU
HD-1 & HD-2

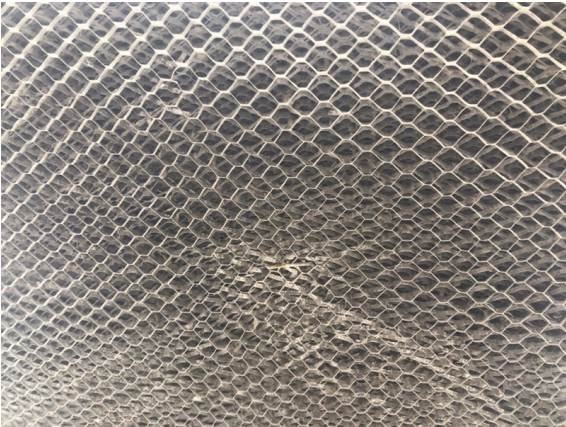
MAU
Dirty outside air filters

MAU: The intake filters had slight dirt accumulation. They were washed.

Notes: [1] FILTERS NOT CLEANED DUE TO BELOW FREEZING TEMPERATURES.

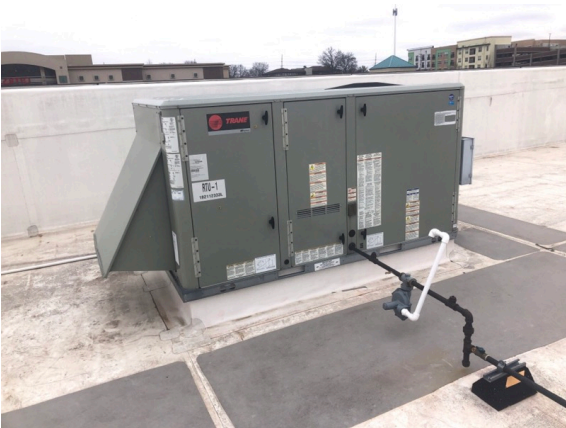
RTU-1
Dining

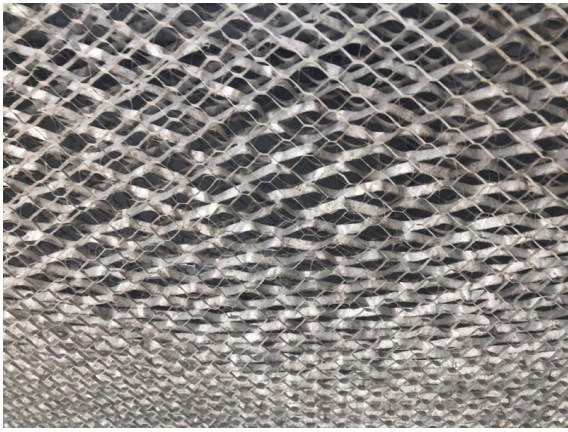
RTU-1
Dirty outside air filters

Notes: [1] OA FILTERS AND COIL NOT CLEANED DUE TO BELOW FREEZING TEMPERATURES.

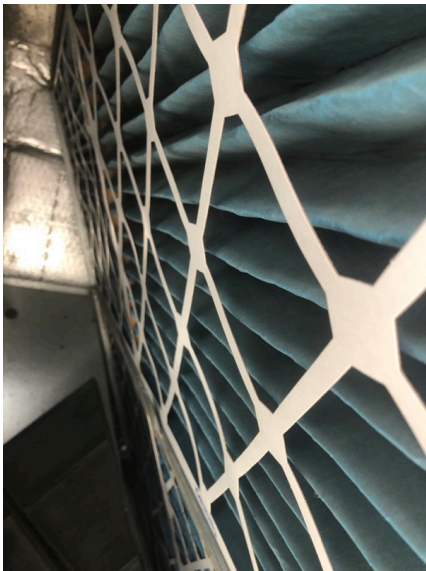
RTU-1
Dirty evaporator filters

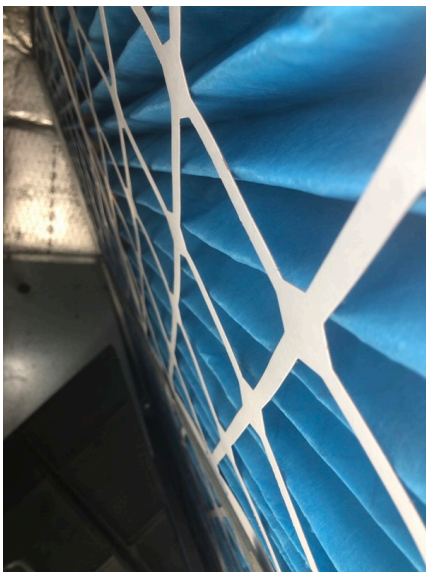
RTU-1
Clean evaporator filters

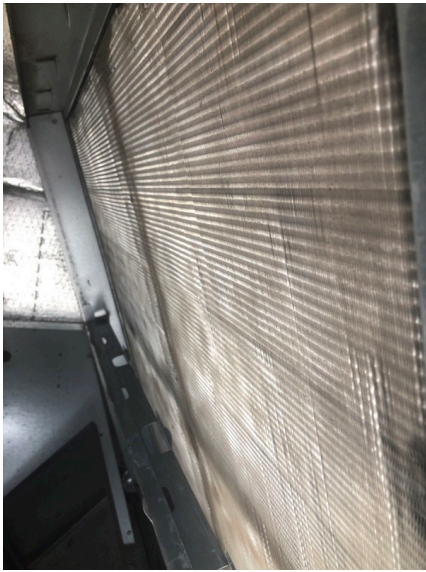
RTU-1
Dirty evaporator coil

RTUs: There evaporator coil was rinsed off and cleaned. During warmer months a self-cleaning chemical is sprayed on the evaporator. The outside air filters were rinsed off to remove any dirty, so the unit stays at the designated outside air set point. Based on static pressures, amps, and fan rpm it shows that the total supply has not changed since the last test and balance.

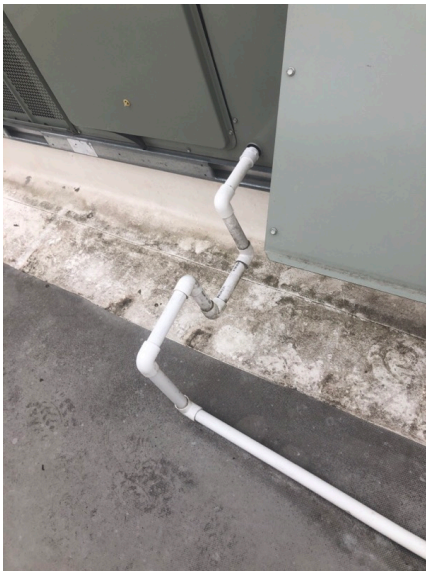
RTU-1
Condensate drain

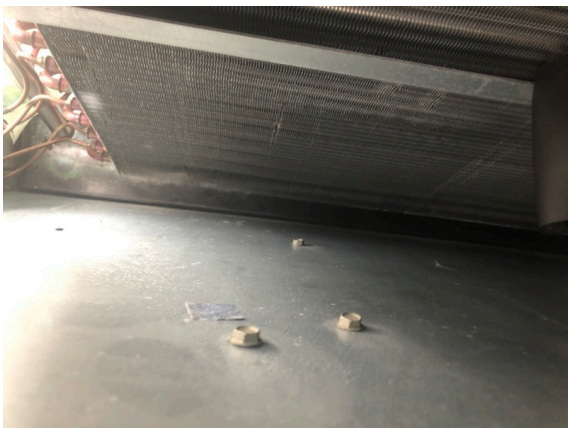
RTU-1
Drain pan

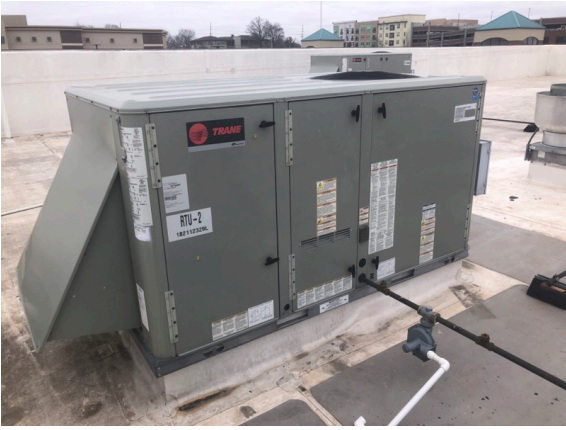
RTU-2
Dining

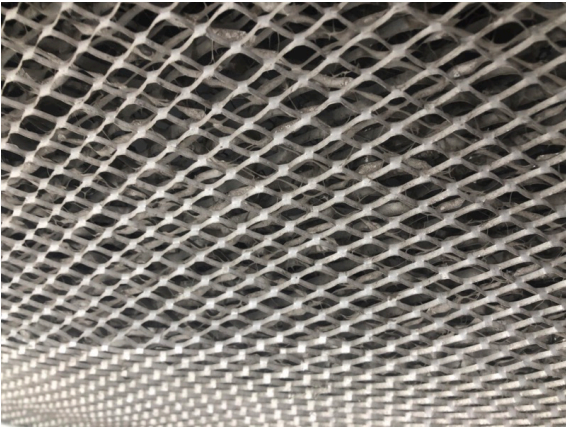
RTU-2
Dirty outside air filters

Notes: [1] OA FILTERS AND COIL NOT CLEANED DUE TO BELOW FREEZING TEMPERATURES.

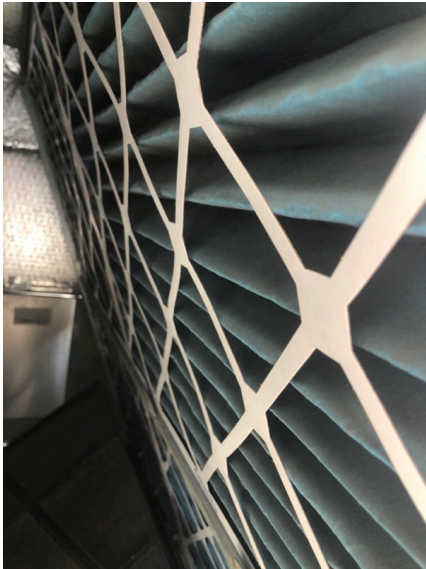
RTU-2
Dirty evaporator filters

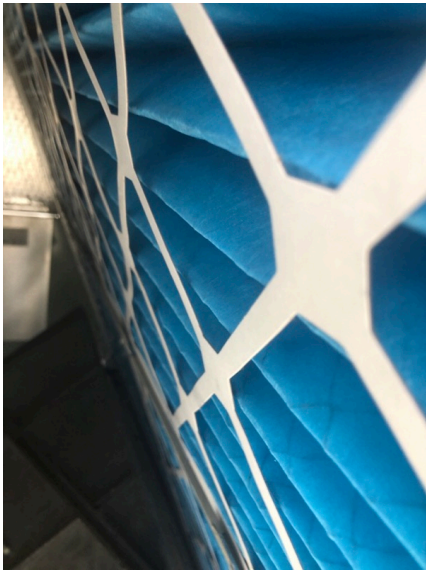
RTU-2
Clean evaporator filters

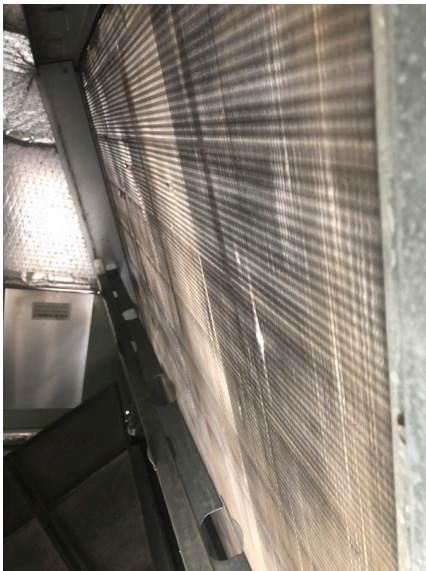
RTU-2
Dirty evaporator coil

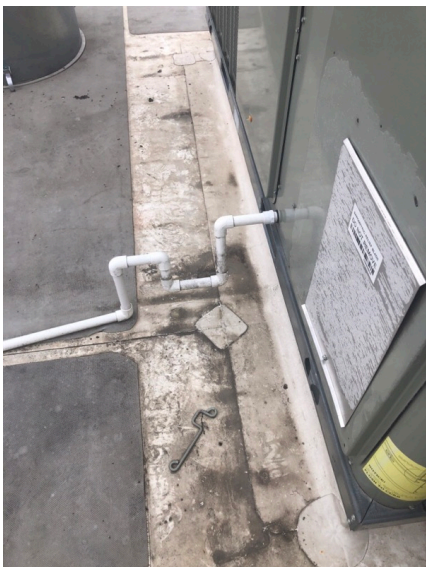
RTU-2
Condensate drain

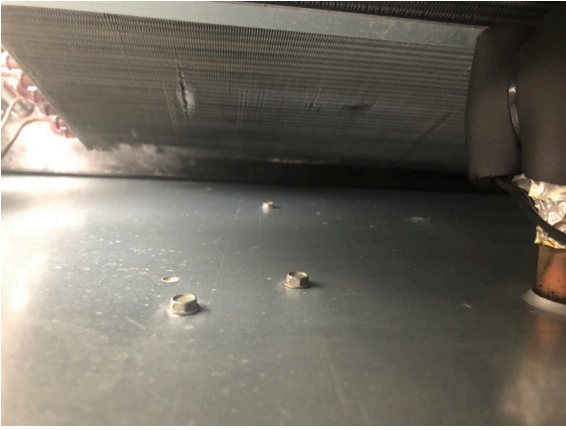
RTU-2
Drain pan

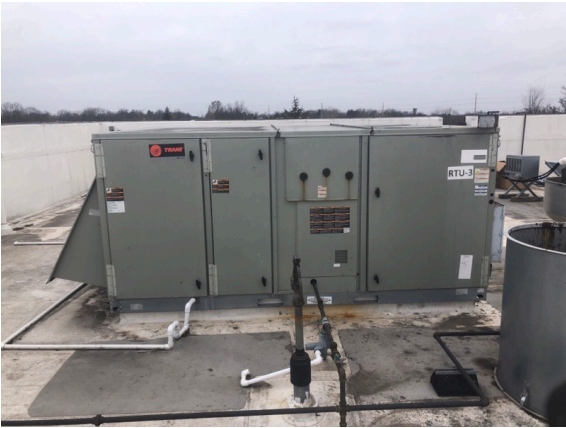
RTU-3
Kitchen

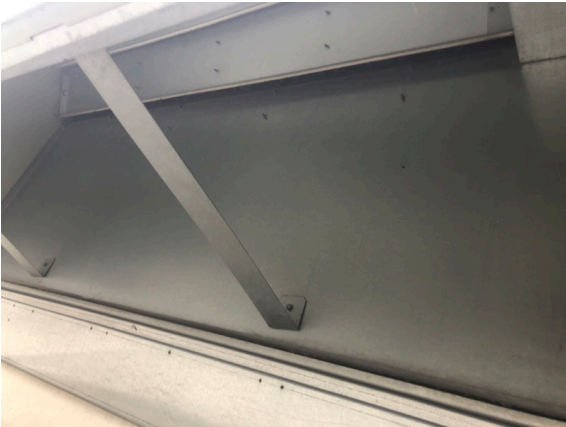
RTU-3
Dirty outside air filters

Notes: [1] OA FILTERS AND COIL NOT CLEANED DUE TO BELOW FREEZING TEMPERATURES.
 [2] OA FILTER BROKEN AND SET ON ROOF NEXT TO UNIT, CANNOT INSTALL.

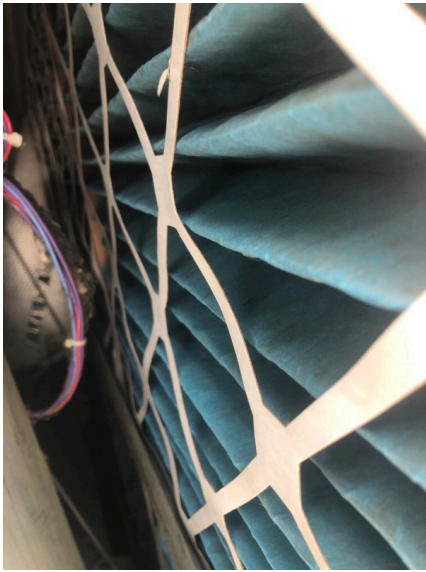
RTU-3
Dirty evaporator filters

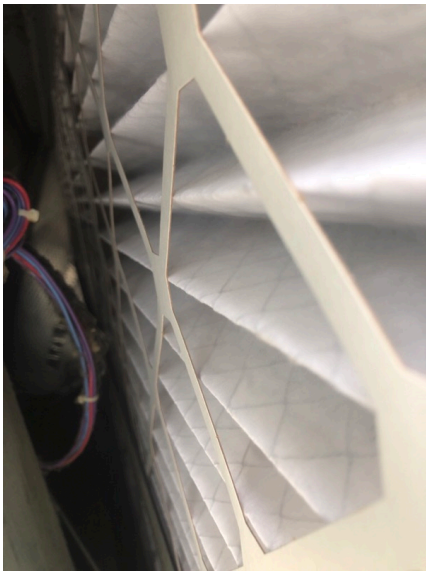
RTU-3
Clean evaporator filters

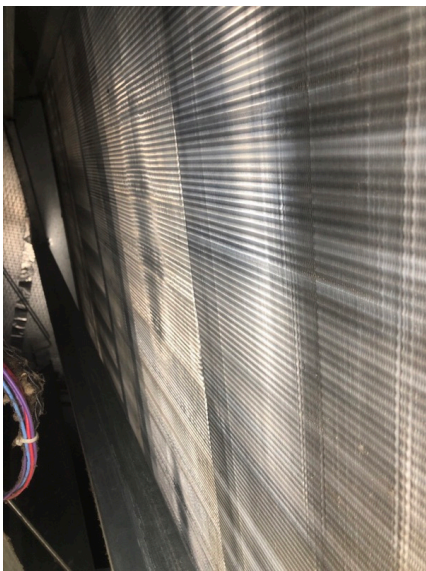
RTU-3
Dirty evaporator coil

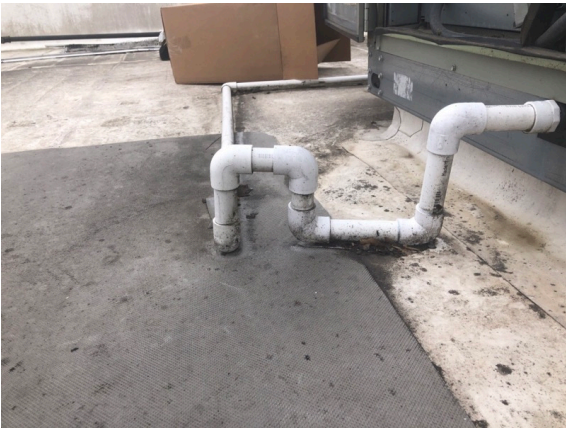
RTU-3
Condensate drain

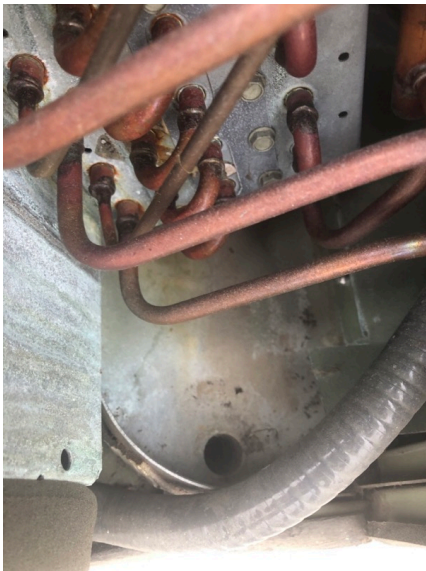
RTU-3
Drain pan

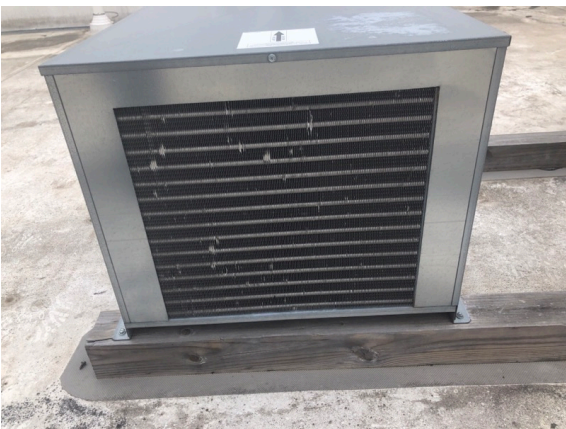
Walk-in Cooler
Dirty condenser

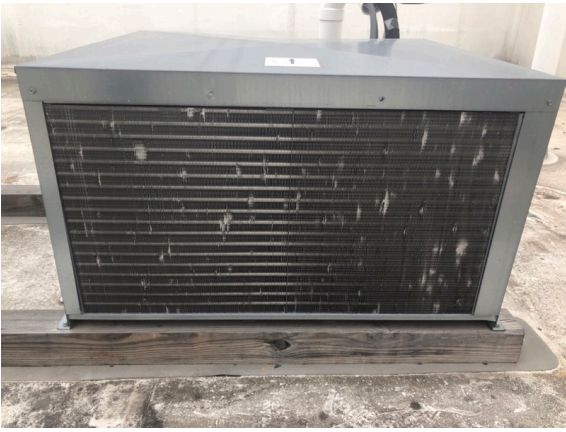
Walk-in Freezer
Dirty condenser
