Report: TAB REPORT
Function: Test, Adjust, & Balance
Date: 11/19/2025
Completed By: National TAB

11-17-25 CHIPOTLE #5765 NOLENSVILLE, TN

Project Summary

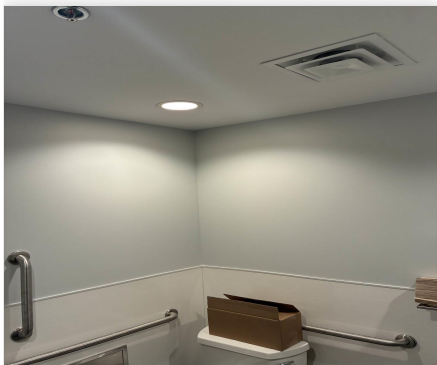
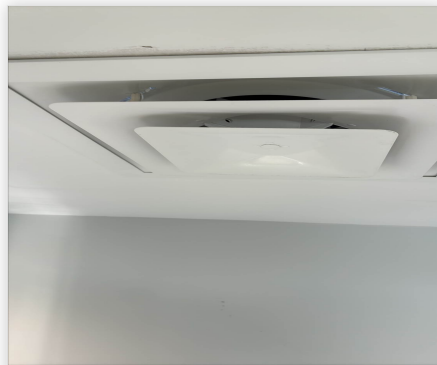
Issue Name : EF-2 GRILLS
Description : EF-2's exhaust grills are different from what design calls for. This did not impede TAB; dampers were present on ductwork.
Created By : National TAB **Assigned To :** National TAB - Noah Stafford
Status : Open
Priority : Low **Asset Tag :** EF2
Originated Date : 11/18/2025 - Noah Stafford - National TAB

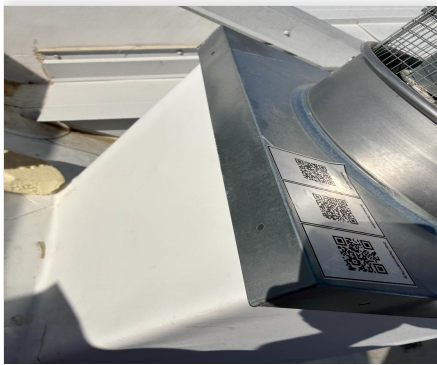
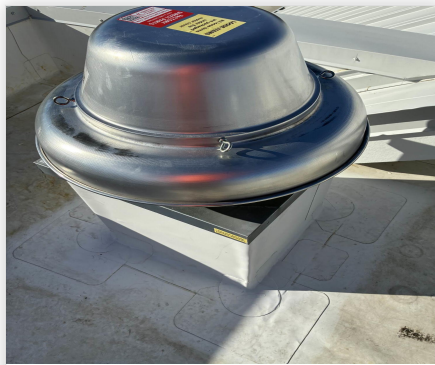
Issue Name : EF-2 MOUNTING
Description : EF-2 is not secured to curb; no mounting screws are installed. Issue does not interfere with TAB.
Created By : National TAB **Assigned To :** National TAB - Noah Stafford
Status : Pending
Priority : High **Asset Tag :** EF2
Originated Date : 11/17/2025 - Noah Stafford - National TAB

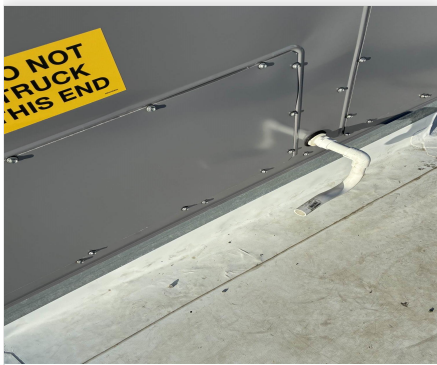
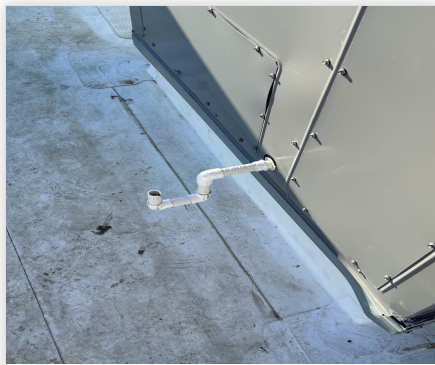
Issue Name : RTU CONDENSATE DRAINS
Description : RTU-1 and RTU-2 condensate drains appear incomplete. This issue does not interfere with TAB.
Created By : National TAB **Assigned To :** National TAB - Noah Stafford
Status : Open
Priority : Medium **Asset Tag :**
Originated Date : 11/17/2025 - Noah Stafford - National TAB

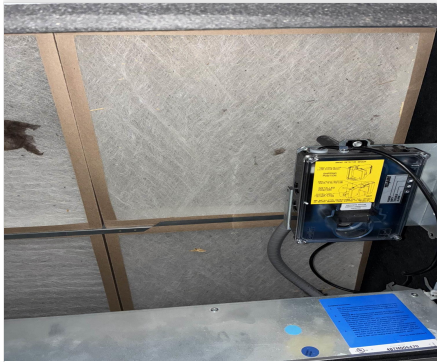
Issue Name : RTU FILTERS
Description : Both RTUs still have the construction filters and need the white long-term filters. Issue does not impede TAB.
Created By : National TAB **Assigned To :** National TAB - Noah Stafford
Status : Open
Priority : Low **Asset Tag :**
Originated Date : 11/20/2025 - Noah Stafford - National TAB

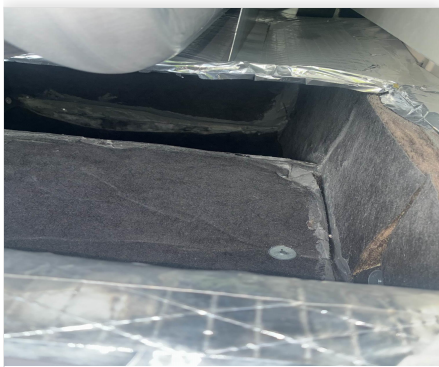
Issue Name : RTU STATIC PRESSURES
Description : Both RTUs have abnormally high static pressures potentially due to two reasons: - air leakage onto the curb from the discharge side - supply drop inlet too narrow TAB cannot be completed on RTU-1 until resolved.
Created By : National TAB **Assigned To :** National TAB - Noah Stafford
Status : Open
Priority : Urgent **Asset Tag :**
Originated Date : 11/18/2025 - Noah Stafford - National TAB

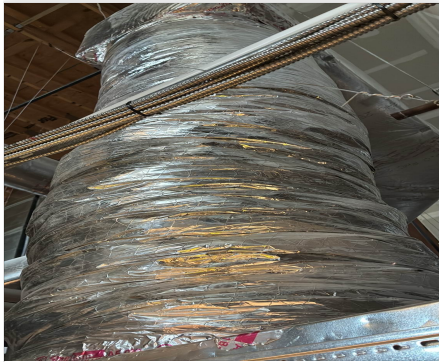
Issue Name : RTU-2 RETURN DUCT
Description : The return duct is round flex duct, but the design calls for rectangular hard duct. This may interfere with TAB.
Created By : National TAB **Assigned To :** National TAB - Noah Stafford
Status : Open
Priority : Medium **Asset Tag :** RTU2
Originated Date : 11/18/2025 - Noah Stafford - National TAB

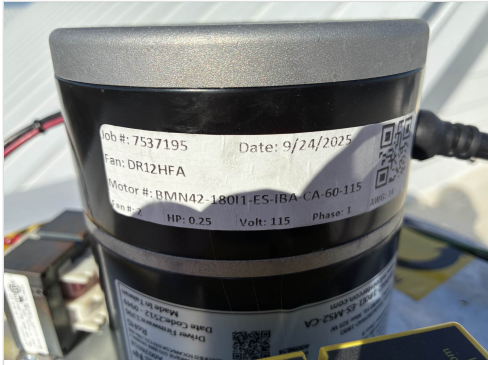
Unit Data - PHOTO LOG

Unit Data		
	Design	Actual
MFG	CAPTIVE-AIRE	CAPTIVE-AIRE
Model Num	DR12HFA	DR12HFA
Serial Num	-	DR12HFA
Type	DOWNBLAST	DOWNBLAST
Configuration	VERTICAL	VERTICAL

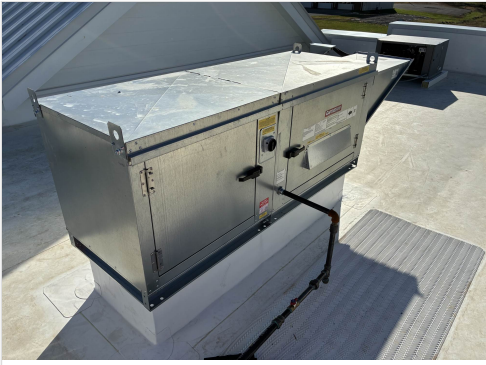
Unit Data - PHOTO LOG

Unit Data		
	Design	Actual
MFG	CAPTIVE-AIRE	CAPTIVE-AIRE
Model Num	A1-D.250-15D	A1-D.250-15D
Serial Num	-	7537195
Type	MAU	MAU
Configuration	VERTICAL	VERTICAL
