**Report: TAB REPORT**  
**Function: Test, Adjust, & Balance**  
**Date: 11/19/2025**  
**Completed By: National TAB**

## 11-17-25 CHIPOTLE #5765 NOLENSVILLE, TN

7350 NOLENSVILLE RD

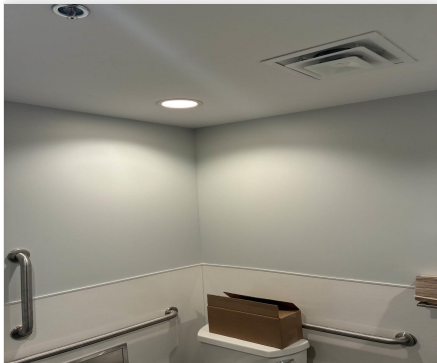
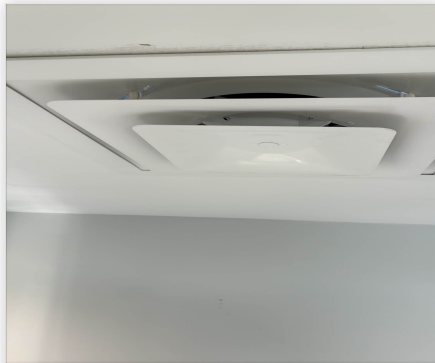
**Issue Name :** EF-2 DIFFUSERS DO NOT MATCH DESIGN  
**Description :** EF-2's exhaust grilles do not match design. This did not impede TAB; dampers were present elsewhere on ductwork.  
**Created By :** National TAB                      **Assigned To :** National TAB - Noah Stafford  
**Status :** Open  
**Priority :** InfoOnly                                      **Asset Tag :** EF2  
**Originated Date :** 11/18/2025 - Noah Stafford - National TAB

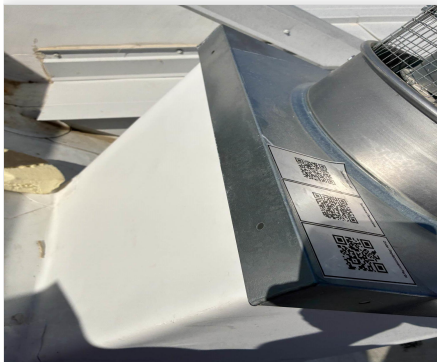
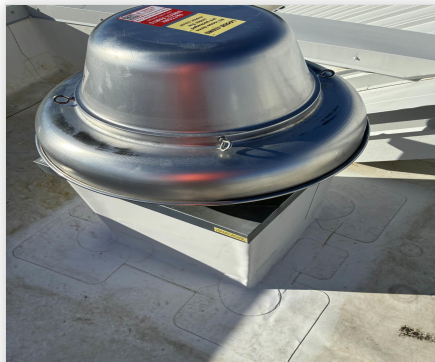
**Issue Name :** EF-2 MOUNTING  
**Description :** EF-2 is not mounted to curb. Install according to manufacturer guidelines.  
**Created By :** National TAB                      **Assigned To :** National TAB - Noah Stafford  
**Status :** Pending  
**Priority :** Medium                                      **Asset Tag :** EF2  
**Originated Date :** 11/17/2025 - Noah Stafford - National TAB

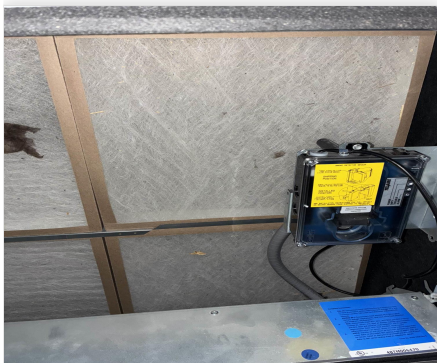
**Issue Name :** RTU FILTERS  
**Description :** Both RTUs still have construction filters installed. Install correctly sized MERV 8 filters. Issue did not impede TAB.  
**Created By :** National TAB                      **Assigned To :** National TAB - Noah Stafford  
**Status :** Open  
**Priority :** Low                                      **Asset Tag :**  
**Originated Date :** 11/20/2025 - Noah Stafford - National TAB

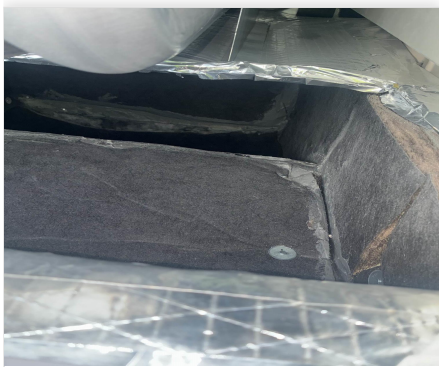
**Issue Name :** RTU-1 & 2 DISCHARGE TRANSITION  
**Description :** Discharge transition on both RTU's is highly restrictive. As a result the airflow for RTU-1 is slightly below design.  
**Created By :** National TAB                      **Assigned To :** National TAB - Noah Stafford  
**Status :** Open  
**Priority :** High                                      **Asset Tag :**  
**Originated Date :** 11/18/2025 - Noah Stafford - National TAB

Airflow is low due to restrictive discharge air transition as well as undersized return ductwork.

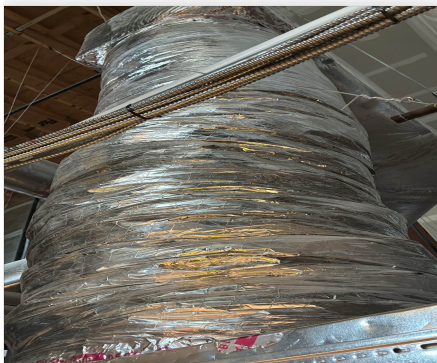
**Issue Name :** RTU-1 RETURN DUCT  
**Description :** The return duct is round 20" flex duct (2.14 square feet free area), but the design calls for rectangular 24x20 (3.33 SF area) hard duct. This duct is too small and is impacting airflow. Duct should be installed per plan.  
**Created By :** National TAB                      **Assigned To :** National TAB - Noah Stafford  
**Status :** Open  
**Priority :** **Medium**                                      **Asset Tag :** RTU1  
**Originated Date :** 11/18/2025 - Noah Stafford - National TAB

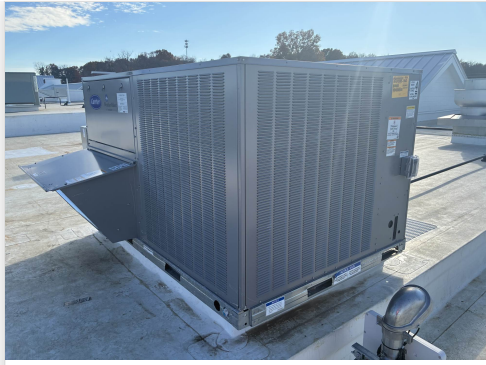
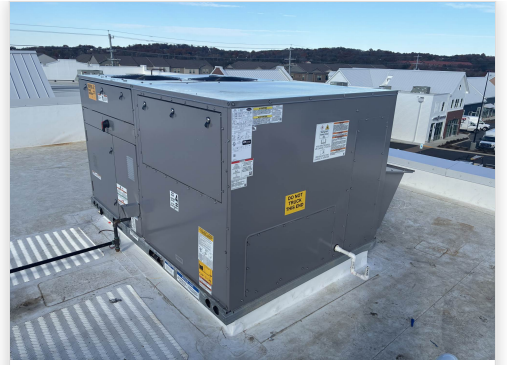
# Unit Data - PHOTO LOG

Unit Data		
	Design	Actual
MFG	CARRIER	CARRIER
Serial Num	-	3025P60525
Model Num	48FEDN12B3M5-8W4C0	48FEDN12B3M5-8W4C0
Type	RTU	RTU
Configuration	VERTICAL	VERTICAL
Num OA Filters 1	-	1
OA Filter Size 1	-	36"x20.5"
Num Final Filter 1	-	4
Final Filter Size 1	-	20"x20"x2"

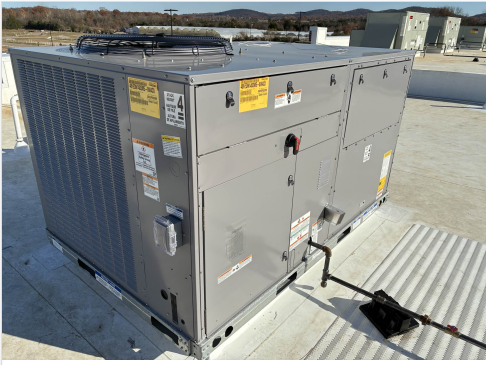
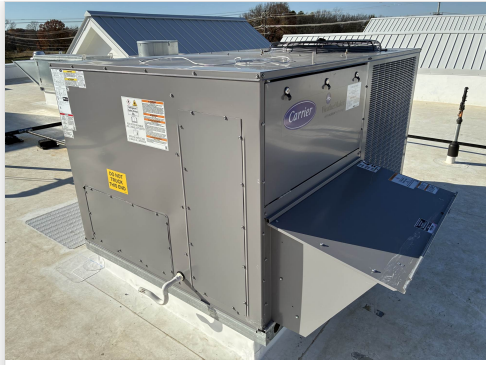
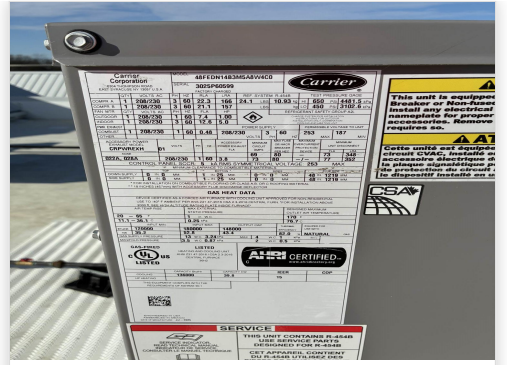
# Unit Data - PHOTO LOG

Unit Data		
	Design	Actual
MFG	CARRIER	CARRIER
Serial Num	-	3025P60599
Model Num	48FEDN14B3M5-8W4C0	48FEDN14B3M5-8W4C0
Type	RTU	RTU
Configuration	VERTICAL	VERTICAL
Num OA Filters 1	-	1
OA Filter Size 1	-	36"x20.5"
Num Final Filter 1	-	4
Final Filter Size 1	-	20"x20"x2"

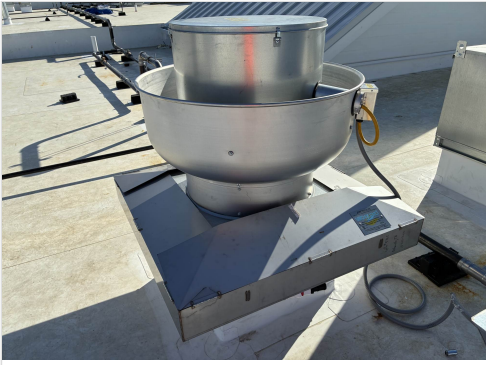
## Unit Data - PHOTO LOG

Unit Data		
	Design	Actual
MFG	CAPTIVE-AIRE	CAPTIVE-AIRE
Model Num	DU180HFA	DU180HFA
Serial Num	-	7537195
Type	UPBLAST	UPBLAST
Configuration	VERTICAL	VERTICAL

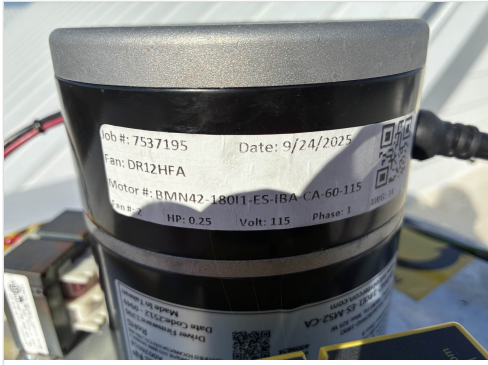
# Unit Data - PHOTO LOG

Unit Data		
	Design	Actual
MFG	CAPTIVE-AIRE	CAPTIVE-AIRE
Model Num	DR12HFA	DR12HFA
Serial Num	-	DR12HFA
Type	DOWNBLAST	DOWNBLAST
Configuration	VERTICAL	VERTICAL

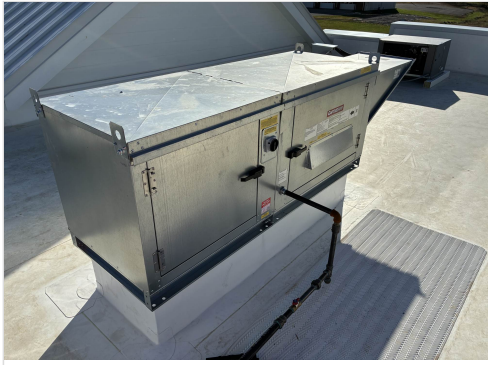
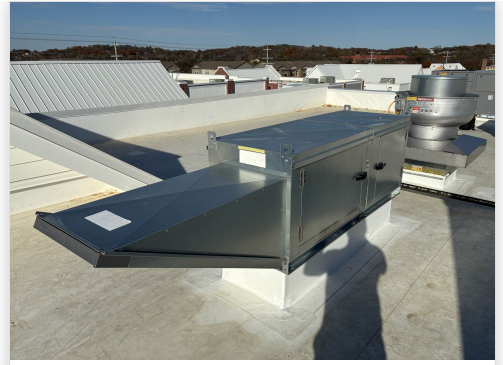
# Unit Data - PHOTO LOG

Unit Data		
	Design	Actual
MFG	CAPTIVE-AIRE	CAPTIVE-AIRE
Model Num	A1-D.250-15D	A1-D.250-15D
Serial Num	-	7537195
Type	MAU	MAU
Configuration	VERTICAL	VERTICAL
