Report: TAB Report
Function: Test, Adjust, & Balance
Date: 01/17/2026
Completed By: National TAB

PROJECT
01-12-26 UCHI - WASHINGTON, DC

Project: 01-12-26 UCHI - WASHINGTON, DC

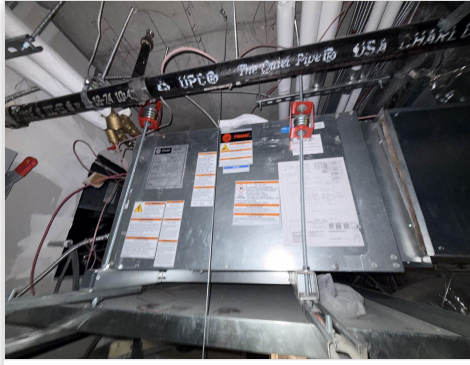
- [1] OA Damper position set to 0%, MUA Is pulling from the mixing box
- [2] No accurate way to read the linear diffusers due to configuration in soffit. ensured all were full open

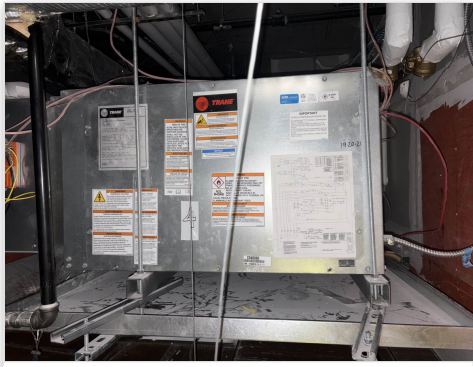
[1] No accurate way to read the linear diffusers due to configuration in soffit. ensured all were full open

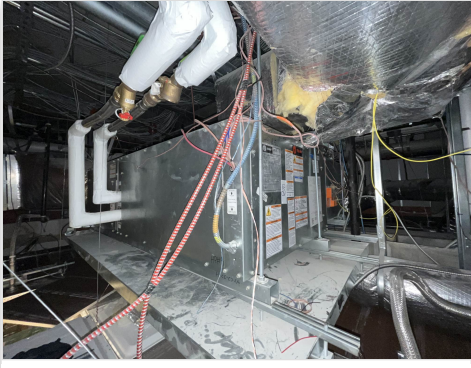
[1] No accurate way to read the linear diffusers due to configuration in soffit. ensured all were full open and balanced restrooms to design
