Report: TAB REPORT
Function: Test, Adjust, & Balance
Date: 05/31/2024

PROJECT
06-03-24 WAWA #8443 HAZLET, NJ

Project: 06-03-24 WAWA #8443 HAZLET, NJ

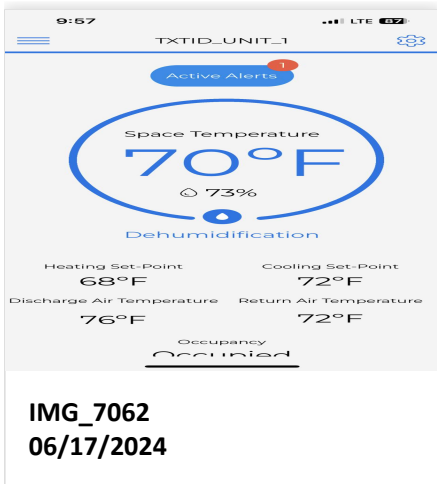
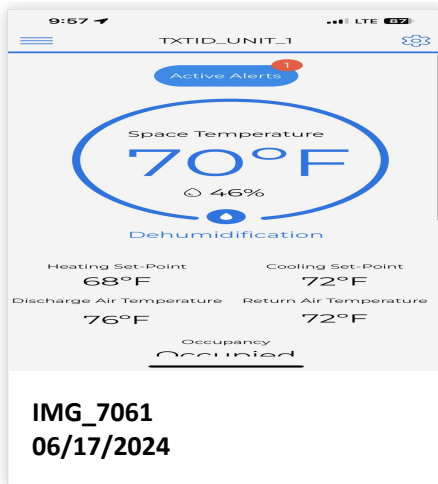
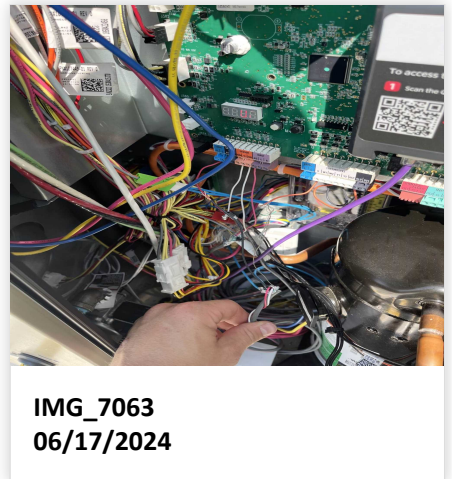
Project Issue File Details

Issue Name : RTU-3 Humidity sensor issue
Description : The humidity sensor is not reading a constant value. The reading fluctuates from 44%-76%-88% and back. Wiring looks to have come undone or is incorrect. Recommend Mc rewire and double check sensor health.

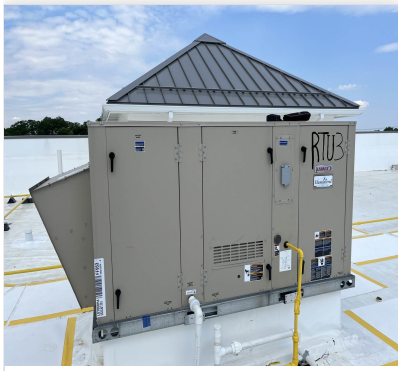
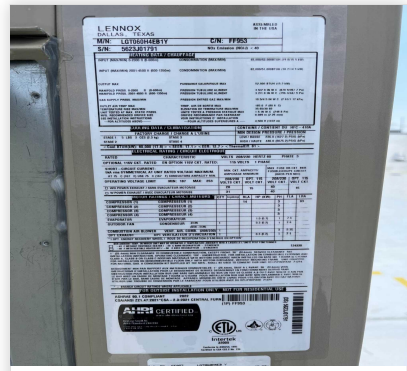
RTU-3 sensor wiring has come loose or has been removed by someone found during return TAB trip

RTU-1:58% RTU-2:63% RTU-3: ERROR, Sensor value is constantly jumping from 44%-76%-88% and back
