National TAB  
1329 E. KEMPER ROAD  
SUITE 4210  
CINCINNATI, OH 45246

**Report: TAB REPORT**  
**Function: Test, Adjust, & Balance**  
**Date: 05/31/2024**

**PROJECT**  
**06-03-24 WAWA #8443 HAZLET, NJ**

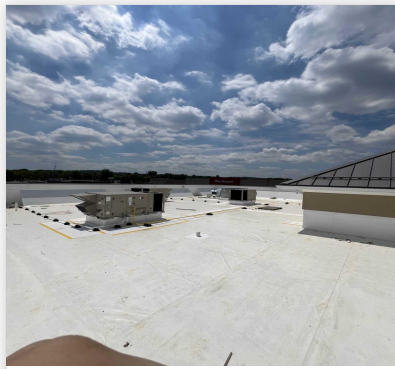
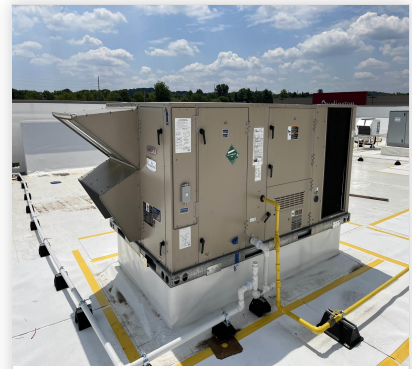
RTU-1

Notes:  
Unit total in design, diffusers not balanced due to issues and time constraints.
