Report: TAB Report
Function: Test, Adjust, & Balance
Date: 04/23/2025
Completed By: National TAB

PROJECT
03-03-25 FIREBIRDS LIBERTY TOWNSHIP,
OH

Project: 03-03-25 FIREBIRDS LIBERTY TOWNSHIP, OH

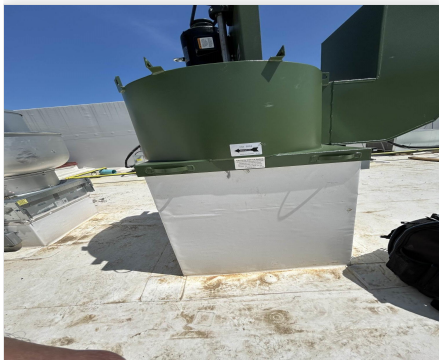
Issue Name : Ef-3 CURB LEAKAGE
Description : Unable to balance ef-3 due to excessive curb leakage.
Created By : National TAB **Assigned To :** National TAB - Will Turnbough
Status : Open
Priority : Urgent **Asset Tag :**
Originated Date : 04/23/2025 - Gabe Merk - National TAB

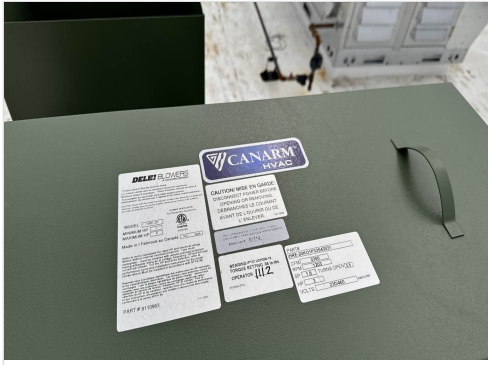
Asset: KEF3

With exception of EF-3 which is obstructed from lifting do to supplied power location.

UNABLE TO BALANCE DUE TO ROOF CURB LEAKAGE. 4/23/25
 UNIT READ OUT WITH ROOF CURB TAPED SHUT. UNABLE TO INCREASE UNIT CFM WITH INCREASING SPEED

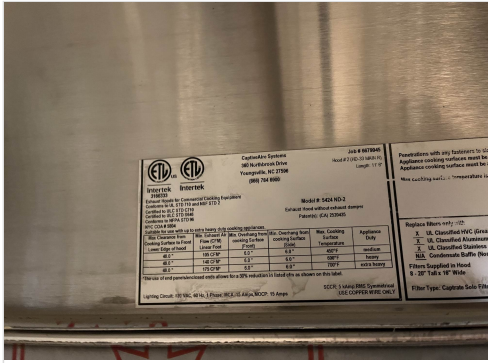
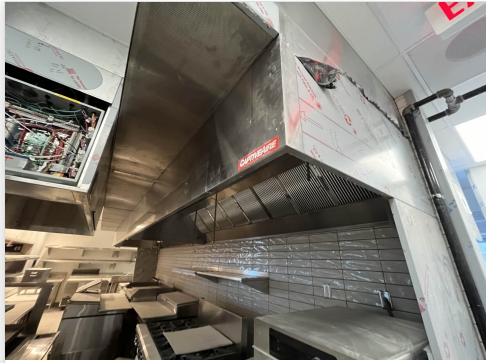
MUA PSP cannot be reduced/balanced with HD-L33 due to no access to the dampers for HD-R33 due to installation location, height of stainless steel above hood and location of MUA duct relative to other items above the hoods. MUA total is within design tolerance.
