**Report: TAB Report**  
**Function: Test, Adjust, & Balance**  
**Date: 04/23/2025**  
**Completed By: National TAB**

**PROJECT**  
**03-03-25 FIREBIRDS LIBERTY TOWNSHIP,**  
**OH**

# National TAB

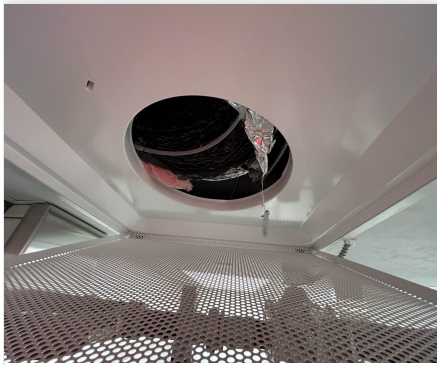
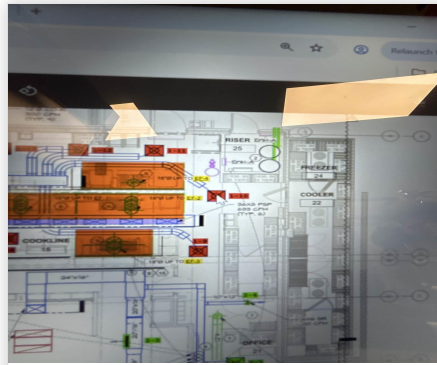
**Issue Name :** Diffuser 1-10  
**Description :** Diffuser 1-10 flex has come loose from diffuser. Airflow will not meet design until rectified.  
**Created By :** National TAB                      **Assigned To :** National TAB - Will Turnbough  
**Status :** Open  
**Priority :** Medium                                      **Asset Tag :**  
**Originated Date :** 04/23/2025 - Gabe Merk - National TAB

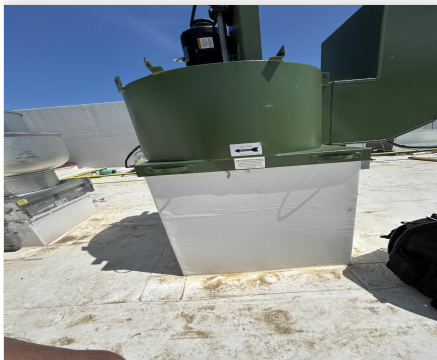
**Issue Name :** Ef-3 CURB LEAKAGE  
**Description :** Unable to balance ef-3 due to excessive curb leakage.  
**Created By :** National TAB                      **Assigned To :** National TAB - Will Turnbough  
**Status :** Open  
**Priority :** Urgent                                      **Asset Tag :**  
**Originated Date :** 04/23/2025 - Gabe Merk - National TAB

UNABLE TO BALANCE DUE TO ROOF CURB LEAKAGE. 4/23/25  
 UNIT READ OUT WITH ROOF CURB TAPED SHUT. UNABLE TO INCREASE UNIT CFM WITH INCREASING SPEED
