Report: TAB REPORT
Function: Test, Adjust, & Balance
Date: 12/01/2022

**11-28 CHIPOTLE #37-4138 FEASTERVILLE,
PA (FEASTERVILLE)**

Project: 11-28 CHIPOTLE #37-4138 FEASTERVILLE, PA (FEASTERVILLE)

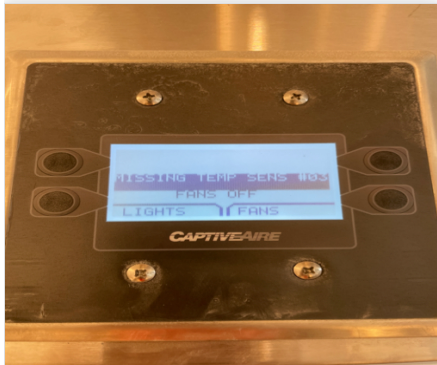
HOOD_HMI_ALARM.jpeg

Issue Name : HOOD ALARM MISSING TEMP SENSOR

Description : There is a hood alarm for missing temperature sensor, the general contractor is aware of this issue and the repair is scheduled for DEC 2, This did not affect the ability to perform the TAB.
