Report: TAB REPORT
Function: Test, Adjust, & Balance
Date: 06/27/2024

PROJECT
06-24-24 DOMINICKS SCOTTSDALE, AZ

Project: 06-24-24 DOMINICKS SCOTTSDALE, AZ

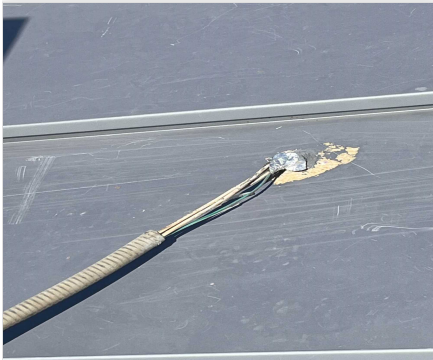
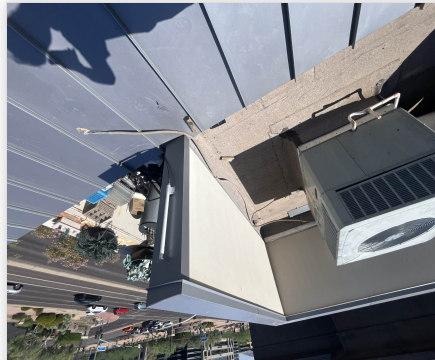
Issue Name : RTU-1: Power Conduit Damaged
Description : Power conduit running from the roof to RTU-1 is damaged and wiring is exposed to the elements. Recommend conduit is repaired.
Created By : National TAB **Assigned To :** National TAB - Michael McDonnell
Status : Open
Priority : Medium **Asset Tag :**
Originated Date : 07/25/2024 - Michael McDonnell - National TAB

[2] POWER CONDUIT TO UNIT DAMAGED-SEE ISSUE
