**Report: TAB REPORT**  
**Function: Test, Adjust, & Balance**  
**Date: 08/15/2022**  
**Completed By: National TAB**

**PROJECT**  
**07-25 CULVERS - BARABOO, WI (REVIVE)**

BARABOO, WI

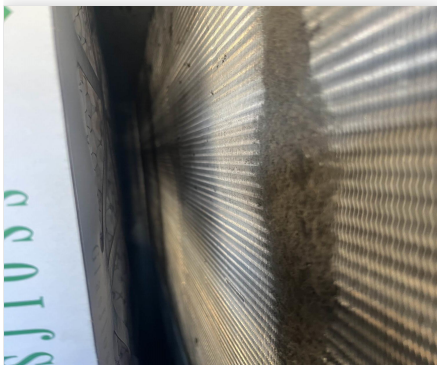
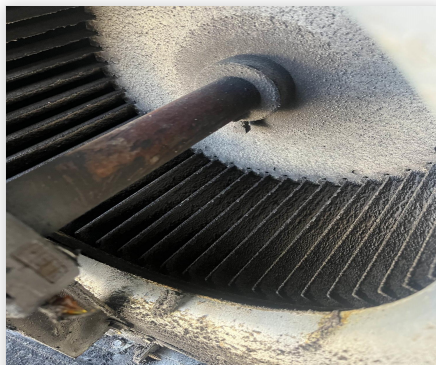
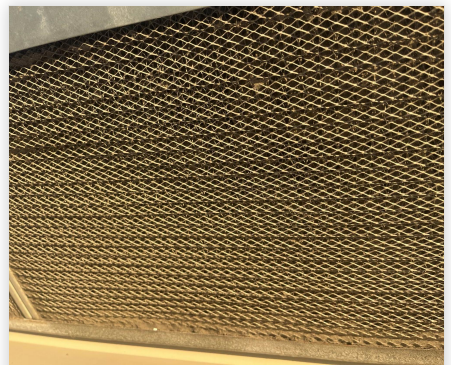
**Issue Name :** RTU Condition  
**Description :** RTUs are in need of cleaning. Evaporator coils have significant buildup and OA filters appear clogged. Blower wheels could also use cleaning. Addressing these items on kitchen unit should help improve airflow.  
**Created By :** National TAB      **Assigned To :** National TAB - Michael McDonnell  
**Status :** Open  
**Priority :** Low      **Asset Tag :**  
**Originated Date :** 12/19/2024 - Michael McDonnell - National TAB

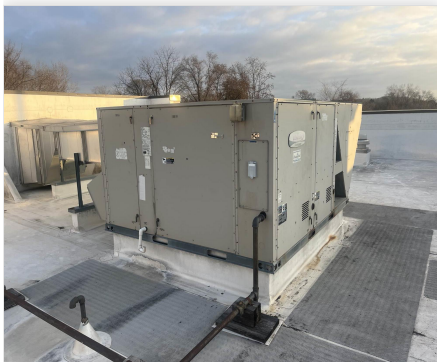
**Issue Name :** RTU-2 (Kitchen): Low Supply Airflow and Distribution  
**Description :** Kitchen RTU is a 20 ton unit and is supplying 244 cfm/ton to the space. Ideally, we would like airflow to be between 350 and 400 cfm per ton. The Units motor sheave appears frozen or stuck in place and could not be adjusted. There is not much room on the pulley and a sheave change would be required to increase airflow. Consult NTAB for change.

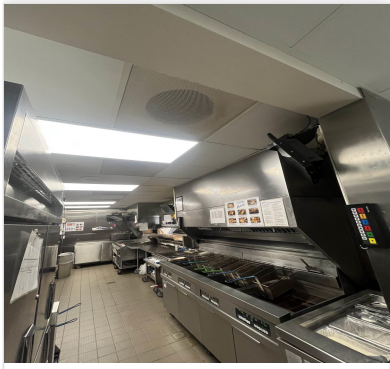
- **12/19/2024 National TAB - Michael McDonnell**
  - Fair majority of airflow is being delivered to the griddle (HD-1) side of the kitchen. Verified low diffusers had damper full open. Not causing any issues, but a full diffuser balance of the system could improve comfort.

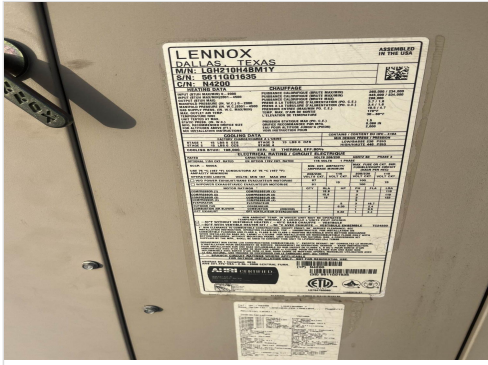
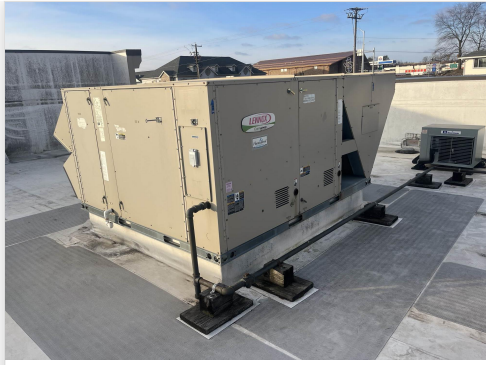
Asset: RTU1

- [1] UNIT IN NEED OF CLEANING-EVAPORATOR COIL DIRTY, OA FILTERS CLOGGED, BLOWER WHEEL DIRTY.
- [2] UNIT OPERATING AT 376 CFM/ TON: WITHIN ACCEPTABLE RANGE OF 350-400 CFM/TON

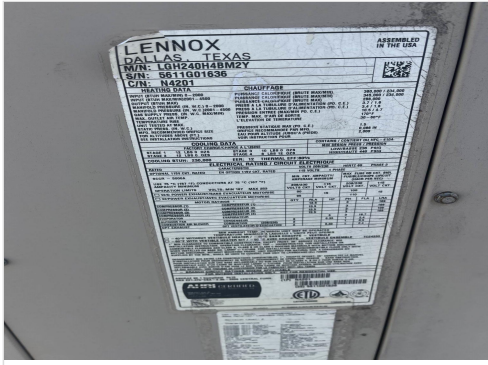
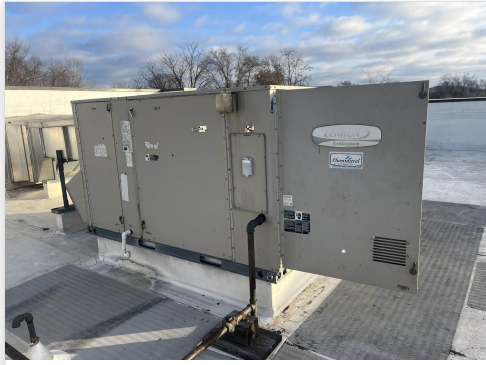
Asset: RTU2

[1] UNIT LOW ON AIRFLOW: 243 CFM /TON. MOTOR SHEAVE IS FROZEN-PULLEY CHANGE NEEDED TO INCREASE AIRFLOW.

[2] OA TO SUPPLY RATIO HIGH, UNIT HAS HUMIDITY CONTROL.

[3] UNIT IN NEED OF CLEANING-EVAPORATOR COIL DIRTY, OA FILTERS CLOGGED, BLOWER WHEEL DIRTY.

[4] OA DUCTED TO REAR PARAPET LOUVRE.

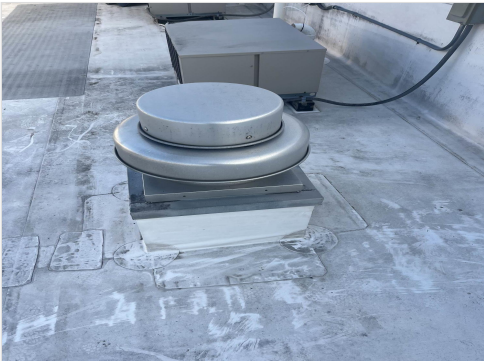
Asset: PRV-1

Notes:  
[1] FAN NOT OPERATING
