Report: TAB REPORT
Function: Test, Adjust, & Balance
Date: 09/14/2023

Ulta Beauty (Baraboo, WI)

Ultra Beauty (Baraboo, WI)

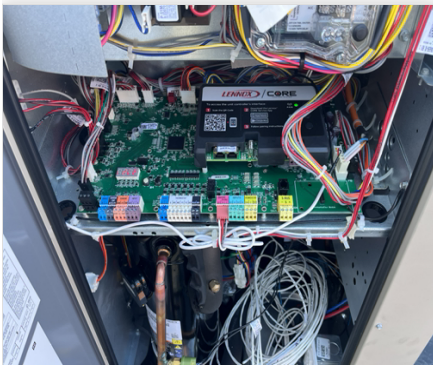
Nocontrols
09/14/2023

Issue Name : 1. RTU Control Wiring Not Installed
Description : RTUs do not have control wiring/controls installed. Units were jumpered for occupancy and fan operation to complete testing.
Created By : National TAB **Assigned To :** National TAB - Michael McDonnell
Status : Open
Originated Date : 09/14/2023 - Michael McDonnell - National TAB

- **09/14/2023 National TAB - Michael McDonnell**
 - Plans indicate outside air damper position is to be set through/with Controls Company. Controls not yet installed. Contacted Novar/Honeywell contacts listed on plans and received no response. Damper positions programmed into RTUs and listed in report. Low speed fan setpoint set to 50% of high speed setpoint.

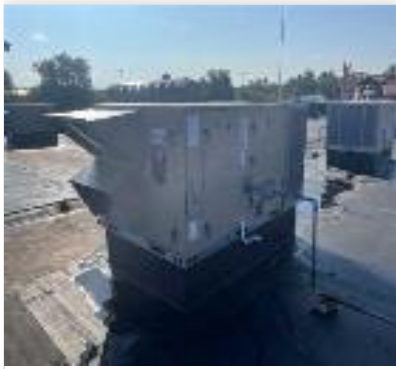
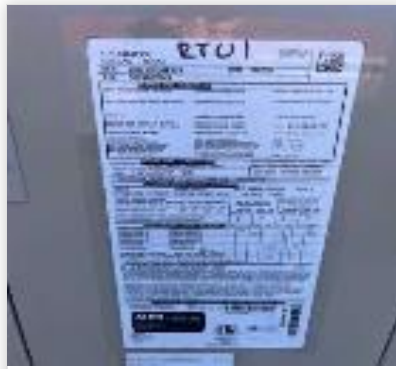
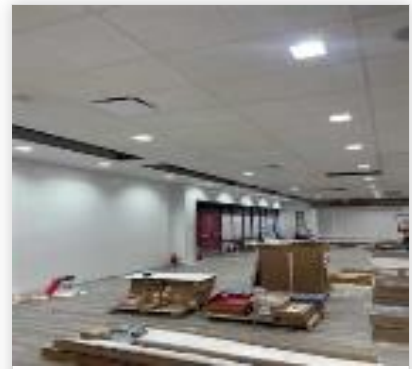
RTU-1

Test Data		
	Design	Actual
SF CFM	3400	3465
RA CFM	2800	2883
OA CFM	600	582
RL Voltage	208	211/211/211
RL Amperage	-	2.0/2.0/1.9
OA Damper Position	-	HIGH SPEED: 29% LOW SPEED: 43%
Brake Horse Power	3.75	0.86

- [1] ALARM 22: LOW PRESSURE SWITCH COMPRESSOR 1, NEEDS SERVICE.
- [2] SYSTEM MOTOR SETPOINTS: HIGH-3000CFM / LOW-1500CFM

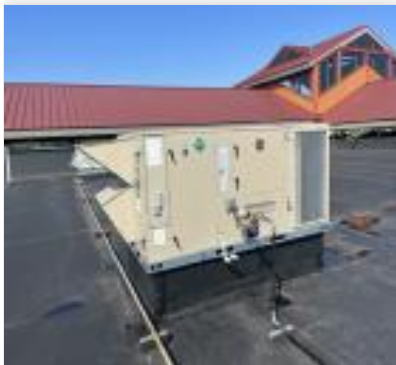
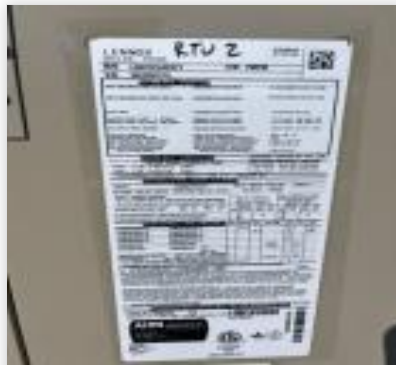
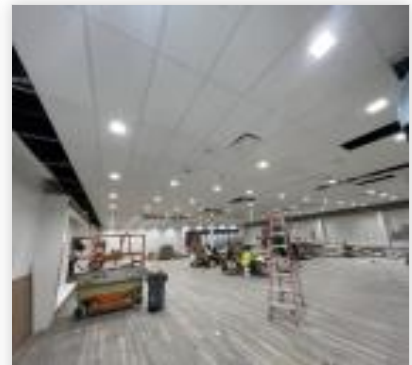
RTU-2

Test Data		
	Design	Actual
SF CFM	3400	3394
RA CFM	2800	2780
OA CFM	600	614
RL Voltage	208	212/212/212
RL Amperage	-	2.1/2.0/2.0
OA Damper Position	-	HIGH SPEED: 29% LOW SPEED: 43%
Brake Horse Power	3.75	0.89

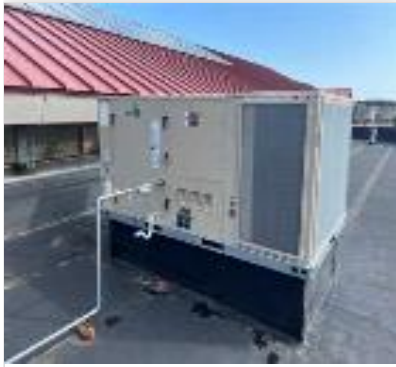
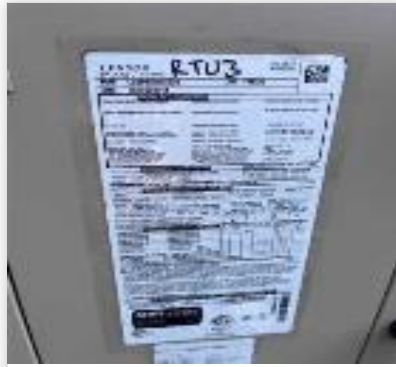
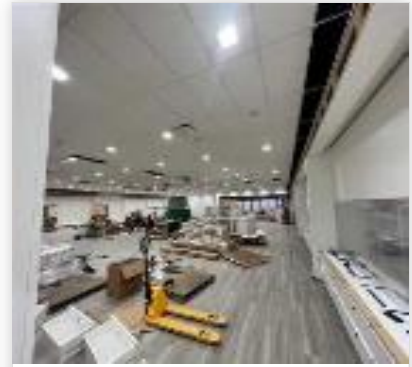
RTU-3

Test Data		
	Design	Actual
SF CFM	3400	3505
RA CFM	2800	2877
OA CFM	600	628
RL Voltage	208	211/211/212
RL Amperage	-	2.4/2.5/2.4
OA Damper Position	-	HIGH SPEED: 28% LOW SPEED: 45%
Brake Horse Power	3.75	1.06

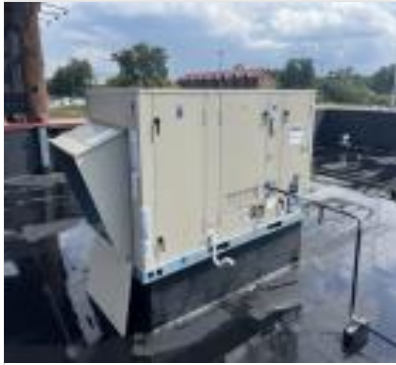
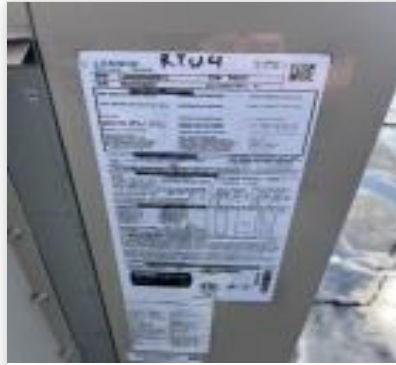
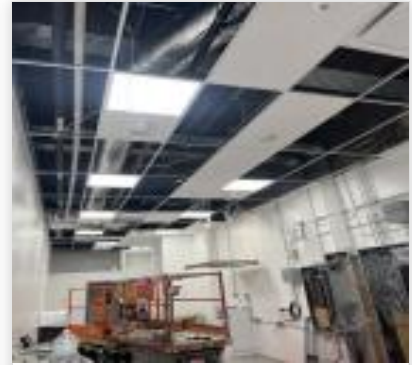
RTU-4

Test Data		
	Design	Actual
SF CFM	2000	2026
RA CFM	1850	1883
OA CFM	150	143
RL Voltage	208	212/212/212
RL Amperage	-	1.9/1.9/1.7
OA Damper Position	-	HIGH SPEED: 21% LOW SPEED: 30%
Brake Horse Power	1.50

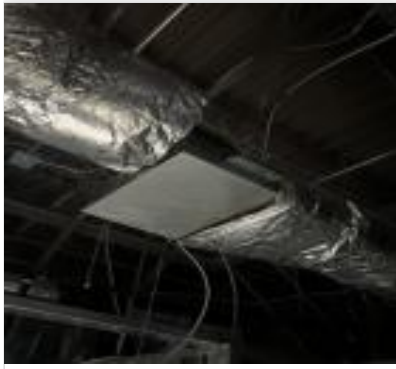
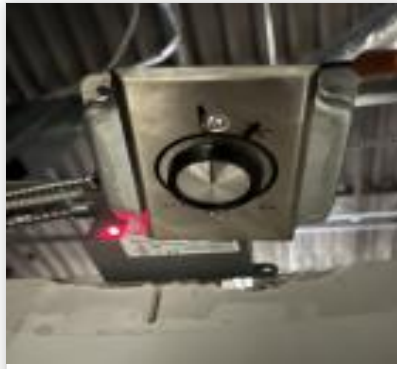
EF-1

Test Data		
	Design	Actual
CFM	200	201
RL Voltage	-	118

[1] MOTOR SETPOINT MARKED ON SPEED CONTROLLER.
