Report: TAB REPORT
Function: Test, Adjust, & Balance
Date: 09/14/2023

Ulta Beauty (Baraboo, WI)

Project: Ulta Beauty (Baraboo, WI)

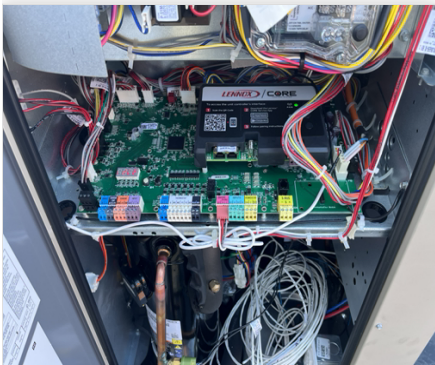
**Nocontrols
09/14/2023**

Issue Name : RTU Control Wiring Not Installed
Description : RTUs do not have control wiring/controls installed. Units were jumpered for occupancy and fan operation to complete testing.
Created By : National TAB **Assigned To :** National TAB - Michael McDonnell
Status : Open
Originated Date : 09/14/2023 - Michael McDonnell - National TAB

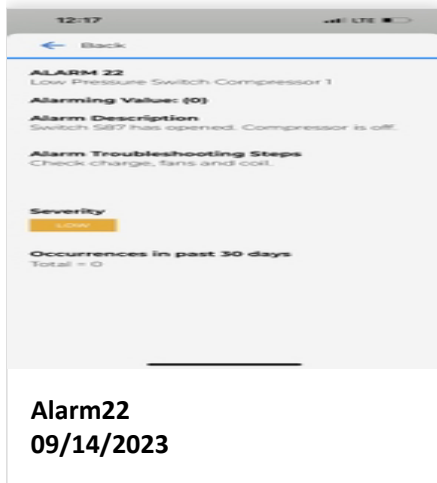
Issue Name : RTU-1: Alarm 22 Low Pressure Switch Comp. 1
Description : RTU-1 is alarmed for low pressure on compressor 1. MC is aware and will service unit.
Created By : National TAB **Assigned To :** National TAB - Michael McDonnell
Status : Open
Originated Date : 09/14/2023 - Michael McDonnell - National TAB

- [1] ALARM 22: LOW PRESSURE SWITCH COMPRESSOR 1, NEEDS SERVICE.
- [2] SYSTEM MOTOR SETPOINTS: HIGH-3000CFM / LOW-1500CFM

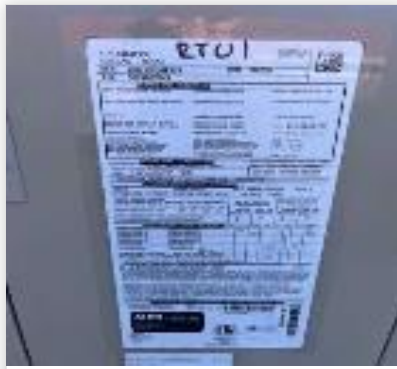
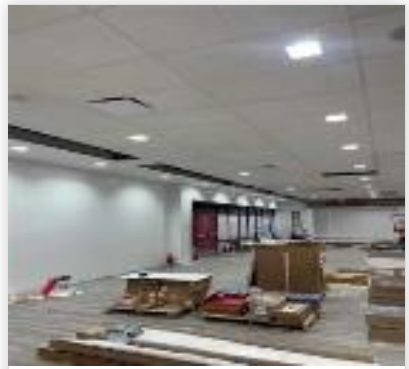
RTU-1

Unit Data		
	Design	Actual
MFG	NA	LENNOX
Serial Num	-	5623G03743
Model Num	NA	LGM102U4
Configuration	VERTICAL	VERTICAL
Num OA Filters 1	-	2
OA Filter Size 1	-	14.25X23
Num PreFilter 1	-	4
PreFilter Size 1	-	20X25X2

Test Data		
	Design	Actual
SF CFM	3400	3465
RA CFM	2800	2883
OA CFM	600	582
RL Voltage	208	211/211/211
RL Amperage	-	2.0/2.0/1.9
OA Damper Position	-	HIGH SPEED: 29% LOW SPEED: 43%
Brake Horse Power	3.75	0.86

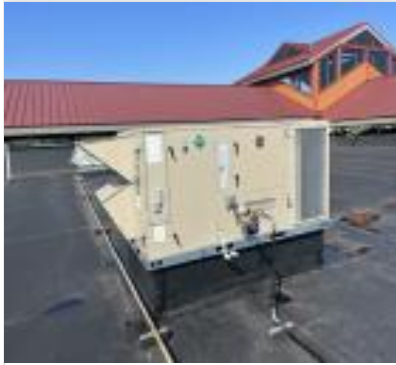
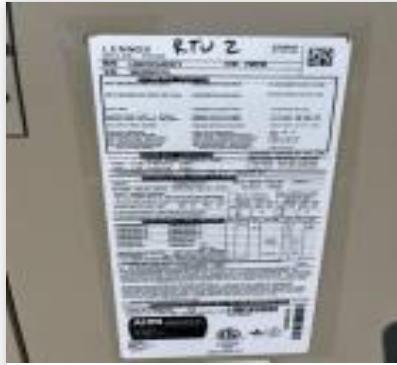
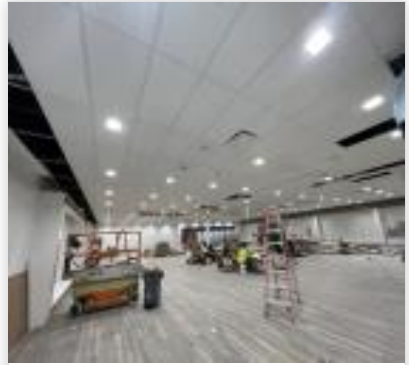
RTU-2

Unit Data		
	Design	Actual
MFG	NA	LENNOX
Serial Num	-	5623G03746
Model Num	NA	LGM102U4
Configuration	VERTICAL	VERTICAL
Num OA Filters 1	-	2
OA Filter Size 1	-	14.25X23
Num PreFilter 1	-	4
PreFilter Size 1	-	20X25X2

Test Data		
	Design	Actual
SF CFM	3400	3394
RA CFM	2800	2780
OA CFM	600	614
RL Voltage	208	212/212/212
RL Amperage	-	2.1/2.0/2.0
OA Damper Position	-	HIGH SPEED: 29% LOW SPEED: 43%
Brake Horse Power	3.75	0.89

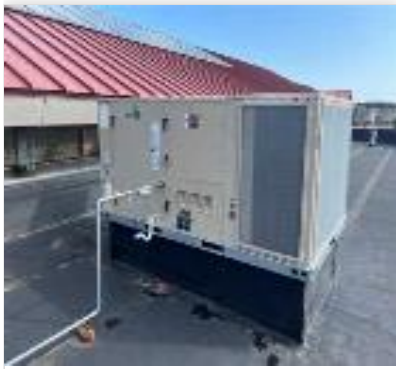
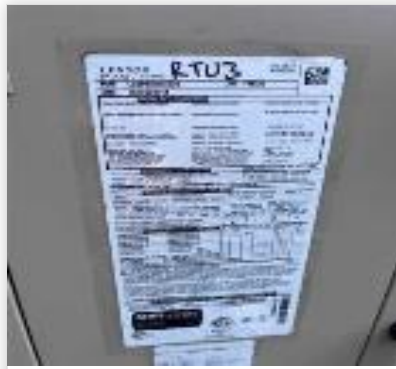
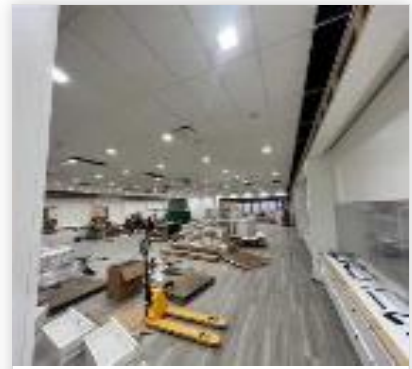
RTU-3

Unit Data		
	Design	Actual
MFG	NA	LENNOX
Serial Num	-	5623G03744
Model Num	NA	LGM102U4
Configuration	VERTICAL	VERTICAL
Num OA Filters 1	-	2
OA Filter Size 1	-	14.25X23
Num PreFilter 1	-	4
PreFilter Size 1	-	20X25X2

Test Data		
	Design	Actual
SF CFM	3400	3505
RA CFM	2800	2877
OA CFM	600	628
RL Voltage	208	211/211/212
RL Amperage	-	2.4/2.5/2.4
OA Damper Position	-	HIGH SPEED: 28% LOW SPEED: 45%
Brake Horse Power	3.75	1.06

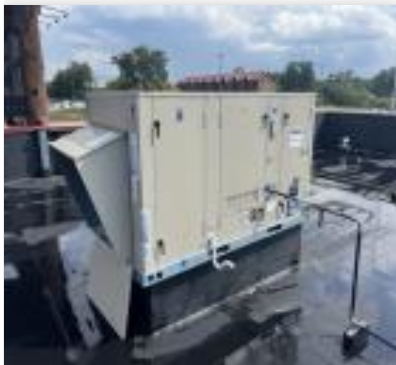
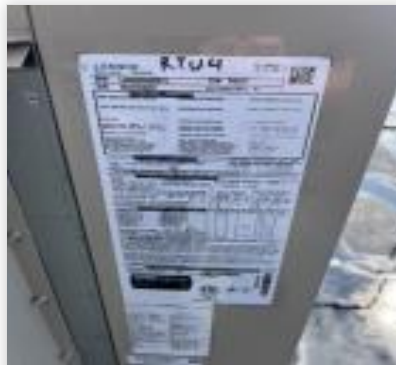
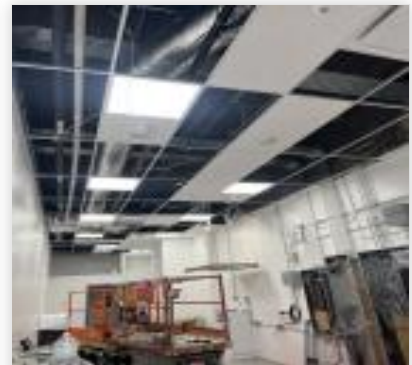
RTU-4

Unit Data		
	Design	Actual
MFG	NA	LENNOX
Serial Num	-	5623F04022
Model Num	NA	LGM060U4
Configuration	VERTICAL	VERTICAL
Num OA Filters 1	-	1
OA Filter Size 1	-	29X14
Num PreFilter 1	-	4
PreFilter Size 1	-	20X20X2

Test Data		
	Design	Actual
SF CFM	2000	2026
RA CFM	1850	1883
OA CFM	150	143
RL Voltage	208	212/212/212
RL Amperage	-	1.9/1.9/1.7
OA Damper Position	-	HIGH SPEED: 21% LOW SPEED: 30%
Brake Horse Power	1.50
