Report: TAB Report
Function: Test, Adjust, & Balance
Date: 12/05/2025
Completed By: National TAB

11-03-25 WAWA #7618 LOUISVILLE, KY

5229 DIXIE HWY

Project: 11-03-25 WAWA #7618 LOUISVILLE, KY

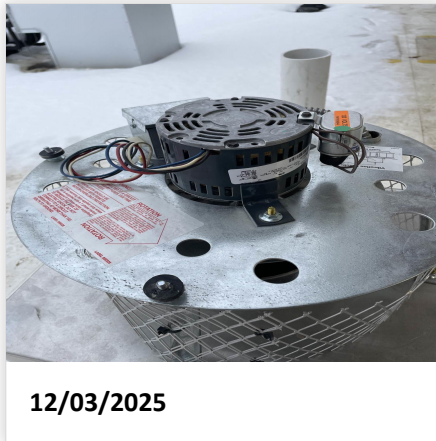
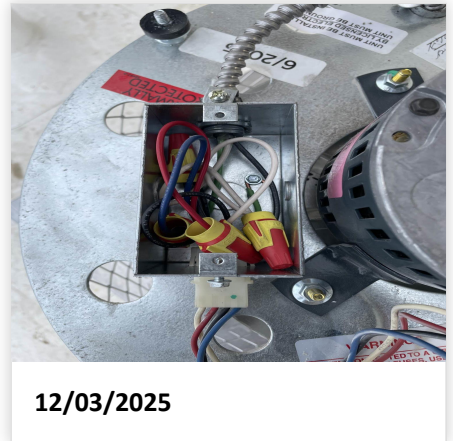
Issue Name : EF Speed Controller
Description : Neither EF-1 nor EF-2 is equipped with a speed controller as specified in EF schedule. Unable to adjust fan speeds. EF flow adjusted using dampers.
Created By : National TAB **Assigned To :** National TAB - Jordan Best
Status : Open
Priority : High **Asset Tag :**
Originated Date : 12/03/2025 - Jordan Best - National TAB
