Report: TAB Report
Function: Test, Adjust, & Balance
Date: 12/05/2025
Completed By: National TAB

11-03-25 WAWA #7618 LOUISVILLE, KY

Project: 11-03-25 WAWA #7618 LOUISVILLE, KY

Project Summary

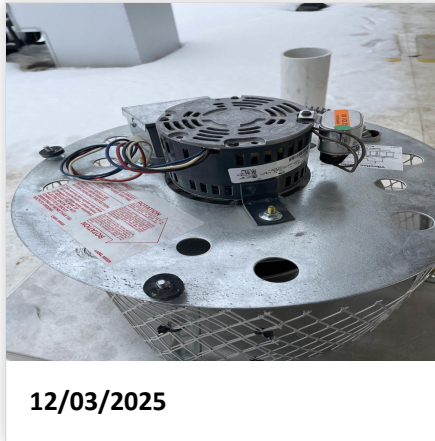
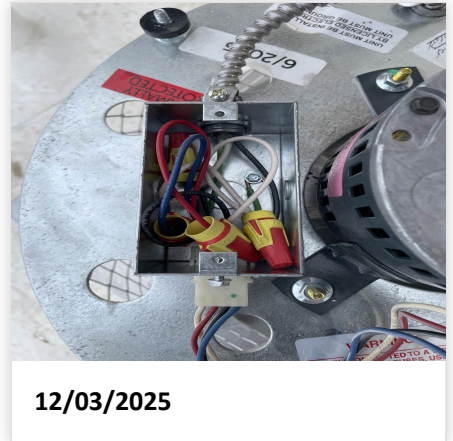
Issue Name : EF Speed Controller
Description : Neither EF-1 nor EF-2 is equipped with a speed controller as specified in EF schedule. Unable to adjust fan speeds.
Created By : National TAB **Assigned To :** National TAB - Jordan Best
Status : Open
Priority : High **Asset Tag :**
Originated Date : 12/03/2025 - Jordan Best - National TAB

No speed controllers installed. Fans balanced using dampers, unable to adjust fan speed.

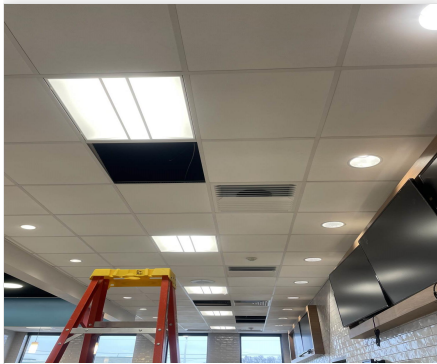
Issue Name : RTU-1 Diffusers Incorrect Position
Description : RTU-1 supply diffusers 6 thru 10 are not in the correct position as seen on GRD / MSET. They're located one tile back from where they should be. Issue did not affect balance,
Created By : National TAB **Assigned To :** National TAB - Jordan Best
Status : Open
Priority : Low **Asset Tag :**
Originated Date : 12/05/2025 - Jordan Best - National TAB

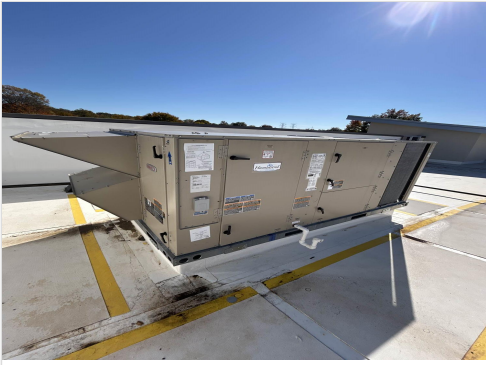
Unit Data - PHOTO LOG

Unit Data		
	Design	Actual
MFG	LENNOX	LENNOX
Serial Num	-	5625E01965
Model Num	LCT150H5E	LCT150H5E
Type	RTU	RTU
Configuration	VERTICAL	VERTICAL
Num OA Filters 1	-	2
OA Filter Size 1	-	14"X24.25"
Num Final Filter 1	-	4
Final Filter Size 1	-	20"X25"X2"

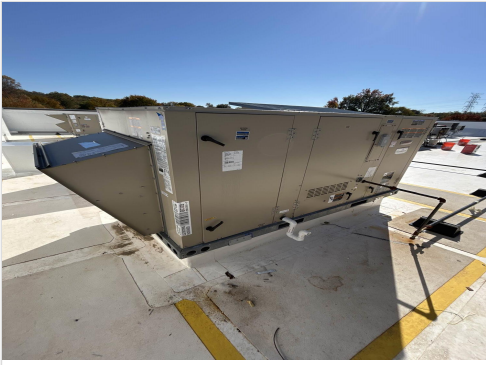
Unit Data - PHOTO LOG

Unit Data		
	Design	Actual
MFG	LENNOX	LENNOX
Serial Num	-	5625E04028
Model Num	LGT072H5E	LGT072H5E
Type	RTU	RTU
Configuration	VERTICAL	VERTICAL
Num OA Filters 1	-	1
OA Filter Size 1	-	15"x28.75"
Num Final Filter 1	-	4
Final Filter Size 1	-	20"x20"x2"
