Report: TAB Report
Function: Test, Adjust, & Balance
Date: 12/05/2025
Completed By: National TAB

11-03-25 WAWA #7618 LOUISVILLE, KY

Table Of Contents

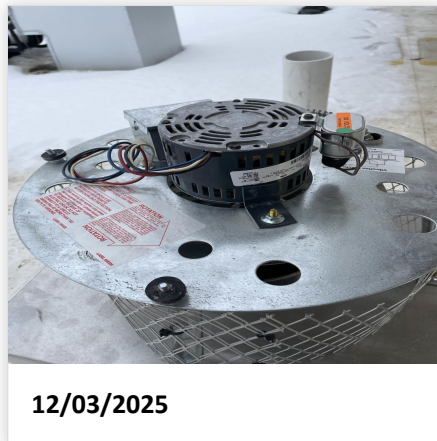
Issue Name : EF Speed Controller
Description : Neither EF-1 nor EF-2 is equipped with a speed controller as specified in EF schedule. Unable to adjust fan speeds.
Created By : National TAB **Assigned To :** National TAB - Jordan Best
Status : Open
Priority : High **Asset Tag :**
Originated Date : 12/03/2025 - Jordan Best - National TAB

EXHAUST FAN SCHEDULE										
MARK	AREA SERVED	MANUFACTURER	MODEL	DESIGN AIRFLOW (CFM)	EXT. S.P. (IN-WG)	VOLTS	PHASE	HP	WEIGHT	NOTES
EF-1	RESTROOMS	GREENHECK	GB-0804	375	0.38	120	1	0.187	59	1.2,3,4,5
EF-2	BACK OF HOUSE	GREENHECK	GB-0806	400	0.38	120	1	0.187	59	1,2,3,4,5
EF-3	TRASH ROOM	GREENHECK	SP-0200	200	0.50	120	1	0.187	14	1,3,4,5

1. PROVIDED BY GC.
2. PROVIDE DISCONNECT SWITCH.
3. PROVIDE 1/2" HIGH PREFABRICATED INSULATED ROOF CURB.
4. MECHANICAL CONTRACTOR TO PROVIDE EXHAUST FAN & WIRED SPEED CONTROLLER.
5. WIRE FOR CONTINUOUS OPERATION.

No speed controllers installed. Fans balanced using dampers, unable to adjust fan speed.

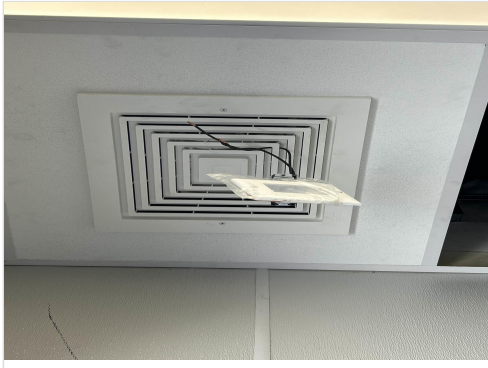
Unit Data - PHOTO LOG

Unit Data		
	Design	Actual
MFG	GREENHECK	BROAN
Model Num	SP-B200	L250E-A
Type	CEILING	CEILING
Configuration	VERTICAL	VERTICAL

Test Data		
	Design	Actual
CFM	200	208
Fan Rotation	-	CORRECT
System SetPt	-	FIXED SPEED
