**Report: TAB Report**  
**Function: Test, Adjust, & Balance**  
**Date: 12/05/2025**  
**Completed By: National TAB**

**11-03-25 WAWA #7618 LOUISVILLE, KY**

5229 DIXIE HWY

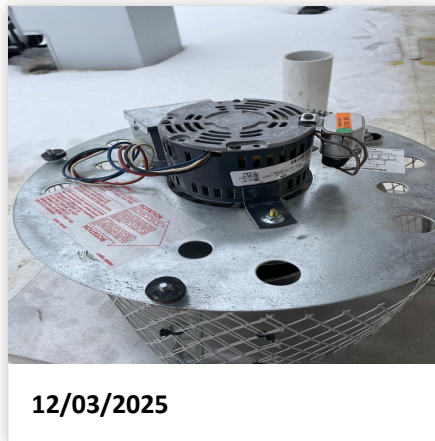
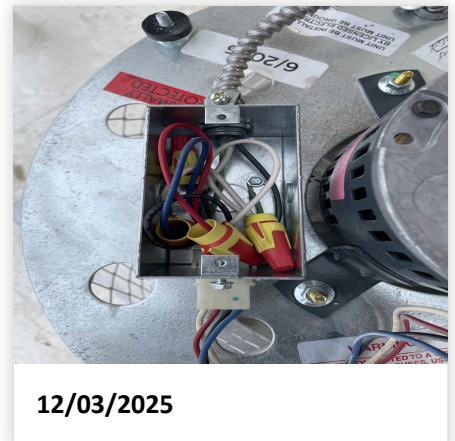
**12/03/2025**

**Issue Name :** EF Speed Controller  
**Description :** Neither EF-1 nor EF-2 is equipped with a speed controller as specified in EF schedule. Unable to adjust fan speeds.  
**Created By :** National TAB      **Assigned To :** National TAB - Jordan Best  
**Status :** Open  
**Priority :** High      **Asset Tag :**  
**Originated Date :** 12/03/2025 - Jordan Best - National TAB

No speed controllers installed. Fans balanced using dampers, unable to adjust fan speed.

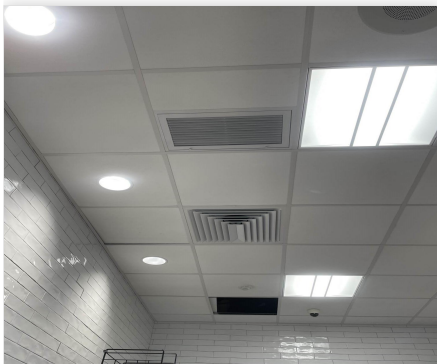
**Issue Name :** EF-2 Return 2  
**Description :** RTU-2, return 2 is oriented incorrectly. Should be flush with wall above oven.  
**Created By :** National TAB                      **Assigned To :** National TAB - Jordan Best  
**Status :** Open  
**Priority :** Medium                                      **Asset Tag :**  
**Originated Date :** 12/05/2025 - Jordan Best - National TAB

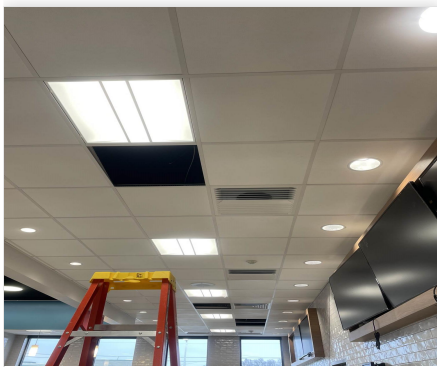
**Issue Name :** RTU-1 Diffusers Incorrect Position  
**Description :** RTU-1 supply diffusers 6 thru 10 are not in the correct position as seen on GRD / MSET. They're located one tile back from where they should be. Issue did not affect balance,  
**Created By :** National TAB                      **Assigned To :** National TAB - Jordan Best  
**Status :** Open  
**Priority :** Low                                      **Asset Tag :**  
**Originated Date :** 12/05/2025 - Jordan Best - National TAB

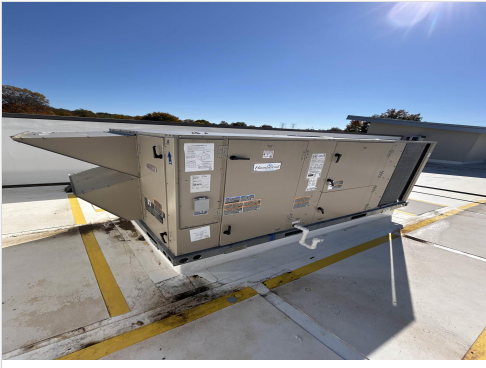
## Unit Data - PHOTO LOG

Unit Data		
	Design	Actual
MFG	LENNOX	LENNOX
Serial Num	-	5625E01965
Model Num	LCT150H5E	LCT150H5E
Type	RTU	RTU
Configuration	VERTICAL	VERTICAL
Num OA Filters 1	-	2
OA Filter Size 1	-	14"X24.25"
Num Final Filter 1	-	4
Final Filter Size 1	-	20"X25"X2"

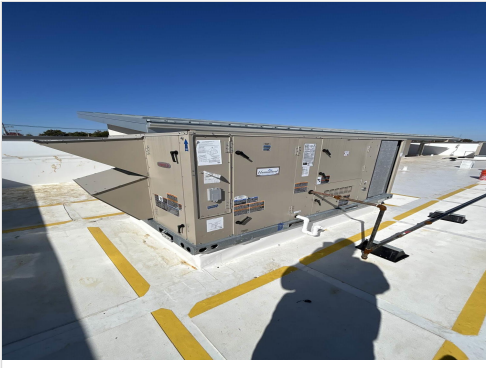
## Unit Data - PHOTO LOG

Unit Data		
	Design	Actual
MFG	LENNOX	LENNOX
Serial Num	-	5625E01958
Model Num	LGT102H5E	LGT102H5E
Type	RTU	RTU
Configuration	VERTICAL	VERTICAL
Num OA Filters 1	-	2
OA Filter Size 1	-	14.25"X24"
Num Final Filter 1	-	4
Final Filter Size 1	-	20"X25"X2"

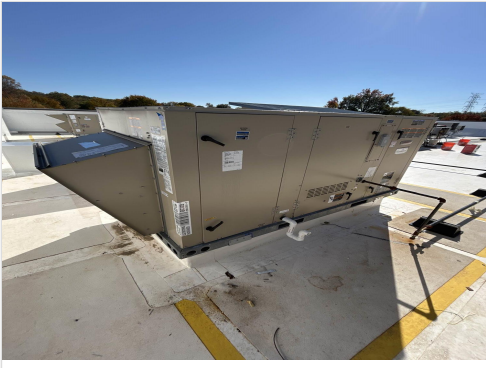
## Unit Data - PHOTO LOG

Unit Data		
	Design	Actual
MFG	LENNOX	LENNOX
Serial Num	-	5625E04028
Model Num	LGT072H5E	LGT072H5E
Type	RTU	RTU
Configuration	VERTICAL	VERTICAL
Num OA Filters 1	-	1
OA Filter Size 1	-	15"x28.75"
Num Final Filter 1	-	4
Final Filter Size 1	-	20"x20"x2"

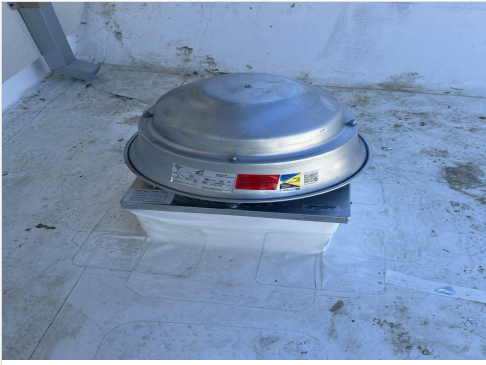
## Unit Data - PHOTO LOG

Unit Data		
	Design	Actual
<b>MFG</b>	GREENHECK	PENNBARRY
<b>Model Num</b>	GB-098-6	DX11R
<b>Serial Num</b>	-	F25AX31170
<b>Type</b>	DOWNBLAST	DOWNBLAST
<b>Configuration</b>	VERTICAL	VERTICAL

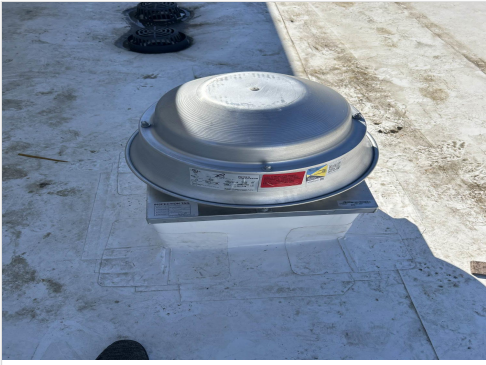
**Unit Data - PHOTO LOG**

Unit Data		
	Design	Actual
MFG	GREENHECK	PENNBARRY
Model Num	GB-098-6	DX11R
Serial Num	-	F25AX31173
Type	DOWNBLAST	DOWNBLAST
Configuration	VERTICAL	VERTICAL

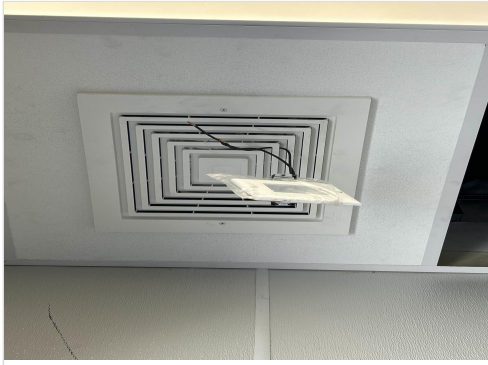
**Unit Data - PHOTO LOG**

Unit Data		
	Design	Actual
MFG	GREENHECK	BROAN
Model Num	SP-B200	L250E-A
Type	CEILING	CEILING
Configuration	VERTICAL	VERTICAL
