Report: TAB Report
Function: Test, Adjust, & Balance
Date: 10/23/2025
Completed By: National TAB

PROJECT
10-13-25 QT #0839 MABLETON, GA

Project: 10-13-25 QT #0839 MABLETON, GA

Project Summary

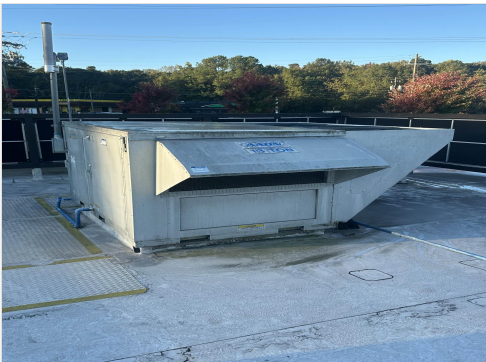
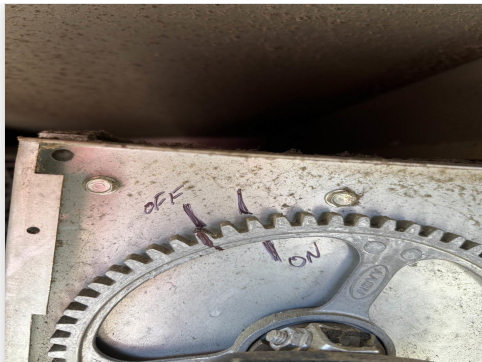
Unit Data - PHOTO LOG

Asset: RT-3

Test Data		
	Design	Actual
SF CFM	4200	4141
SF RPM	-	1349
OA CFM (Hoods On)	800	864
OA CFM (Hoods Off)	350	366
RL Voltage	-	161 VFD
RL Amperage	-	9.58 VFD
VFD Max SetPt	-	46 HZ
VFD Min SetPt	-	24 HZ
OA Damper Position (Hoods On)	-	46%
OA Damper Position (Hoods Off)	-	26%

General	
	Actual
Fan Rotation Correct	YES
Unit Filters Clean	NO
Condensate Drain Installed	YES
