Report: TAB Report
Function: Test, Adjust, & Balance
Date: 10/23/2025
Completed By: National TAB

PROJECT
10-13-25 QT #0839 MABLETON, GA

Project: 10-13-25 QT #0839 MABLETON, GA

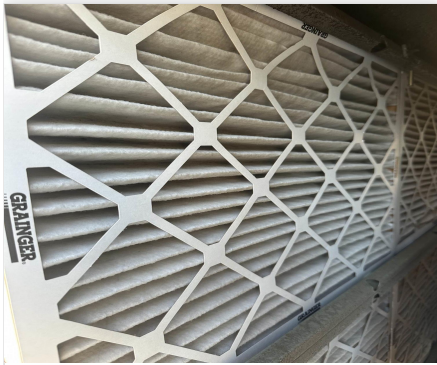
Issue Name : DIRTY AIR FILTERS
Description : The air filters in all RTU's are dirty and need to be replaced.
Created By : National TAB **Assigned To :** National TAB - Sagar Patel
Status : Open
Priority : Low **Asset Tag :**
Originated Date : 10/16/2025 - Ben Searles - National TAB

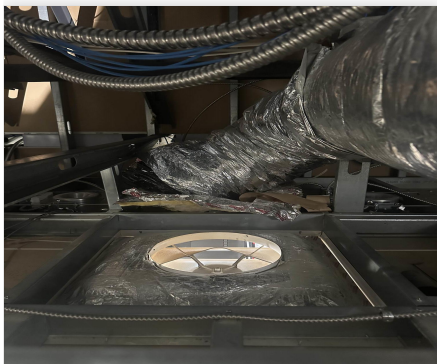
Issue Name : DUCTWORK NOT CONNECTED
Description : The ductwork for supply diffuser 1-4 is not connected. Unable to balance AC1 until the duct is connected.
Created By : National TAB **Assigned To :** National TAB - Sagar Patel
Status : Open
Priority : Urgent **Asset Tag :**
Originated Date : 10/16/2025 - Ben Searles - National TAB

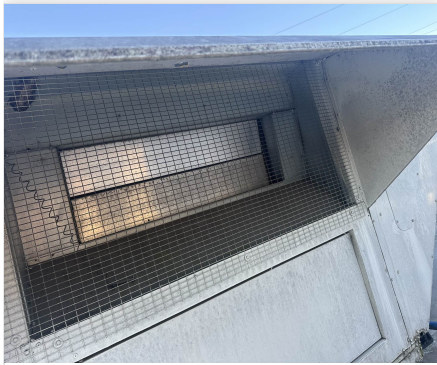
Issue Name : UNITS MISSING OA FILTERS
Description : All RTU's are missing their OA filters.
Created By : National TAB **Assigned To :** National TAB - Brianna Biggs
Status : Open
Priority : Medium **Asset Tag :**
Originated Date : 10/16/2025 - Ben Searles - National TAB

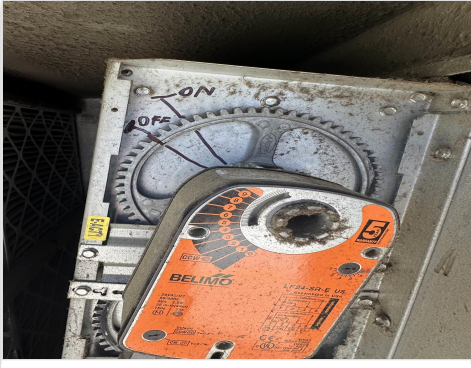
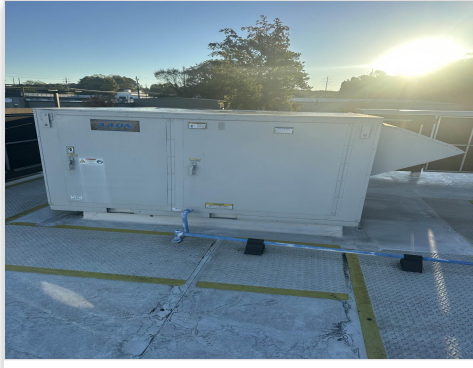
Asset: RT-1

Unit Data		
	Design	Actual
MFG	NA	AAON
Serial Num	-	201808-ANEL17345
Model Num	NA	RN-013-8-0-EAOA-152
Num OA Filters 1	-	1
OA Filter Size 1	-	25X22.5
Num Final Filter 1	-	4
Final Filter Size 1	-	20X25X2
Num Final Filter 2	-	
Final Filter Size 2	-

General	
	Actual
Fan Rotation Correct	YES
Unit Filters Clean	NO
Condensate Drain Installed	YES

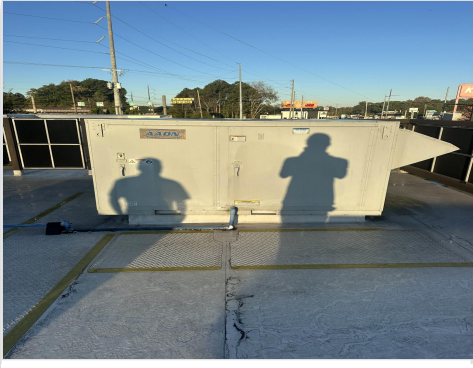
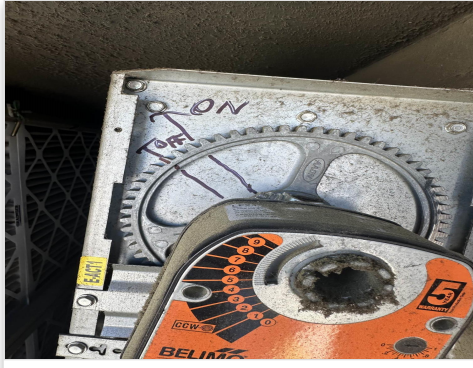
Asset: RT-2

Unit Data		
	Design	Actual
MFG	NA	AAON
Serial Num	-	201807-ANEK17344
Model Num	NA	RN-013-8-0-EAOA-152
Num OA Filters 1	-	1
OA Filter Size 1	-	35X22.5
Num Final Filter 1	-	4
Final Filter Size 1	-	20X25X2
Num Final Filter 2	-	
Final Filter Size 2	-

General	
	Actual
Fan Rotation Correct	YES
Unit Filters Clean	NO
Condensate Drain Installed	YES

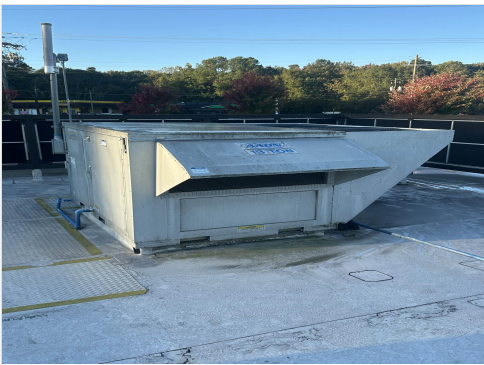
Asset: RT-3

Unit Data		
	Design	Actual
MFG	NA	AAON
Serial Num	-	201808-ANEK17346
Model Num	NA	RN-013-8-0-EAOA-152
Num OA Filters 1	-	1
OA Filter Size 1	-	35X22.5
Num Final Filter 1	-	4
Final Filter Size 1	-	20X25X2
Num Final Filter 2	-	
Final Filter Size 2	-

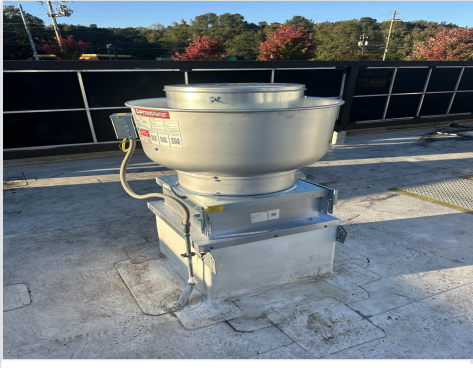
Asset: EF3

Unit Data		
	Design	Actual
MFG	NA	CAPTIVEAIRE
Model Num	NA	DU50HFA
Serial Num	-	7644850
Type	UPBLAST	UPBLAST
Configuration	VERTICAL	VERTICAL

Notes:
FAN IS RUNNING BACKWARDS
