Report: TAB Report
Function: Test, Adjust, & Balance
Date: 10/23/2025
Completed By: National TAB

PROJECT
10-13-25 QT #0839 MABLETON, GA

695 VETERANS MEMORIAL HWY SW

Project: 10-13-25 QT #0839 MABLETON, GA

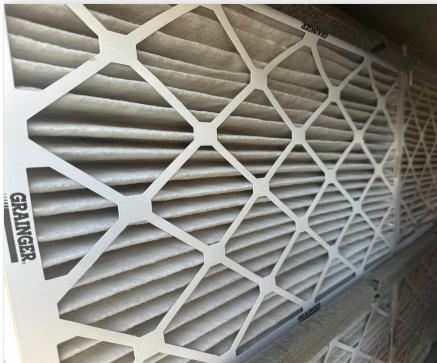
Issue Name : DIRTY AIR FILTERS
Description : The air filters in all RTU's are dirty and need to be replaced.
Created By : National TAB **Assigned To :** National TAB - Sagar Patel
Status : Open
Priority : Low **Asset Tag :**
Originated Date : 10/16/2025 - Ben Searles - National TAB

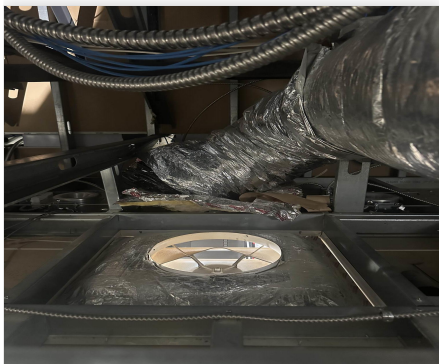
Issue Name : DUCTWORK NOT CONNECTED
Description : The ductwork for supply diffuser 1-4 is not connected. Unable to balance AC1 until the duct is connected.
Created By : National TAB **Assigned To :** National TAB - Sagar Patel
Status : Open
Priority : Urgent **Asset Tag :**
Originated Date : 10/16/2025 - Ben Searles - National TAB

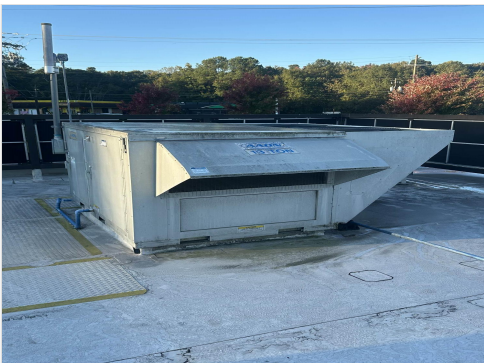
Asset: RT-3

Unit Data		
	Design	Actual
MFG	NA	AAON
Serial Num	-	201808-ANEK17346
Model Num	NA	RN-013-8-0-EAOA-152
Num OA Filters 1	-	1
OA Filter Size 1	-	35X22.5
Num Final Filter 1	-	4
Final Filter Size 1	-	20X25X2
Num Final Filter 2	-	
Final Filter Size 2	-
