Report: TAB Report
Function: Test, Adjust, & Balance
Date: 10/23/2025
Completed By: National TAB

PROJECT
10-13-25 QT #0839 MABLETON, GA

Project: 10-13-25 QT #0839 MABLETON, GA

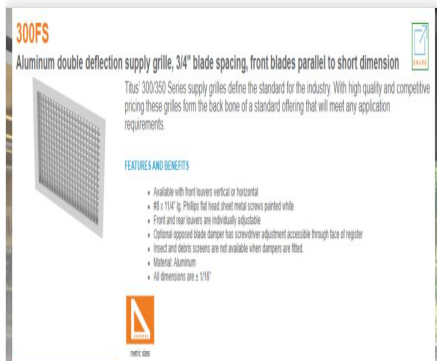
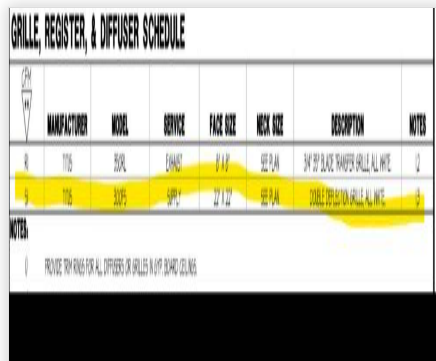
Issue Name : DIFFUSERS ARE THE WRONG TYPE
Description : The installed diffusers in the kitchen are not the specified model
Created By : National TAB **Assigned To :** National TAB - Sagar Patel
Status : Open
Priority : Medium **Asset Tag :**
Originated Date : 10/16/2025 - Ben Searles - National TAB

300FS
 Aluminum double deflection supply grille, 3/4" blade spacing, front blades parallel to short dimension
 These 300/350 Series supply grilles define the standard for the industry. With high quality and competitive pricing these grilles form the backbone of a standard offering that will meet any application requirements.

MANUFACTURER	MODEL	SERVICE	FACE SIZE	HOOK SIZE	DESCRIPTION	NOTES
Titus	300L	300L	18" x 18"	3/8" DIA	34" 3/4" BLADE 300FS GRILLE AL W/TE	Q
Titus	300FS	300FS	22" x 22"	3/8" DIA	300FS 22" X 22" GRILLE AL W/TE	Q

- **11/12/2025 National TAB - Sagar Patel**
 - Diffusers are still incorrect. Titus diffusers are on back order.

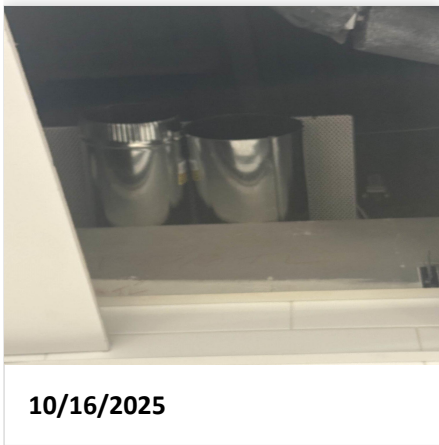
Issue Name : MISSING RETURN
Description : Return grille 1-4 is not installed. Unable to balance EF1 until the return is installed.
Created By : National TAB **Assigned To :** National TAB - Sagar Patel
Status : Open
Priority : Urgent **Asset Tag :**
Originated Date : 10/16/2025 - Ben Searles - National TAB
