**Report: TAB Report**  
**Function: Test, Adjust, & Balance**  
**Date: 10/23/2025**  
**Completed By: National TAB**

**PROJECT**  
**10-13-25 QT #0839 MABLETON, GA**

Project: 10-13-25 QT #0839 MABLETON, GA

Project: 10-13-25 QT #0839 MABLETON, GA  
Function: Test, Adjust, & Balance

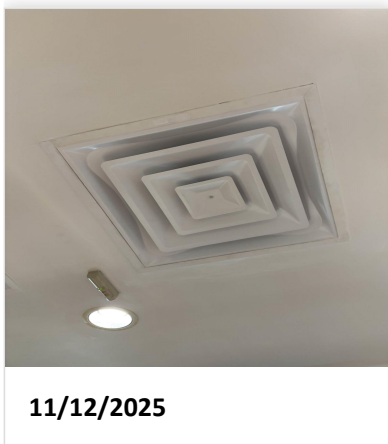
- **11/12/2025 National TAB - Sagar Patel**
  - Diffusers are still incorrect. Titus diffusers are on back order.
