Report: TAB Report
Function: Test, Adjust, & Balance
Date: 05/08/2025
Completed By: National TAB

05-05-25 WHATABURGER #1365 DAPHNE, AL

Project: 05-05-25 WHATABURGER #1365 DAPHNE, AL

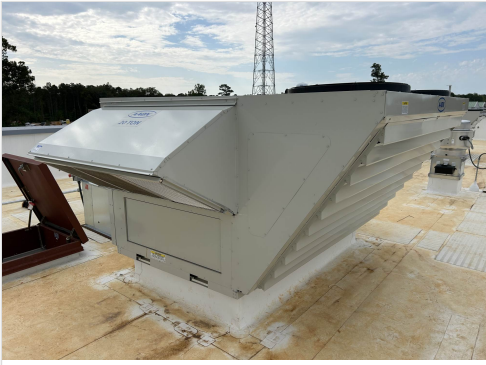
Unit Data - PHOTO LOG

Asset: RTU1

Unit Data		
	Design	Actual
MFG	AAON	AAON
Serial Num	-	202412-BNGP120376
Model Num	RN-020-8-0-GB04-349	RN-020-3-H-BABY-S0-21-000-A
Num OA Filters 1	-	3
OA Filter Size 1	-	18.25x23.25
Num Final Filter 1	-	6
Final Filter Size 1	-	20x25x2

Test Data		
	Design	Actual
SF CFM (Traverse)	-	
SF CFM	3850	3896
SF RPM	-	823
MOTOR RPM	-	823
RA CFM (Traverse)	-	1371
RA CFM	1390	1394
OA CFM	2460	2502
RL Voltage	-	128 VFD
RL Amperage	-	5.20 VFD
SF System SetPt	-	42 HZ
RA Damper Position	-	MANUAL (MARKED)
Min OA Damper Position	-	MANUAL (MARKED)
Min OA Damper Type	-	ECONOMIZER

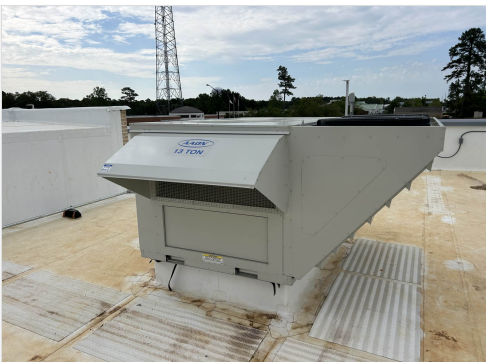
Unit Data - PHOTO LOG

Asset: RTU2

Unit Data		
	Design	Actual
MFG	AAON	AAON
Serial Num	-	202411- ANGK120350
Model Num	RN-013-8-0- GB04-3F9	RN-013-8-0- GB14-3F9
Num OA Filters 1	-	1
OA Filter Size 1	-	22.25x44.5
Num Final Filter 1	-	4
Final Filter Size 1	-	20x25x2

Test Data		
	Design	Actual
SF CFM (Traverse)	-	1983
SF CFM	2050	2081
SF RPM	-	960
MOTOR RPM	-	960
RA CFM (Traverse)	-	505
RA CFM	500	527
OA CFM	1550	1554
RL Voltage	-	201 VFD
RL Amperage	-	5.55 VFD
SF System SetPt	-	49 HZ
RA Damper Position	-	MANUAL (MARKED)
Min OA Damper Position	-	MANUAL (MARKED)
Min OA Damper Type	-	ECONOMIZER

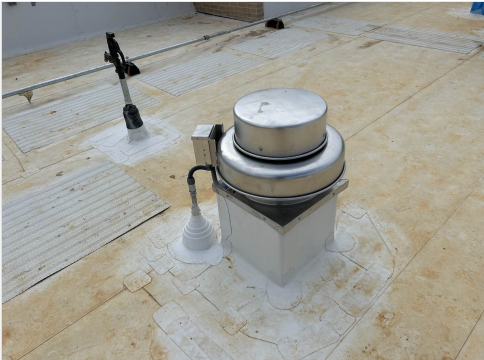
Unit Data - PHOTO LOG

Asset: EF1

Unit Data		
	Design	Actual
MFG	GREENHECK	GREENHECK
Model Num	G-080-VG	G-080-VG-1-17-X
Serial Num	-	26339163
Type	DOWNBLAST	DOWNBLAST
Configuration	VERTICAL	VERTICAL

Test Data		
	Design	Actual
CFM	300	303
Fan RPM	-	DD
Fan Rotation	-	CW
Motor RPM	-	DD
System SetPt	-	SPEED CONTROLLER (MARKED)
RL Voltage	-	
RL Amperage	-	
Total ESP	0.50"	
Fan Inlet SP	-	
Fan Discharge SP	-	ATM

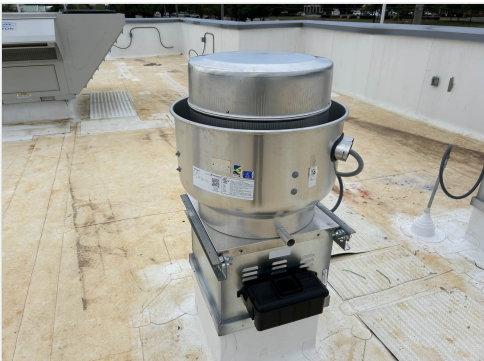
Unit Data - PHOTO LOG

Asset: KEF1

Unit Data		
	Design	Actual
MFG	GREENHECK	GREENHECK
Model Num	CUE-140-VG	CUE-140-VG
Serial Num	-	26339454
Type	UPBLAST	UPBLAST
Configuration	VERTICAL	VERTICAL

Test Data		
	Design	Actual
CFM	1994	2004
Fan RPM	-	DD
Fan Rotation	-	CW
Motor RPM	-	DD
System SetPt	-	SPEED CONTROLLER (MARKED)
RL Voltage	208	209
RL Amperage	7.0	3.0
Total ESP	1.00"	0.42"
Fan Inlet SP	-	-0.42"
Fan Discharge SP	-	ATM

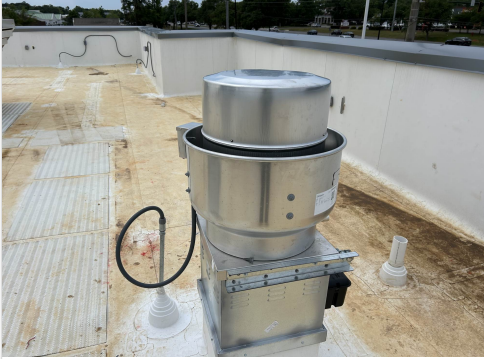
Unit Data - PHOTO LOG

Asset: KEF2

Unit Data		
	Design	Actual
MFG	GREENHECK	GREENHECK
Model Num	CUE-120-VG	CUE-120-5-VG-1-19-G
Serial Num	-	26339475
Type	UPBLAST	UPBLAST
Configuration	VERTICAL	VERTICAL

Test Data		
	Design	Actual
CFM	1216	1255
Fan RPM	-	DD
Fan Rotation	-	CW
Motor RPM	-	DD
System SetPt	-	SPEED CONTROLLER (MARKED)
RL Voltage	208	208
RL Amperage	3.8	2.4
Total ESP	0.75"	0.62"
Fan Inlet SP	-	-0.62"
Fan Discharge SP	-	ATM

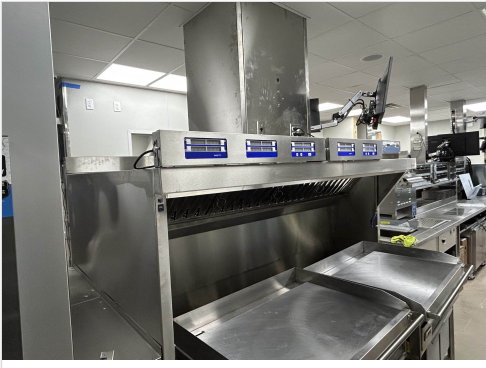
Unit Data - PHOTO LOG

Asset: HD1

Unit Data		
	Design	Actual
MFG	H&K INTERNATIONAL	H&K INTERNATIONAL
Model Num	HKD023	HKD023
Job / Serial Num	-	8157744-001
Type	-	ISLAND
Hood length	-	87"
Hood Width	-	56"

Test Data Exhaust		
	Design	Actual
Filter Type	-	S/S BAFFLE
Filter Size 1	-	12x20
Filter Qty 1	-	8
Filter AK factor size 1	1.5	1.5
Filter Total AK Area	12.0	12.0
Filter1 FPM	-	162
Filter2 FPM	-	186
Filter3 FPM	-	183
Filter4 FPM	-	154
Filter5 FPM	-	142
Filter6 FPM	-	173
Filter7 FPM	-	183
Filter8 FPM	-	157
Filter Ave FPM(corr)	-	167
CFM	1994	2004

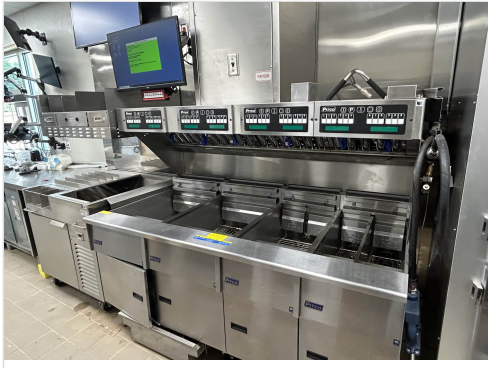
Unit Data - PHOTO LOG

Asset: HD2

Unit Data		
	Design	Actual
MFG	H&K INTERNATIONAL	H&K INTERNATIONAL
Model Num	HDK027	HKD023
Job / Serial Num	-	8157820-001
Type	-	TYPE I LOW PROXIMITY
Hood length	-	72"
Hood Width	-	26"

Test Data Exhaust		
	Design	Actual
Filter Type	-	S/S BAFFLE
Filter Size 1	-	12x16
Filter Size 2	-	12x20
Filter Qty 1	-	3
Filter Qty 2	-	1
Filter AK factor size 1	1.16	1.16
Filters AK factor size 2	1.5	1.5
Filter Total AK Area	4.98	4.98
Filter1 FPM	-	252
Filter2 FPM	-	274
Filter3 FPM	-	251
Filter4 FPM	-	233
Filter Ave FPM(corr)	-	252
CFM	1216	1255
