Report: TAB Report
Function: Test, Adjust, & Balance
Date: 01/22/2026
Completed By: National TAB

PROJECT
03-09-26 QT #1137 PIEDMONT, SC

7599 AUGUSTA RD

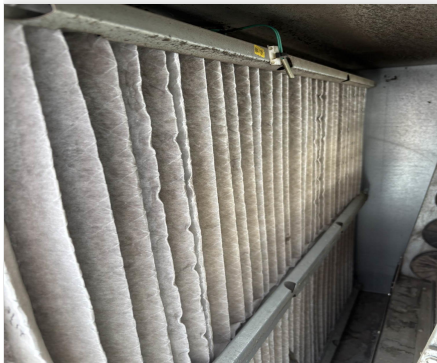
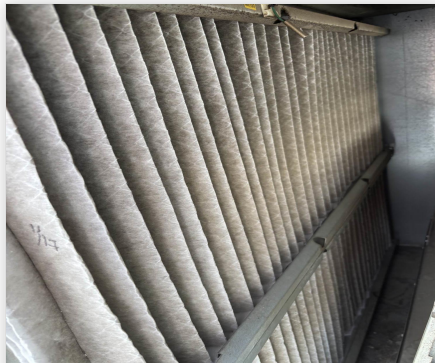
Issue Name : Dirty final filters
Description : RTU 2&3 both have dirty final filters that will need to be exchanged soon.
Created By : National TAB **Assigned To :** National TAB - Dan Hertenstein
Status : Open
Priority : Medium **Asset Tag :**
Originated Date : 03/10/2026 - Christian Moller - National TAB

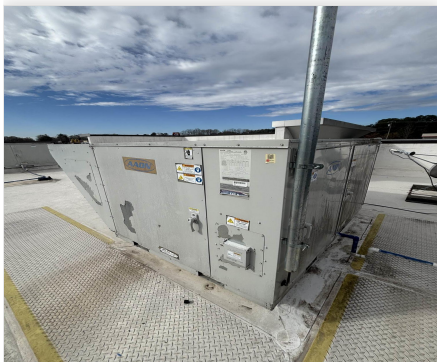
Issue Name : RTU 1 fan not working
Description : Upon arrival RTU 1's supply fan was not working. The unit itself has power, the VFD and economizer are working properly and it's connected to Emerson. The VFD is trying to run the fan at 36Hz however the fan isn't on. There were no amps coming from the motor to the VFD suggesting there is a problem with the motor itself.

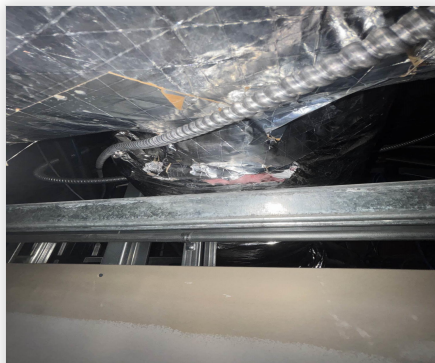
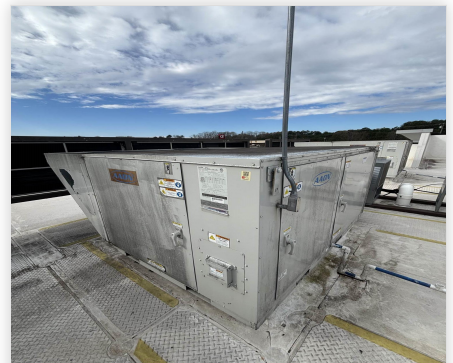
Issue Name : RTU 3 SGRD 1 leakage
Description : SGRD 1 on RTU 3 has a leak coming from the duct just past the hood. This is causing the diffuser to be low on flow.
Created By : National TAB **Assigned To :** National TAB - Dan Hertenstein
Status : Open
Priority : Urgent **Asset Tag :** SGRD1
Originated Date : 03/10/2026 - Christian Moller - National TAB

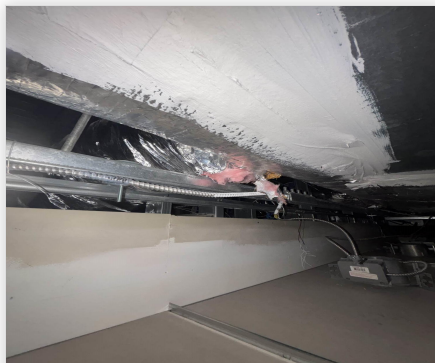
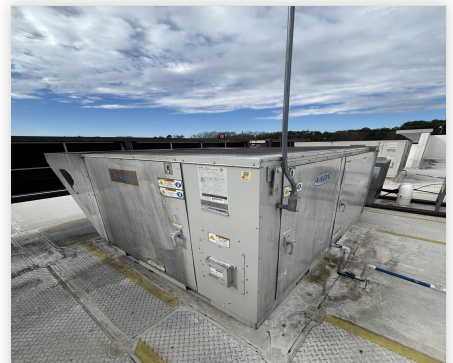
Issue Name : RTU 3 SGRD 2 leakage
Description : SGRD 2 on RTU 3 has a leak coming from the duct just above the hood. This is causing the diffuser to be low on flow.
Created By : National TAB **Assigned To :** National TAB - Dan Hertenstein
Status : Open
Priority : Urgent **Asset Tag :** SGRD2
Originated Date : 03/10/2026 - Christian Moller - National TAB

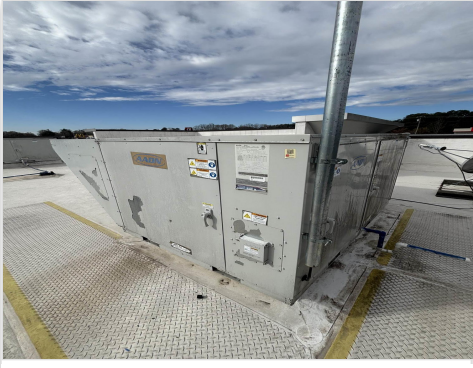
Asset: RT-1

Notes:
[1] UNIT NOT WORKING. SEE ISSUES.

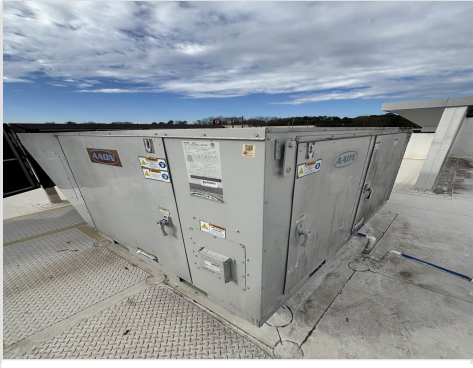
Asset: RT-2

Notes:
[2] DIRTY FINAL FILTERS. SEE ISSUES.

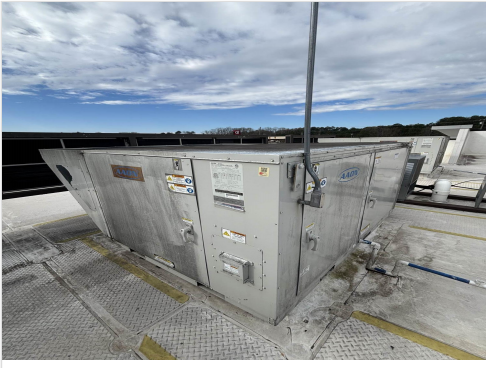
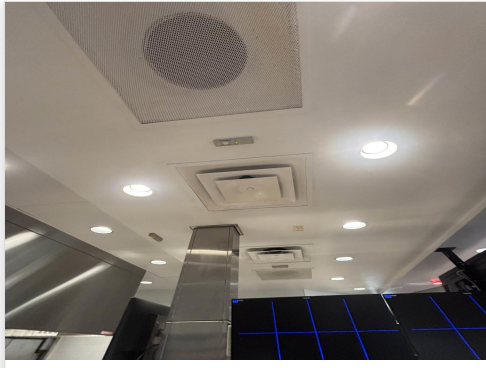
Asset: RT-3

[2] DIRTY FINAL FILTERS. SEE ISSUES.

[3] SGRD 1&2 DUCT LEAKAGE. SEE ISSUES.

[4] WRONG DIFFUSERS INSTALLED. SEE ISSUES.

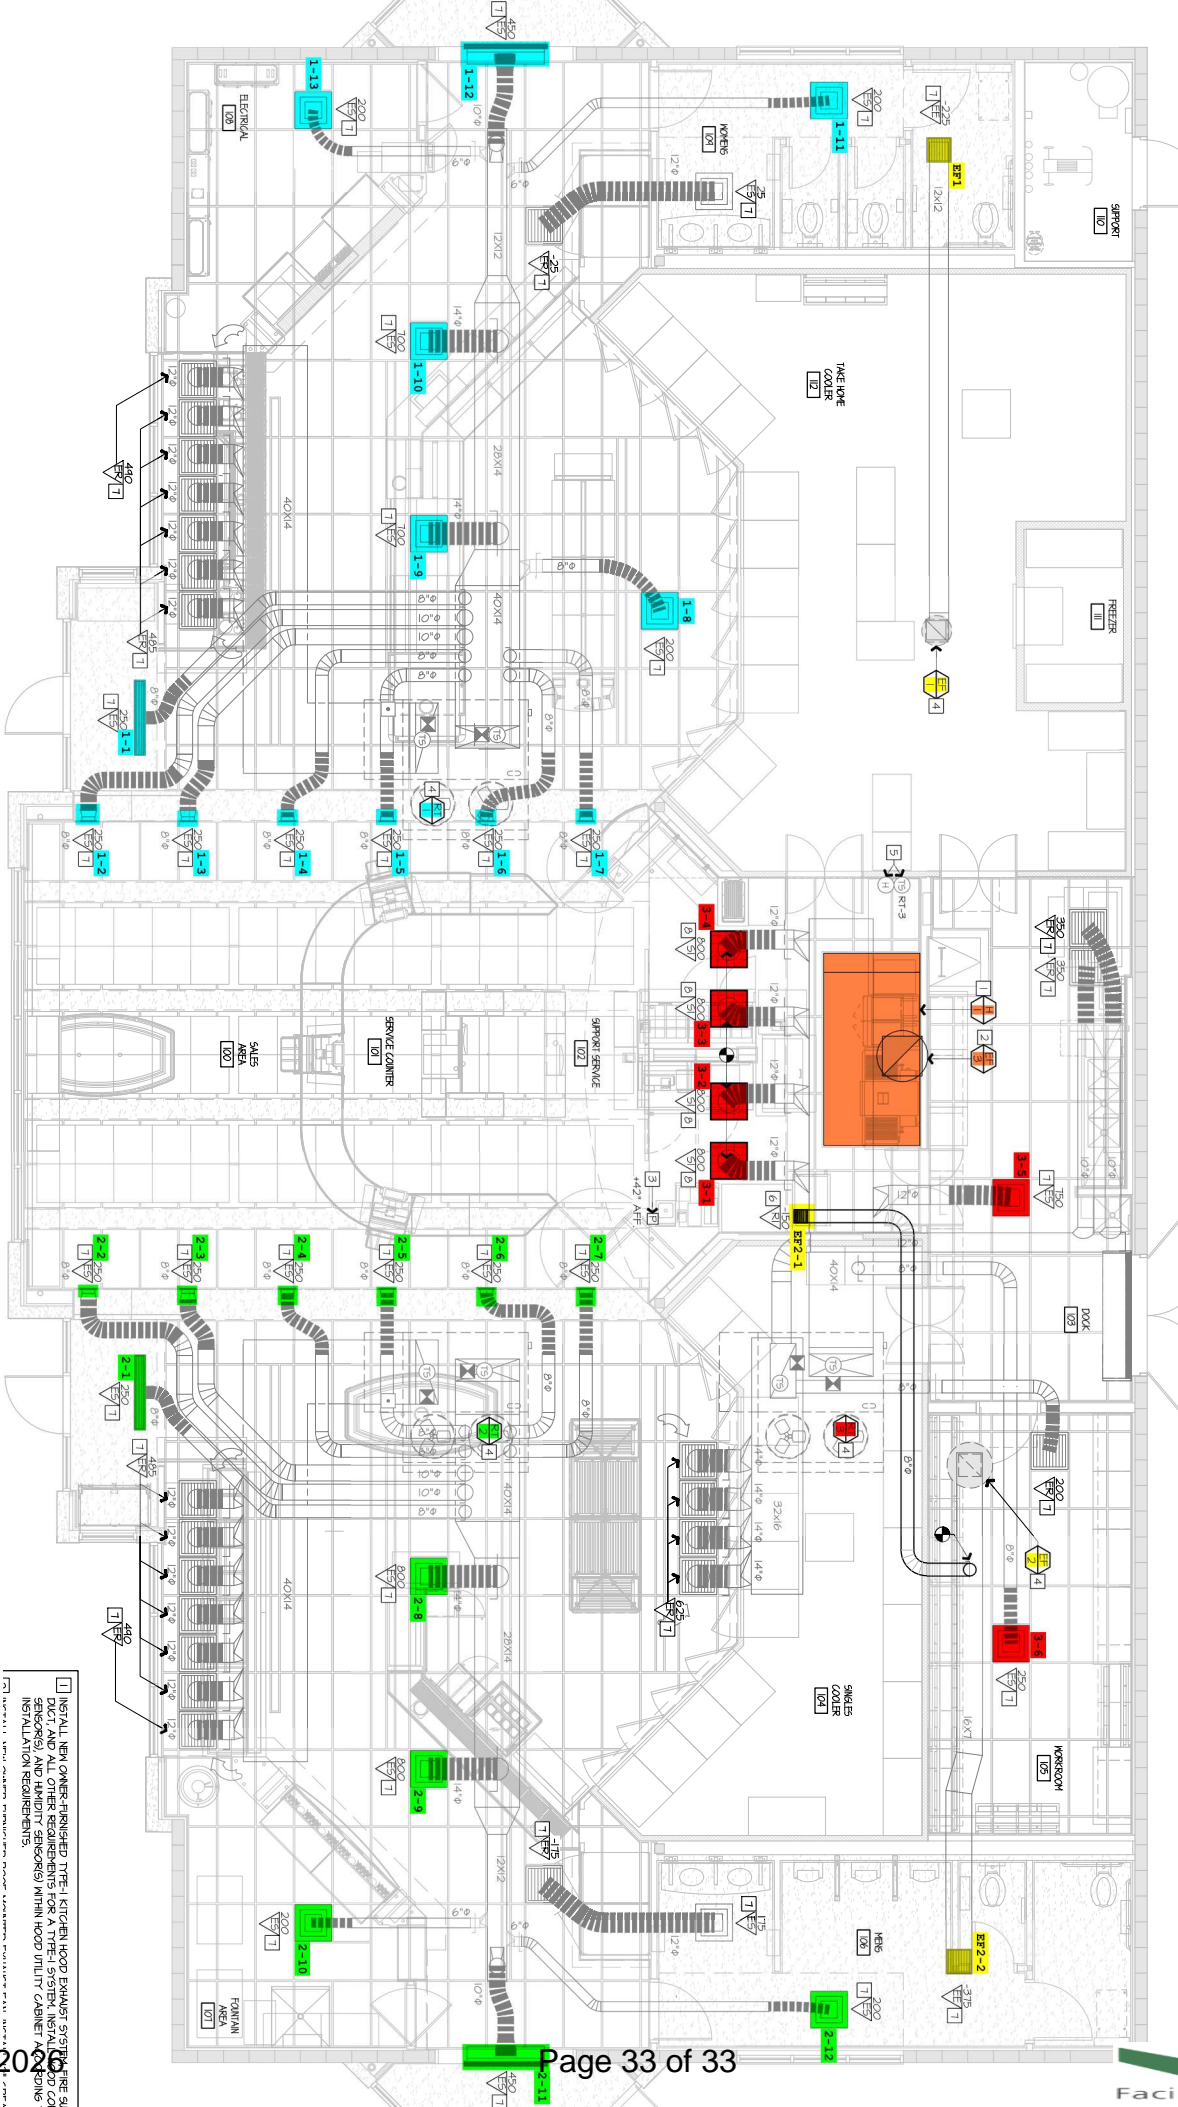
INSTALL WITH OWNER APPROVED TYPE I KITCHEN HOOD EXHAUST SYSTEM AND GREASE DUCT, AND ALL OTHER REQUIREMENTS FOR A TYPE-I SYSTEM. INSTALL HOOD CAP SENSORS, AND HANDIITY SENSORS) WITHIN HOOD UTILITY CABINET AS PER INSTALLATION REQUIREMENTS.
