Report: TAB Report
Function: Test, Adjust, & Balance
Date: 08/14/2025
Completed By: National TAB

PROJECT
08-18-25 FIREBIRDS NEW ALBANY, OH

Project: 08-18-25 FIREBIRDS NEW ALBANY, OH

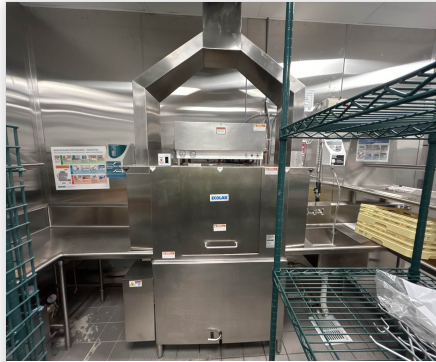
Issue Name : EF-1 Low on flow
Description : Producing 300 cfm via traverse when its designed for 800. Static pressure is high. No obstructions found when inspecting the duct work and rotation is correct
Created By : National TAB **Assigned To :** National TAB - Brianna Biggs
Status : Open
Priority : **Urgent** **Asset Tag :**
Originated Date : 08/13/2025 - Aaron Cosby - National TAB

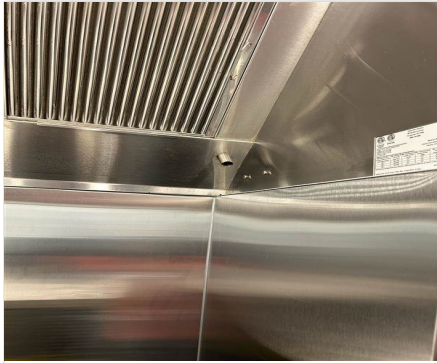
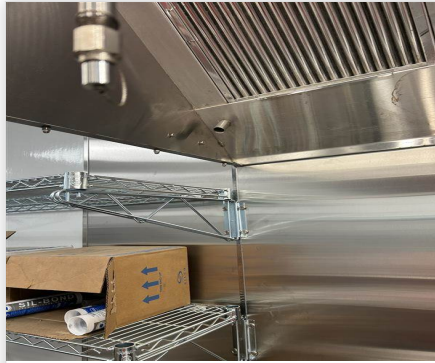
Issue Name : HD-4 grease cups not installed
Description : Cups not located near the hood
Created By : National TAB **Assigned To :** National TAB - Brianna Biggs
Status : Open
Priority : High **Asset Tag :**
Originated Date : 08/13/2025 - Aaron Cosby - National TAB

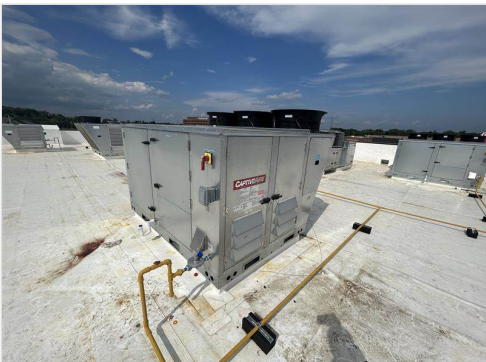
Asset: RTU 1

Unit Data		
	Design	Actual
MFG	CAPTIVE-AIRE	CAPTIVE-AIRE
Serial Num	-	6687721
Model Num	CASRTU3-I.500-20-20T	CASRTU3-I.500-20-20T
Type	RTU	RTU
Configuration	VERTICAL	VERTICAL
Num OA Filters 1	-	4
OA Filter Size 1	-	16X25X2"
Num Final Filter 1	-	8
Final Filter Size 1	-	20X25X2"

Test Data		
	Design	Actual
SF CFM	3195	
SF RPM	-	NA
RA CFM	-	
OA CFM	1670	1603
RL Voltage	-	138 VFD
RL Amperage	-	11.5 VFD
SF Rotation	-	GOOD
SF System SetPt	-	52.9 HZ
Min OA Damper Position	-	4.6 V
Min OA Damper Type	-	ECON

Notes:
 65 HZ
 0.44" discharge
 0.77" OA
 0.53" return
 0.54" intake
 0.55" space

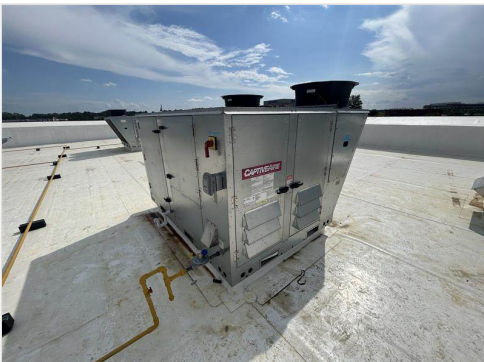
Asset: RTU 2

Unit Data		
	Design	Actual
MFG	CAPTIVE-AIRE	CAPTIVE-AIRE
Serial Num	-	6687721
Model Num	CASRTU3-I.300-18-15T	CASRTU3-I.300-18-15T
Type	RTU	RTU
Configuration	VERTICAL	VERTICAL
Num OA Filters 1	-	4
OA Filter Size 1	-	16X25X2"
Num Final Filter 1	-	8
Final Filter Size 1	-	20X25X2"

Test Data		
	Design	Actual
SF CFM	3210	
SF RPM	-	NA
RA CFM	-	
OA CFM	1253	1227
RL Voltage	-	209 VFD
RL Amperage	-	6.6 VFD
SF Rotation	-	GOOD
SF System SetPt	-	68.6 HZ
Min OA Damper Position	-	4.1 V
Min OA Damper Type	-	ECON

Notes:
 68.6 HZ
 0.70 discharge
 0.72" OA
 0.56" return
 0.52" intake
 0.56" space

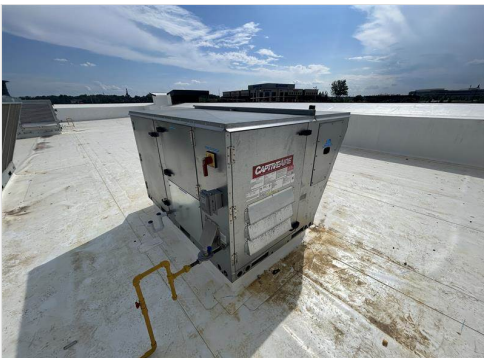
Asset: RTU 3

Unit Data		
	Design	Actual
MFG	CAPTIVE-AIRE	CAPTIVE-AIRE
Serial Num	-	6687721
Model Num	CASRTU1-I.125-13-5T	CASRTU1-I.125-13-5T
Type	RTU	RTU
Configuration	VERTICAL	VERTICAL
Num OA Filters 1	-	2
OA Filter Size 1	-	16X20X2"
Num Final Filter 1	-	8
Final Filter Size 1	-	16X16X2"

Test Data		
	Design	Actual
SF CFM	1600	1498
SF RPM	-	NA
RA CFM	-	1136
OA CFM	337	362
RL Voltage	-	203 VFD
RL Amperage	-	2.5 VFD
SF Rotation	-	GOOD
SF System SetPt	-	56.7 HZ
Min OA Damper Position	-	4.3 V
Min OA Damper Type	-	ECON

- 56.7 HZ
- 0.35" discharge
- 0.81" OA
- 0.54" return
- 0.52" intake
- 0.56" space

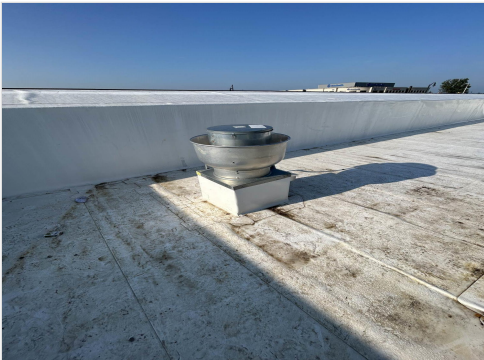
Asset: EF1

Unit Data		
	Design	Actual
MFG	CAPTIVE-AIRE	CAPTIVE-AIRE
Model Num	DU33HFA	DU33HFA
Serial Num	-	6687721
Type	CEILING	UPBLAST
Configuration	VERTICAL	VERTICAL

Test Data		
	Design	Actual
CFM	800	300
Fan RPM	1386	NA
Fan Rotation	-	GOOD
Motor RPM	-	NA
System SetPt	-	HIGH SPEED
RL Voltage	-	NA
RL Amperage	-	NA
Total ESP	0.500"	1.36"
Fan Discharge SP	-	ATM

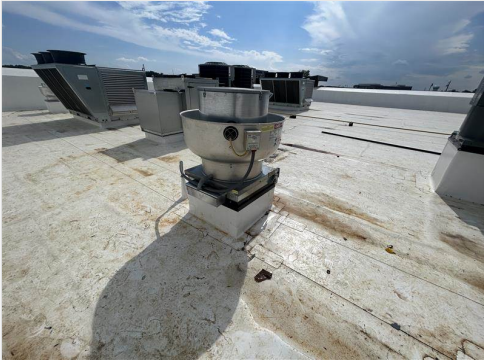
Asset: KEF2

Unit Data		
	Design	Actual
MFG	CAPTIVE-AIRE	CAPTIVE-AIRE
Model Num	DU180HFA	DU180HFA
Serial Num	-	6687721
Type	UPBLAST	UPBLAST
Configuration	VERTICAL	VERTICAL

Test Data		
	Design	Actual
CFM	2300	2196
Fan RPM	1212	NA
Fan Rotation	-	GOOD
System SetPt	-	48.9 HZ
RL Voltage	-	114/115/115
RL Amperage	-	4.4/4.3/4.3
Total ESP	1.500"	0.65"
Fan Discharge SP	-	ATM

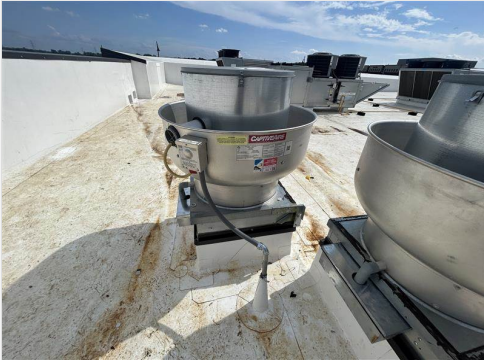
Asset: KEF4

Unit Data		
	Design	Actual
MFG	CAPTIVE-AIRE	CAPTIVE-AIRE
Model Num	DU180HFA	DU180HFA
Serial Num	-	6687721
Type	UPBLAST	UPBLAST
Configuration	VERTICAL	VERTICAL

Test Data		
	Design	Actual
CFM	2200	2296
Fan RPM	1129	NA
Fan Rotation	-	GOOD
System SetPt	-	60 HZ
RL Voltage	-	115/115/115
RL Amperage	-	5.2/5.1/5.2
Total ESP	1.400"	0.64"
Fan Discharge SP	-	ATM

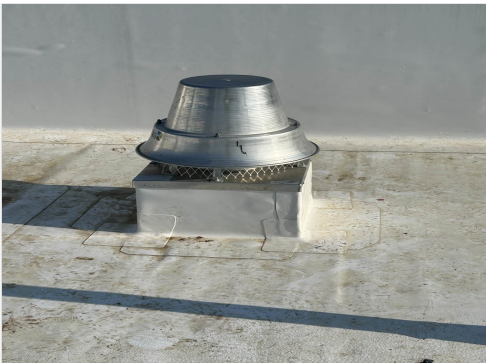
Asset: TEF1

Unit Data		
	Design	Actual
MFG	GREENHECK	GREENHECK
Model Num	G-080	G-080
Serial Num	-	L24XZ56577
Type	CENTRIFUGAL	DOWNBLAST
Configuration	VERTICAL	VERTICAL

Test Data		
	Design	Actual
CFM	200	211
Fan RPM	-	NA
Fan Rotation	-	GOOD
Motor RPM	-	NA
RL Voltage	-	118
RL Amperage	-	0.4
Total ESP	0.5"	0.15"

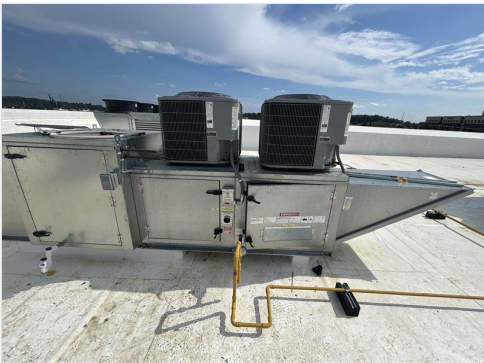
Asset: MAU1

Unit Data		
	Design	Actual
MFG	CAPTIVE-AIRE	CAPTIVE-AIRE
Model Num	A2-D.500-20D-MPU	A2-D.500-20D-MPU
Serial Num	-	6687721
Type	MAU	MAU
Configuration	VERTICAL	VERTICAL

Test Data		
	Design	Actual
CFM	3800	3569
SF RPM	1660	NA
Motor RPM	-	NA
RL Voltage	-	210/208/208
RL Amperage	-	12.3/12.5/12.5
Total ESP	-	0.66"

Gas Heat		
	Design	Actual
Heater Operates (y/n)	-	N
Flame Status (pass/fail)	-	FAIL
Inlet Air Temp SetPt	55	55
Discharge Air Temp SetPt	60	60
Air Flow Switch SP Actual	-	0

Issue Name : MUA-1 Heating not operational
Description : Captive Aire did startup when gas wasn't connected to the building, so the heating startup was not done. When trying to test it, with tech support, it did not function. The gas, pilot, and ignition were all tested. The flame is not lighting because the ignition isn't sparking the gas, meaning the problem lies in the ignition transformer.
Created By : National TAB **Assigned To :** National TAB - Brianna Biggs
Status : Open
Priority : Urgent **Asset Tag :**
Originated Date : 08/13/2025 - Aaron Cosby - National TAB
