**Report: TAB Report**  
**Function: Test, Adjust, & Balance**  
**Date: 08/14/2025**  
**Completed By: National TAB**

**PROJECT**  
**08-18-25 FIREBIRDS NEW ALBANY, OH**

Project: 08-18-25 FIREBIRDS NEW ALBANY, OH

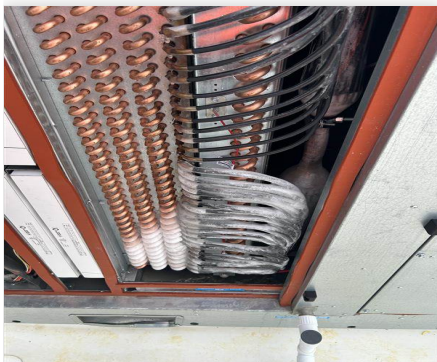
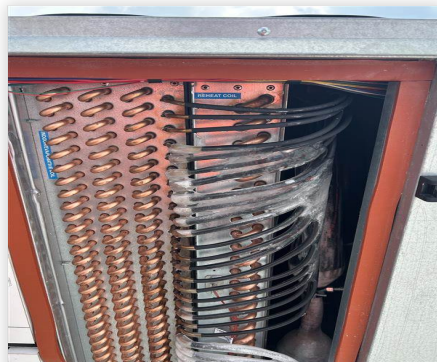
**Issue Name :** DOAS-1 Evaporator coil freezing  
**Description :** When unit runs normally, at the correct speed and default temp set point, the evaporator coil freezes. The temp set point was changed to 85 degrees to ensure it does not freeze  
**Created By :** National TAB      **Assigned To :** National TAB - Will Turnbough  
**Status :** Open  
**Priority :** InfoOnly      **Asset Tag :**  
**Originated Date :** 08/13/2025 - Aaron Cosby - National TAB

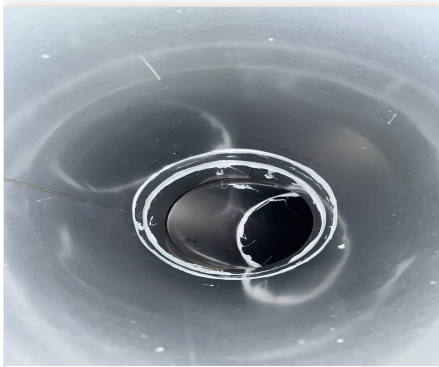
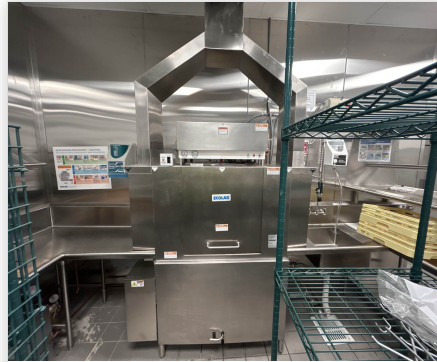
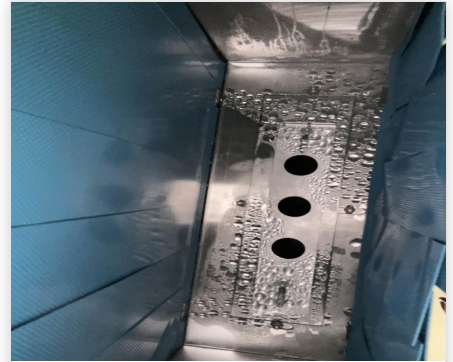
**Issue Name :** EF-1 Low on flow  
**Description :** Producing 300 cfm via traverse when its designed for 800. Static pressure is high. No obstructions found when inspecting the duct work and rotation is correct  
**Created By :** National TAB                      **Assigned To :** National TAB - Brianna Biggs  
**Status :** Open  
**Priority :** **Urgent**                                      **Asset Tag :**  
**Originated Date :** 08/13/2025 - Aaron Cosby - National TAB

Asset									
Asset Name	Location	Type	Size	DESIGN CFM	AK	CFM(1)	CFM(2)	FINAL CFM	% to design
EGRD1	DISHROOM	DISHWASHER	12X12	400	1	150	150	150	37.5
EGRD2	DISHROOM	DISHWASHER	12X12	400	1	150	150	150	37.5
Total				800		300	300	300	37.5%

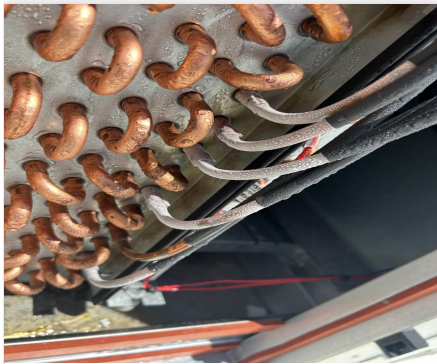
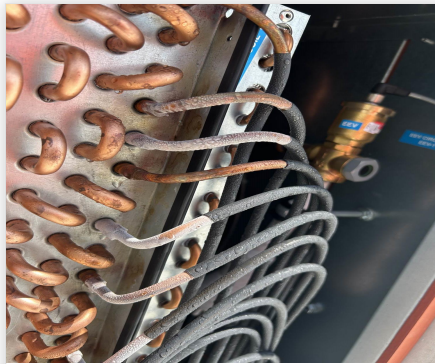
**Issue Name :** RTU-1 Evaporator coils freezing  
**Description :** When the unit is running at correct speed and default temp set point and the coils freeze. Doesn't seem to get worse than the picture shows. Temp set point was changed to 73 degrees to ensure the coils don't freeze  
**Created By :** National TAB                      **Assigned To :** National TAB - Brianna Biggs  
**Status :** Open  
**Priority :** InfoOnly                                      **Asset Tag :**  
**Originated Date :** 08/13/2025 - Aaron Cosby - National TAB

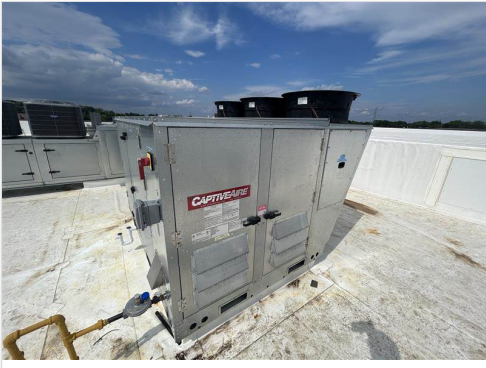
Asset: DOAS 1

Test Data		
	Design	Actual
SF CFM	3990	3979
SF RPM	-	NA
RA CFM	0	0
OA CFM	3990	3990
RL Voltage	-	151 VFD
RL Amperage	-	10.1 VFD
SF Rotation	-	GOOD
SF System SetPt	-	52.9 HZ
Min OA Damper Position	-	100%

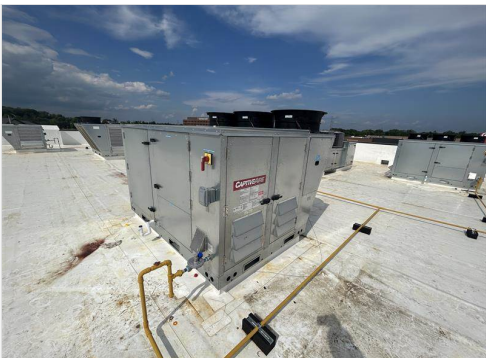
Asset: RTU 1

Test Data		
	Design	Actual
SF CFM	3195	3230
SF RPM	-	NA
RA CFM	-	1627
OA CFM	1670	1603
RL Voltage	-	138 VFD
RL Amperage	-	11.5 VFD
SF Rotation	-	GOOD
SF System SetPt	-	52.9 HZ
Min OA Damper Position	-	4.6 V
Min OA Damper Type	-	ECON

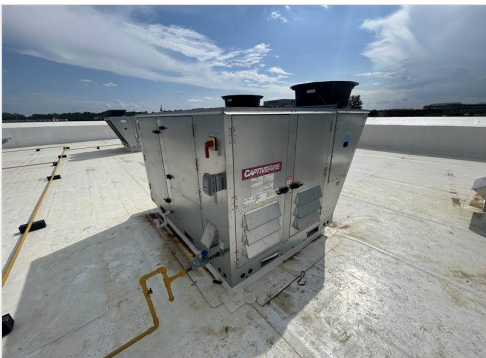
Asset: RTU 2

Test Data		
	Design	Actual
SF CFM	3210	3363
SF RPM	-	NA
RA CFM	-	2136
OA CFM	1253	1227
RL Voltage	-	209 VFD
RL Amperage	-	6.6 VFD
SF Rotation	-	GOOD
SF System SetPt	-	68.6 HZ
Min OA Damper Position	-	4.1 V
Min OA Damper Type	-	ECON

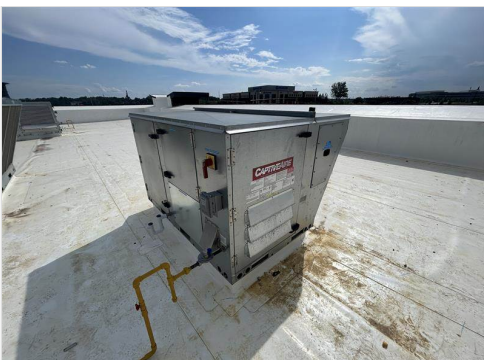
Asset: RTU 3

Test Data		
	Design	Actual
SF CFM	1600	1498
SF RPM	-	NA
RA CFM	-	1136
OA CFM	337	362
RL Voltage	-	203 VFD
RL Amperage	-	2.5 VFD
SF Rotation	-	GOOD
SF System SetPt	-	56.7 HZ
Min OA Damper Position	-	4.3 V
Min OA Damper Type	-	ECON

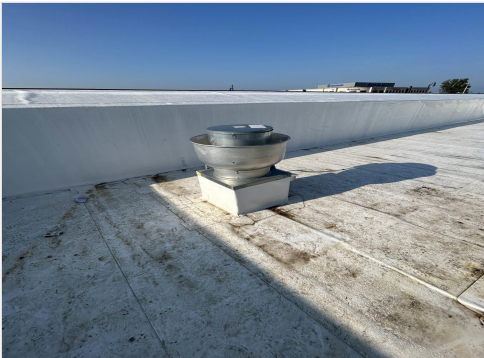
Asset: EF1

Test Data		
	Design	Actual
CFM	800	300
Fan RPM	1386	NA
Fan Rotation	-	GOOD
Motor RPM	-	NA
System SetPt	-	HIGH SPEED
RL Voltage	-	NA
RL Amperage	-	1.8
Total ESP	0.500"	1.36"
Fan Discharge SP	-	ATM

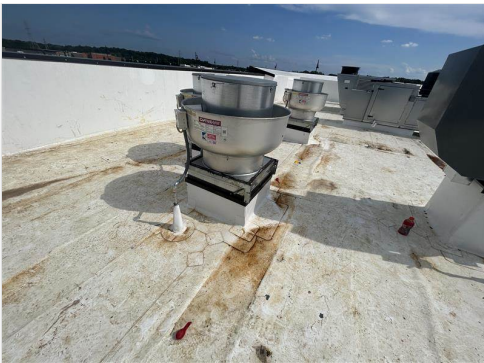
Asset: KEF1

Test Data		
	Design	Actual
CFM	2300	2146
Fan RPM	1212	NA
Fan Rotation	-	GOOD
System SetPt	-	48.2 HZ
RL Voltage	-	106/106/106
RL Amperage	-	4.5/4.4/4.4
Total ESP	1.500"	0.93"
Fan Discharge SP	-	ATM

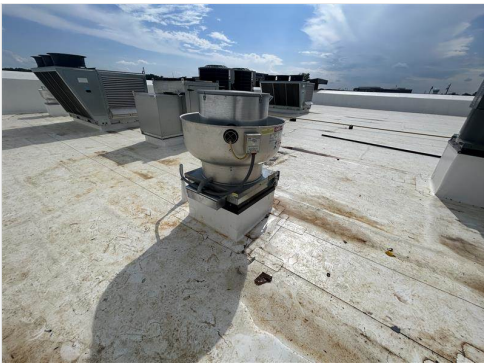
Asset: KEF2

Test Data		
	Design	Actual
CFM	2300	2196
Fan RPM	1212	NA
Fan Rotation	-	GOOD
System SetPt	-	48.9 HZ
RL Voltage	-	114/115/115
RL Amperage	-	4.4/4.3/4.3
Total ESP	1.500"	0.65"
Fan Discharge SP	-	ATM

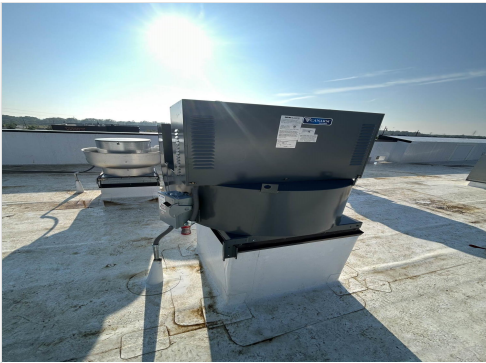
Asset: KEF3

KEF-3 won't hinge back because it is sealed to the curb. Hinge kit is installed however

Notes:  
48.2 HZ  
Pressure readings unavailable as the fan is sealed to the curb and won't hinge back

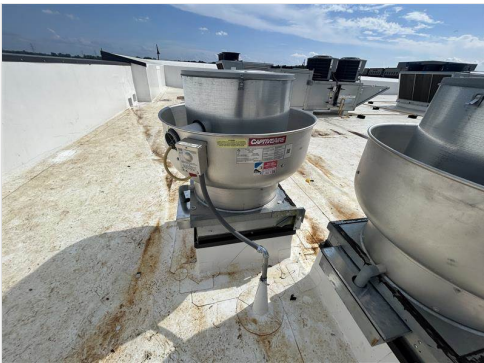
Asset: KEF4

Test Data		
	Design	Actual
CFM	2200	2296
Fan RPM	1129	NA
Fan Rotation	-	GOOD
System SetPt	-	60 HZ
RL Voltage	-	115/115/115
RL Amperage	-	5.2/5.1/5.2
Total ESP	1.400"	0.64"
Fan Discharge SP	-	ATM

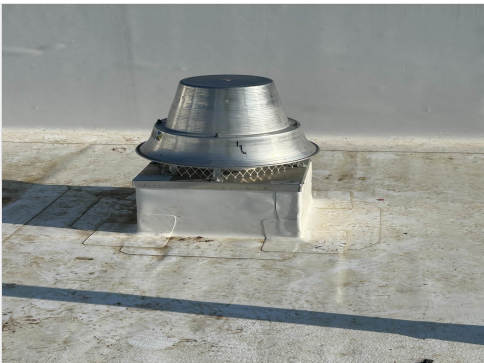
Asset: TEF1

Test Data		
	Design	Actual
CFM	200	211
Fan RPM	-	NA
Fan Rotation	-	GOOD
Motor RPM	-	NA
RL Voltage	-	118
RL Amperage	-	0.4
Total ESP	0.5"	0.15"

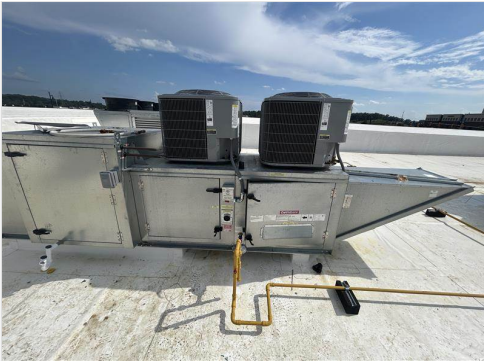
Asset: MAU1

**Issue Name :** MUA-1 Heating not operational  
**Description :** Captive Aire did startup when gas wasn't connected to the building, so the heating startup was not done. When trying to test it, with tech support, it did not function. The gas, pilot, and ignition were all tested. The flame is not lighting because the ignition isn't sparking the gas, meaning the problem lies in the ignition transformer.  
**Created By :** National TAB                      **Assigned To :** National TAB - Brianna Biggs  
**Status :** Open  
**Priority :** [Medium](#)                                      **Asset Tag :**  
**Originated Date :** 08/13/2025 - Aaron Cosby - National TAB

Gas Heat		
	Design	Actual
Heater Operates (y/n)	-	N
Flame Status (pass/fail)	-	FAIL
Inlet Air Temp SetPt	55	55
Discharge Air Temp SetPt	60	60
Air Flow Switch SP Actual	-	0
