Report: TAB Report
Function: Test, Adjust, & Balance
Date: 08/14/2025
Completed By: National TAB

PROJECT
08-18-25 FIREBIRDS NEW ALBANY, OH

Project: 08-18-25 FIREBIRDS NEW ALBANY, OH

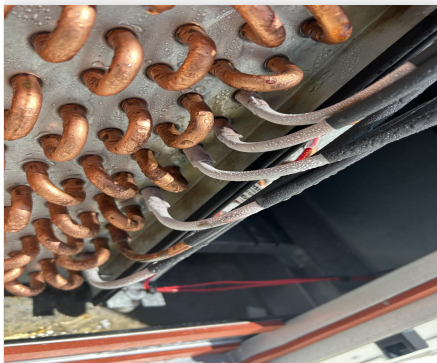
Issue Name : RTU-1 Evaporator coils freezing
Description : When the unit is running at correct speed and default temp set point the coils begin to freeze. Doesn't seem to get worse than the picture shows. Temp set point was changed to 73 degrees to ensure the coils don't freeze
Created By : National TAB **Assigned To :** National TAB - Brianna Biggs
Status : Open
Priority : **Medium** **Asset Tag :**
Originated Date : 08/13/2025 - Aaron Cosby - National TAB

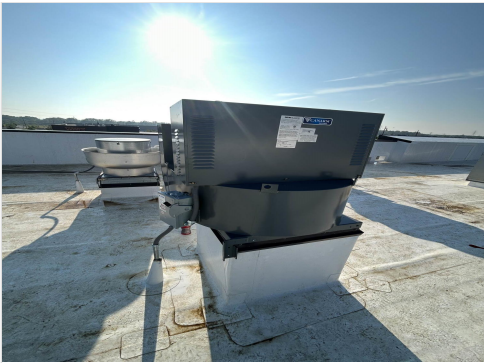
Asset: KEF3

Notes:
48.2 HZ
Pressure readings unavailable as the fan is sealed to the curb and won't hinge back

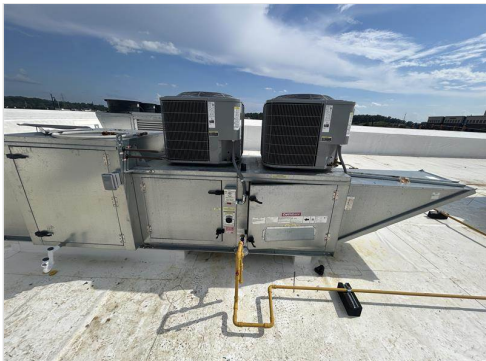
Asset: MAU1

Gas Heat		
	Design	Actual
Heater Operates (y/n)	-	N
Flame Status (pass/fail)	-	FAIL
Inlet Air Temp SetPt	55	55
Discharge Air Temp SetPt	60	60
Air Flow Switch SP Actual	-	0
