**Report: TAB REPORT**  
**Function: Test, Adjust, & Balance**  
**Date: 01/19/2026**  
**Completed By: National TAB**

**02-02-26 WAWA #7420 SCOTTSBURG, IN**

1215 WEST MCCLAIN AVENUE

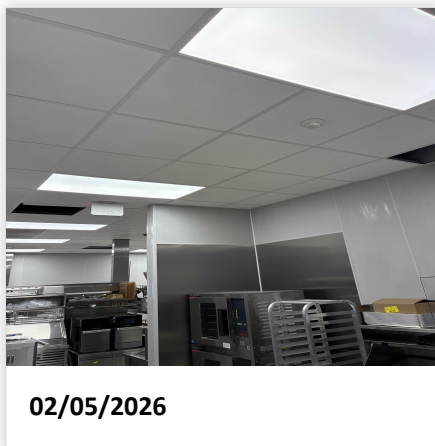
Project Issue File Details

**Issue Name :** RTU-1 MISSING DIFFUSER  
**Description :** Diffuser 1-5 on RTU-1 and necessary ductwork are not present. TAB cannot be completed to spec until resolved.  
**Created By :** National TAB                      **Assigned To :** National TAB - Noah Stafford  
**Status :** Open  
**Priority :** High                                      **Asset Tag :**  
**Originated Date :** 02/04/2026 - Noah Stafford - National TAB

Back kitchen supply diffuser on RTU-1 is missing. No other related issues.

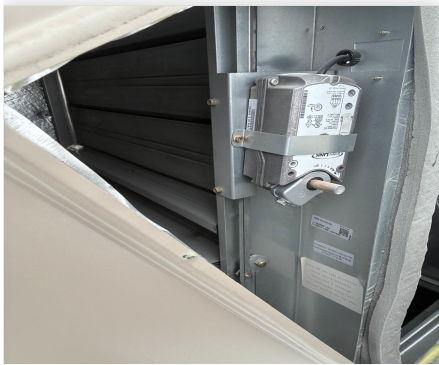
Project Issue File Details

**Issue Name :** RTU-2 ECONOMIZER  
**Description :** RTU-2 economizer is not moving and therefore cannot be calibrated to set outdoor air. TAB cannot be completed until resolved.  
**Created By :** National TAB                      **Assigned To :** National TAB - Noah Stafford  
**Status :** Open  
**Priority :** High                                      **Asset Tag :** RTU2  
**Originated Date :** 02/05/2026 - Noah Stafford - National TAB

RTU-2 economizer not responding to control inputs.

Not marked on RTU-2 due to economizer issue.

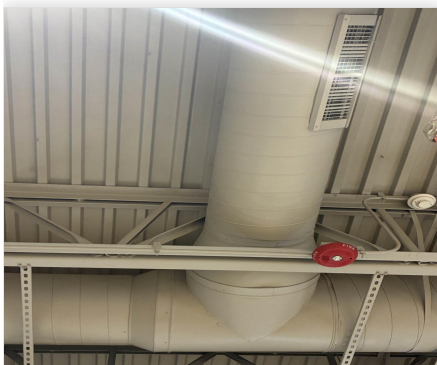
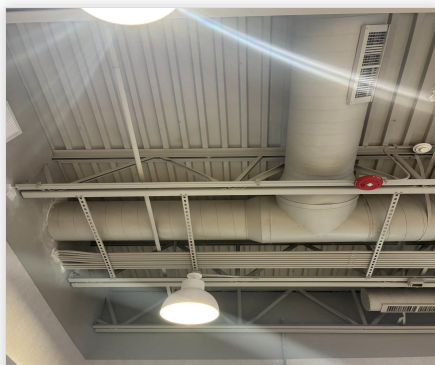
Project Issue File Details

**Issue Name :** RTU-2 MISSING DAMPER  
**Description :** RTU-2 missing a damper at takeoff. Closing every damper on this takeoff insufficient to redirect flow as needed. TAB cannot be completed until resolved.  
**Created By :** National TAB                      **Assigned To :** National TAB - Noah Stafford  
**Status :** Open  
**Priority :** High                                      **Asset Tag :**  
**Originated Date :** 02/05/2026 - Noah Stafford - National TAB
