Report: TAB REPORT
Function: Test, Adjust, & Balance
Date: 07/09/2025
Completed By: National TAB

06-16-25 FREDDY'S NORTH BRUNSWICK, NJ

Project: 06-16-25 FREDDY'S NORTH BRUNSWICK, NJ

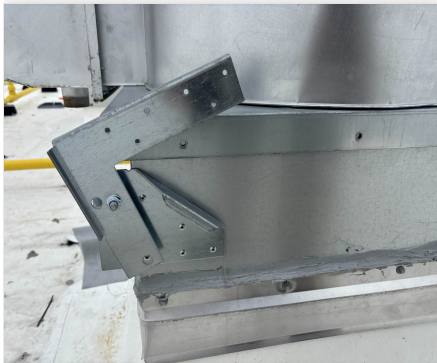
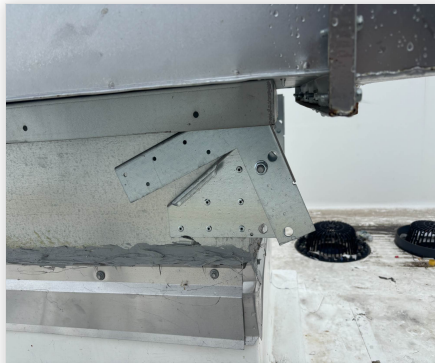
Issue Name : KEF1: Hinge Kit Not Installed
Description : Hinge kit installation incomplete.
Created By : National TAB **Assigned To :** National TAB - Will Turnbough
Status : Open
Priority : Low **Asset Tag :**
Originated Date : 06/16/2025 - Ryan Smith - National TAB

Duct for KEF1 checked from below, unable to check from roof due to lack of hinge kit.

With hinge kit not installed, not safe to measure inlet static pressure.

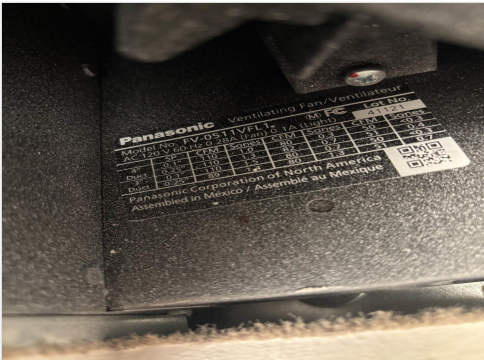
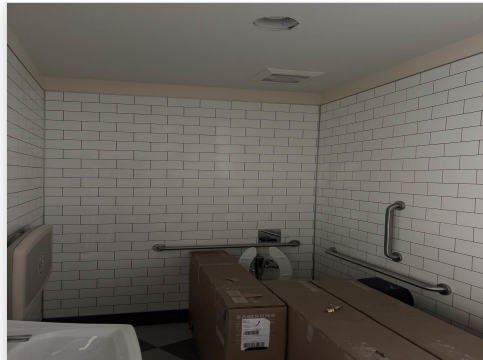
Asset: EF1

Unit Data		
	Design	Actual
MFG	GREENHECK	PANASONIC
Model Num	SP-A200-390	FV-0511VFL1
Serial Num	-	41121
Type	CEILING	CEILING
Configuration	VERTICAL	VERTICAL

Test Data		
	Design	Actual
CFM	75	43
Fan RPM	-	NA
Fan Rotation	-	CCW
Motor RPM	-	NA
System SetPt	-	110 CFM
RL Voltage	-	NA
RL Amperage	-	NA
Total ESP	.250"	NA
Fan Inlet SP	-	NA
Fan Discharge SP	-	NA

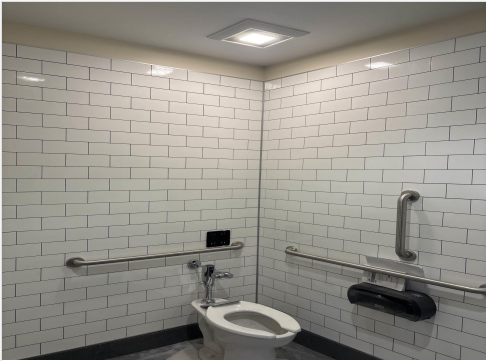
Asset: EF2

Unit Data		
	Design	Actual
MFG	GREENHECK	PANASONIC
Model Num	SP-A200-390	FV-0511VFL1
Serial Num	-	50128
Type	CEILING	VENTILATING FAN
Configuration	VERTICAL	VERTICAL

Test Data		
	Design	Actual
CFM	75	34
Fan RPM	-	NA
Fan Rotation	-	CCW
Motor RPM	-	NA
System SetPt	-	110 CFM
RL Voltage	-	NA
RL Amperage	-	NA
Total ESP	.250"	NA
Fan Inlet SP	-	NA
Fan Discharge SP	-	NA

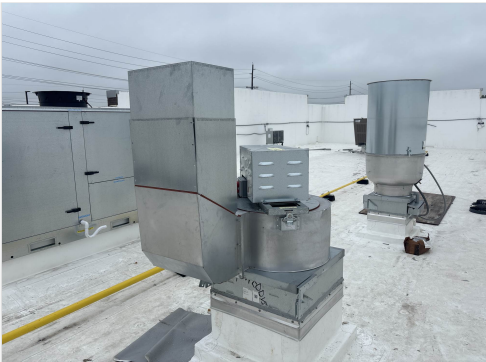
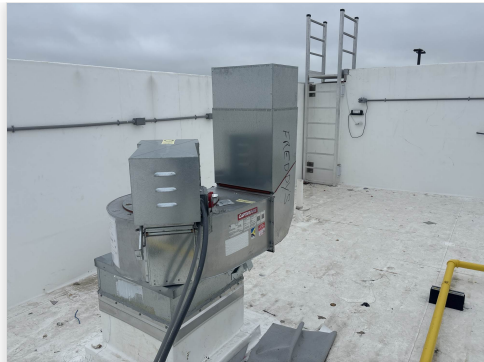
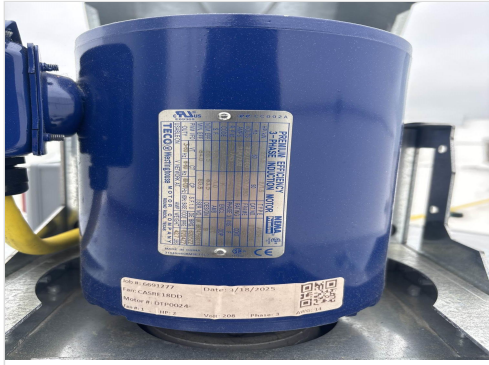
Asset: KEF1

Unit Data		
	Design	Actual
MFG	CAPTIVEAIRE	CAPTIVEAIRE
Model Num	CAPTICASRE18DD	CASRE18DD
Serial Num	-	6691277
Type	UTILITY	UTILITY
Configuration	VERTICAL	VERTICAL

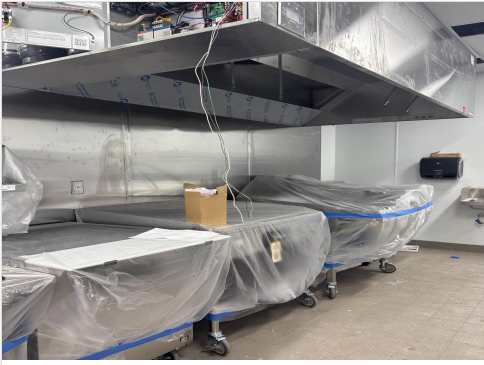
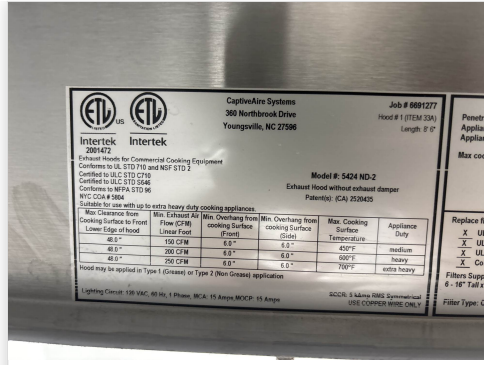
Asset: HD1

Unit Data		
	Design	Actual
MFG	CAPTIVEAIRE	CAPTIVEAIRE
Model Num	5424-ND-2	5424 ND-2
Job / Serial Num	-	6691277
Type	TYPE I - CANOPY	TYPE I - CANOPY
Hood length	108"	102"
Hood Width	54"	54"

Test Data Exhaust		
	Design	Actual
Filter Type	CAPTRATE SOLO FILTER	CAPTRATE SOLO FILTER
Filter Size 1	16X16	16X16
Filter Qty 1	5	6
Filter AK factor size 1	1.62	1.62
Filter Total AK Area	8.10	9.72
Filter1 FPM	-	177
Filter2 FPM	-	180
Filter3 FPM	-	180
Filter4 FPM	-	188
Filter5 FPM	-	174
Filter6 FPM	-	172
Filter Ave FPM(corr)	-	178
CFM	1600	1730

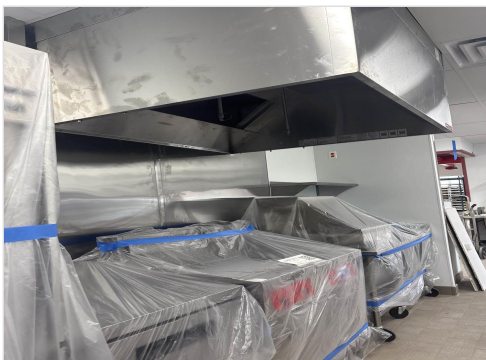
Asset: HD2

Unit Data		
	Design	Actual
MFG	CAPTIVEAIRE	CAPTIVEAIRE
Model Num	5424-ND-2	5424 ND-2
Job / Serial Num	-	6691277
Type	TYPE I - CANOPY	TYPE I - CANOPY
Hood length	65"	60"
Hood Width	54"	54"

Test Data Exhaust		
	Design	Actual
Filter Type	CAPTRATE SOLO FILTER	CAPTRATE SOLO FILTER
Filter Size 1	16X16	16X16
Filter Qty 1	2	3
Filter AK factor size 1	1.62	1.62
Filter Total AK Area	4.86	4.86
Filter1 FPM	-	153
Filter2 FPM	-	151
Filter3 FPM	-	160
Filter Ave FPM(corr)	-	155
CFM	775	753
