# TAB Punch List for CFA 5308

Prepared by Will T

Aug 6, 2024

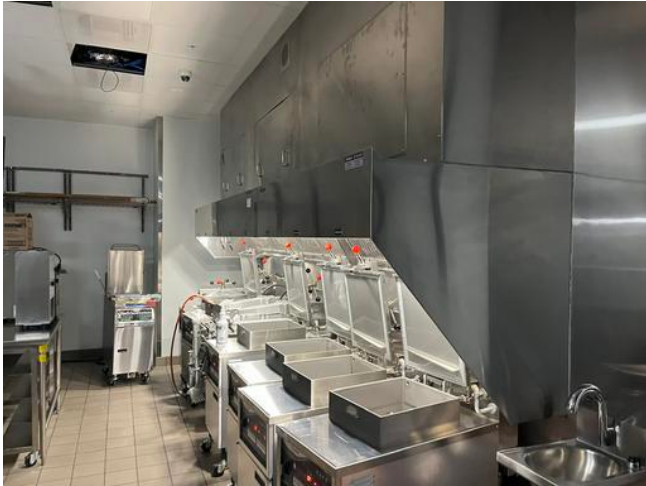
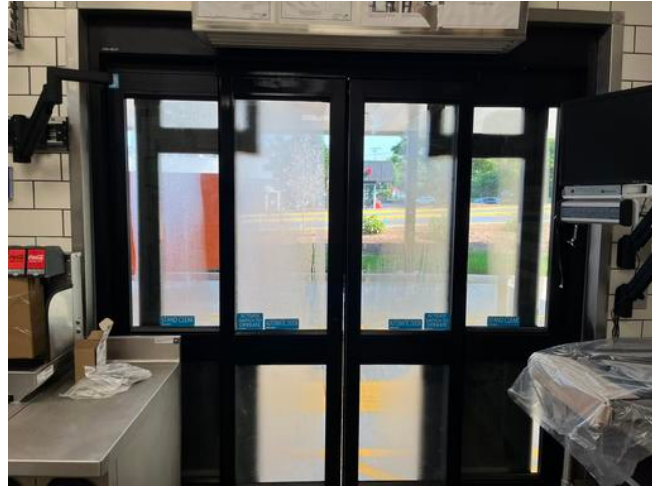
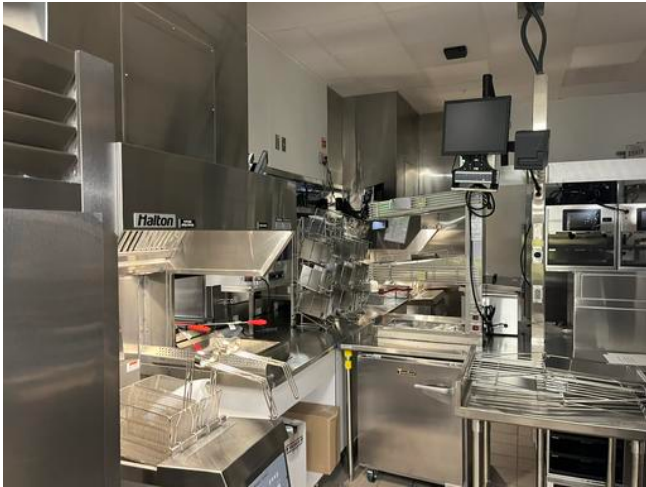
Store occupied / unoccupied switch does not properly alter hood sequence. This is causing a big negative pressure overnight that the building is trying to compensate for, causing condensation on the inside.

EC talked with tech support and discovered that hood panel was not programmed from factory. This has been corrected and status is changed to pending.

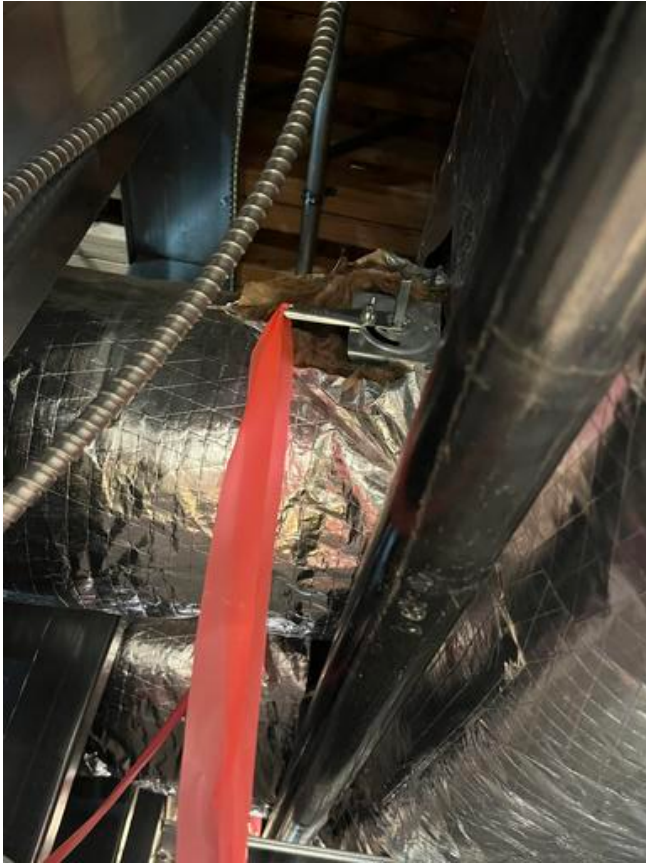
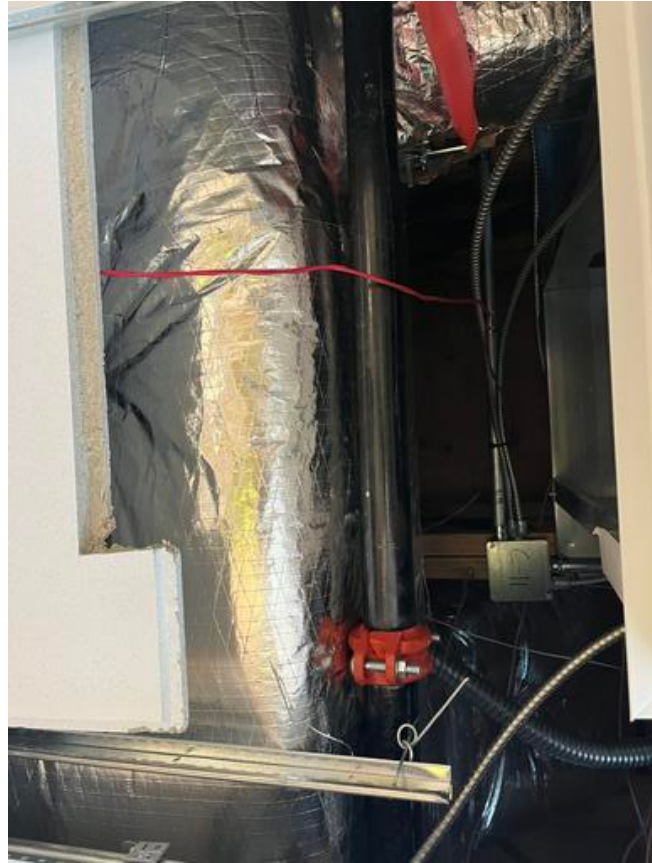
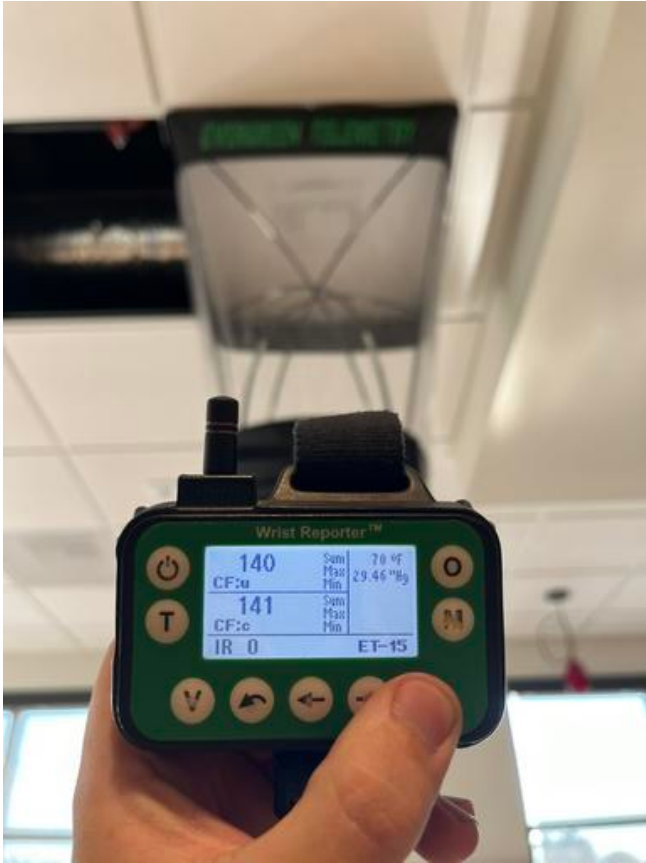
Diffuser 11 on AC2 has low airflow at 140CFM of 225CFM design. The damper has been checked and is fully open. There are also no problems with the duct or flex. The diffuser is in the middle of the dining area where it is not anticipated to affect comfort levels in the space.

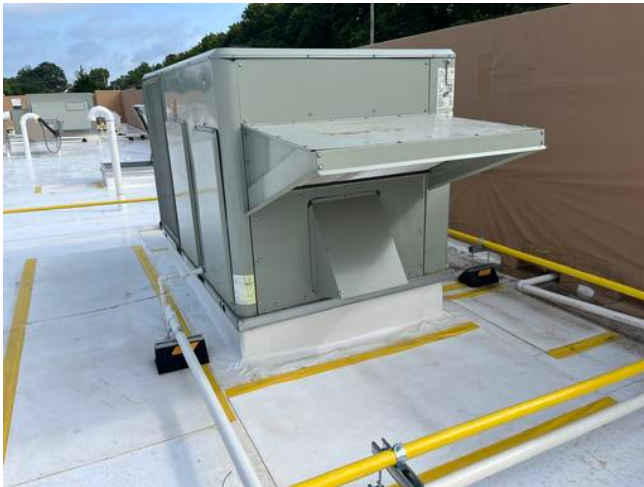
IMG\_8416

AC4 is scheduled to have powered exhaust that is not installed on the unit.

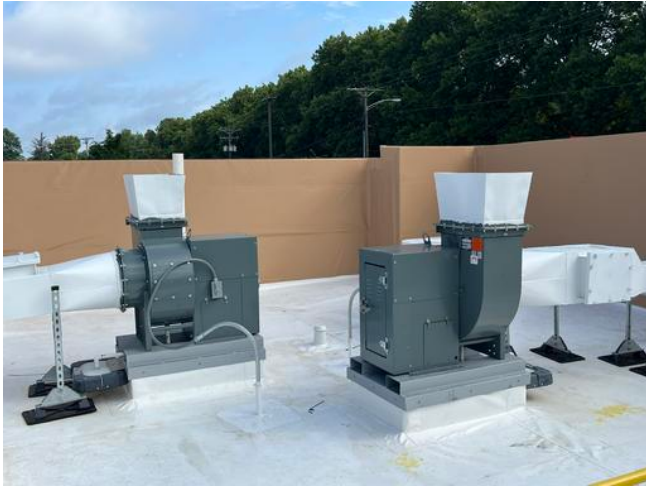
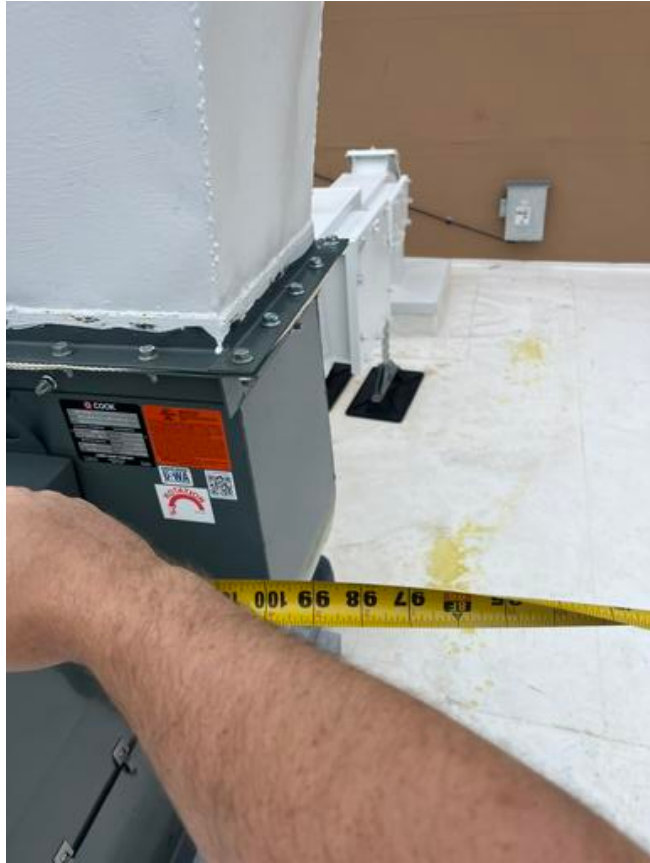
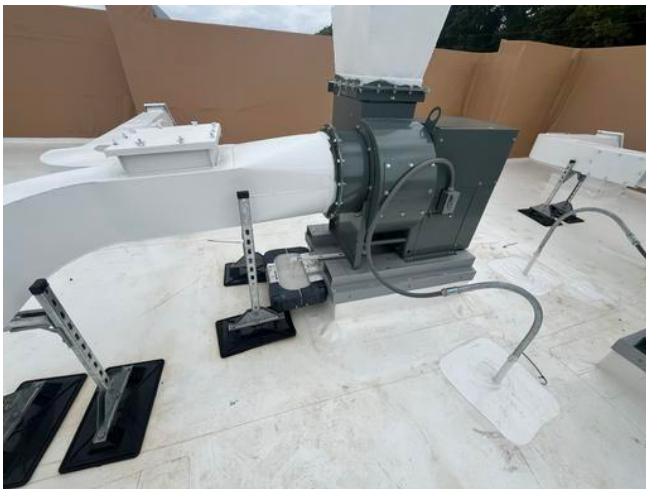
Exhaust fan discharge nozzle is not constructed to kitchen hood exhaust fan detail. Fans are within 10' of parapet walls or RTU and do not extend 2" above.

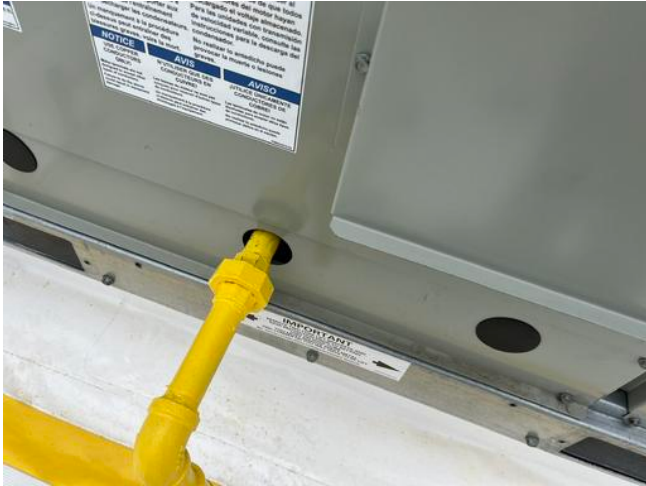
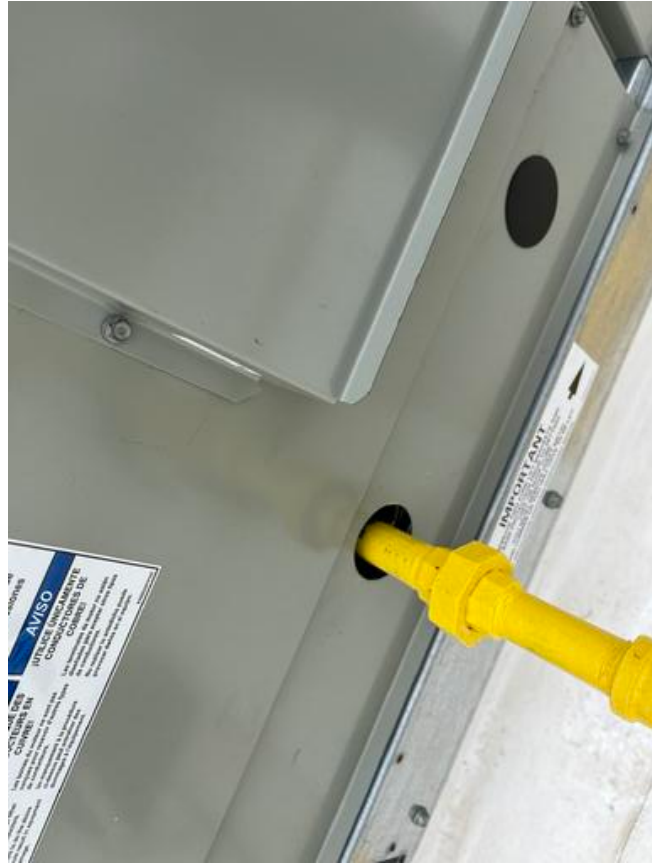
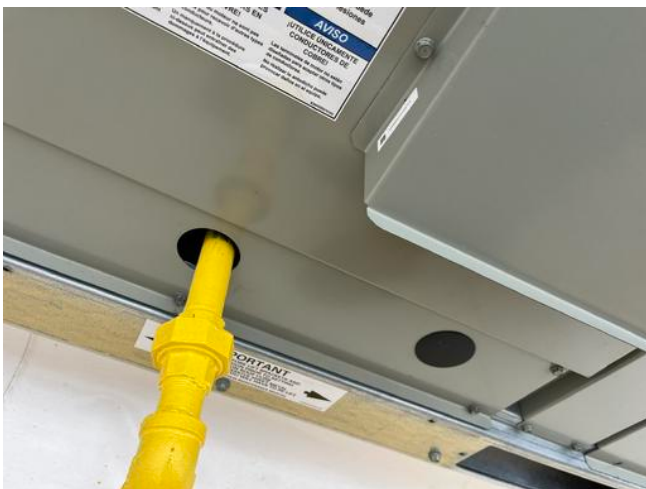
AC gas inlet grommet is missing at the gas line/RTU penetration point. Only missing on AC1, AC2, and AC3. MC stated the units did not come with grommets for gasline.

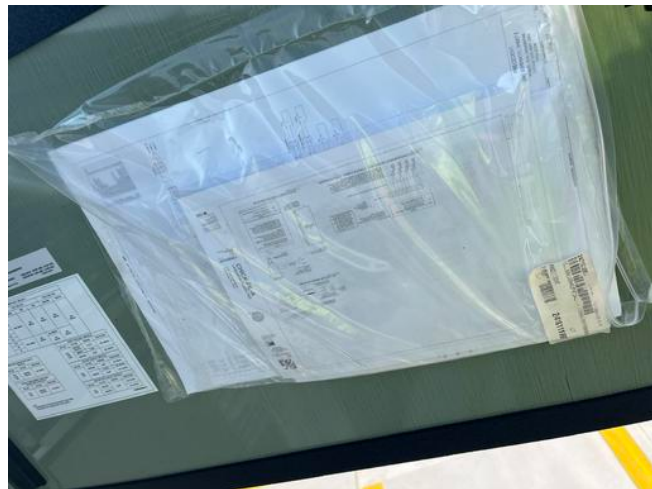
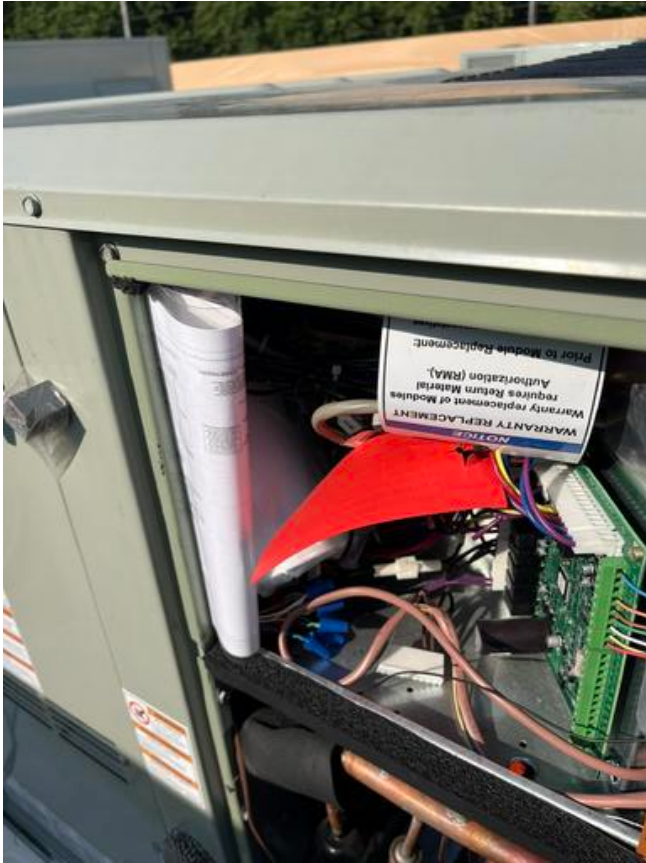
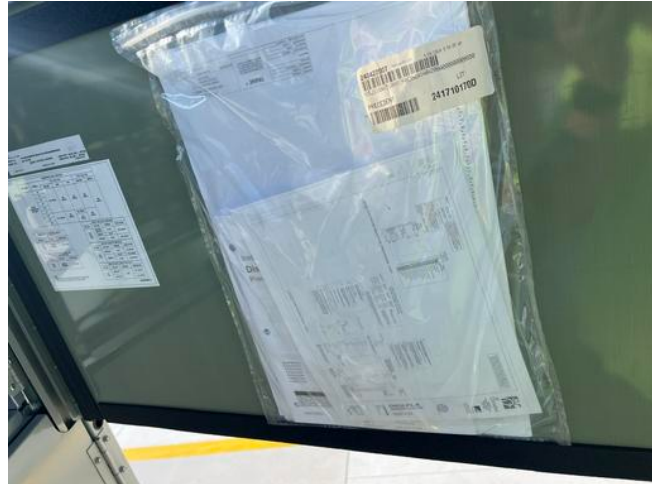
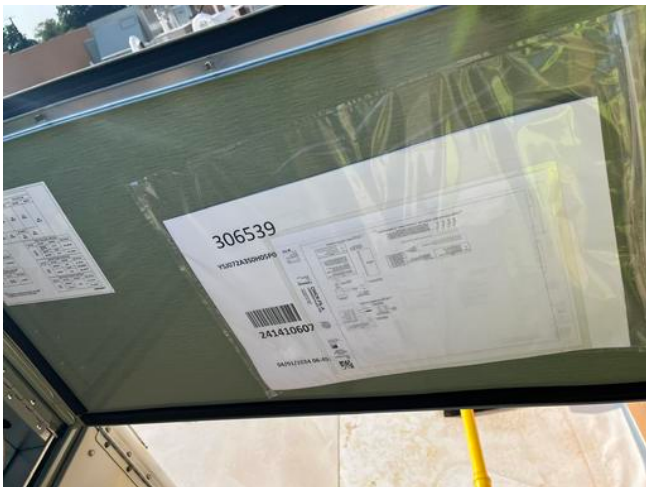
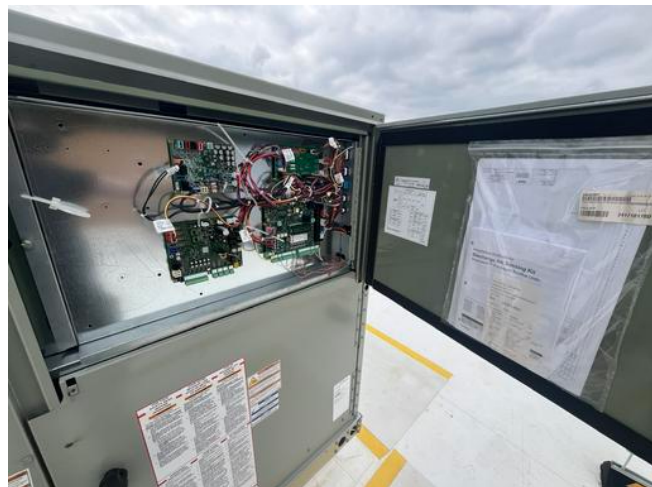
Equipment missing laminated copy of controls detail low voltage wiring diagrams. MC is aware and is getting copies made at their office.

Laminated copies of wiring added by MC. Ready to close out

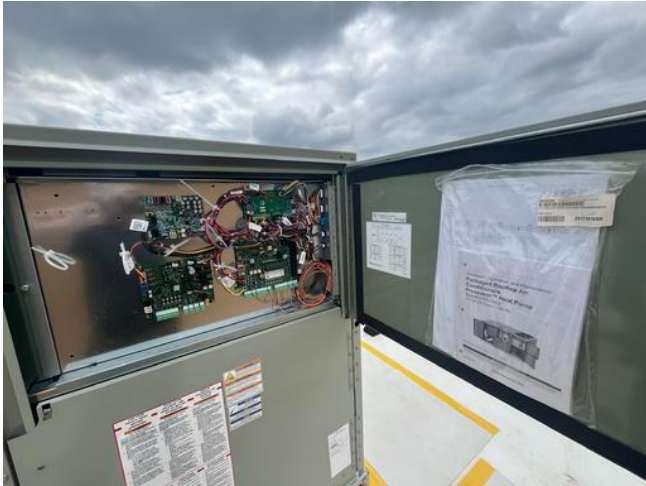
IMG\_8406

Units with Fresh Air Tempering kits are to have the discharge sensor routed per specification into the discharge duct via wiring portal. If Trane set turn-on/turn-off temps to 60/65 in Kitchen, 62/67 in Drive-Thru/Serving, 63/68 in Dining/Play Area. Specified in options for each unit but not installed

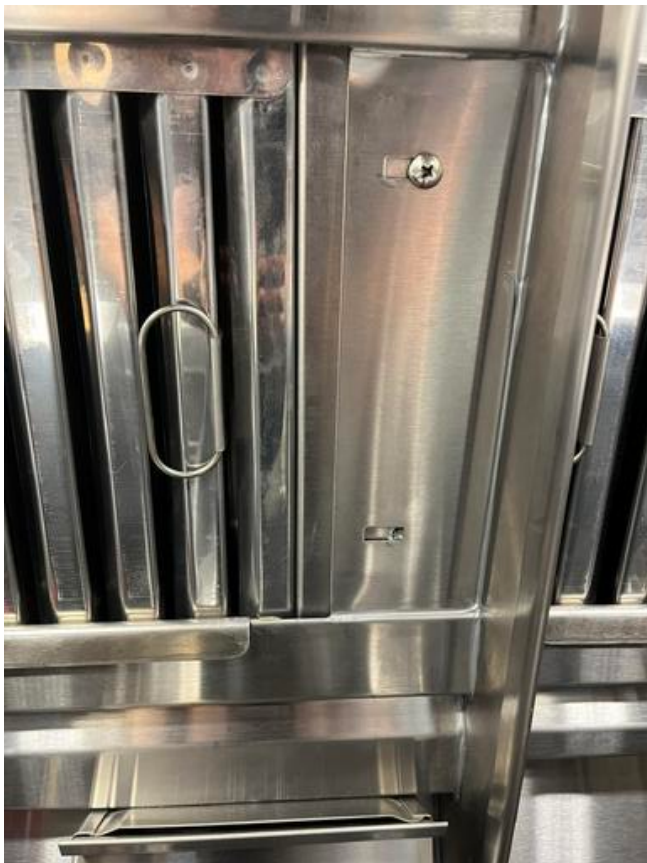
IMG\_8386

Adjustment slider for the filters on Hood1L is missing a screw on the bottom.

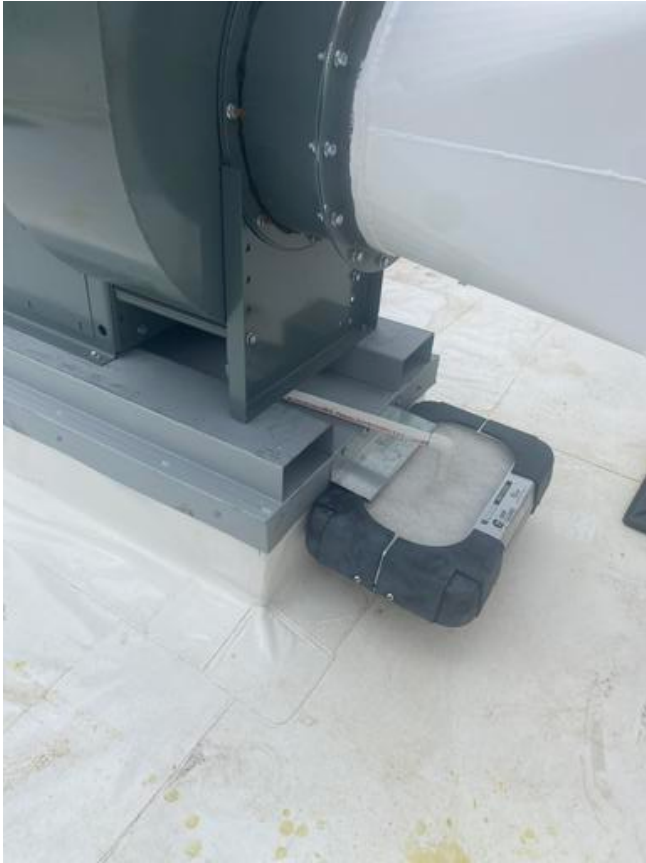
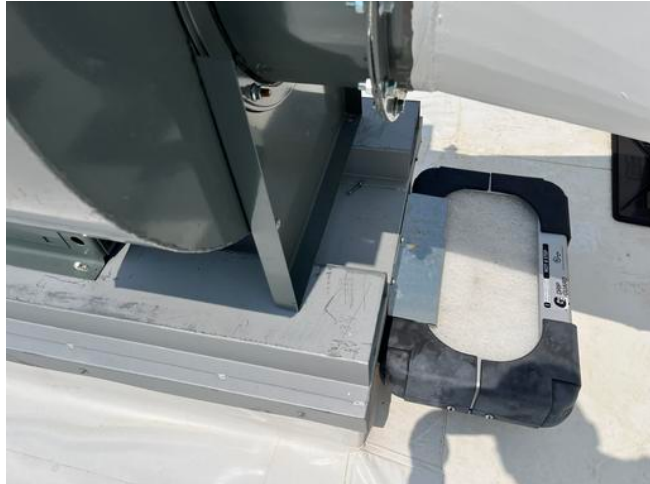
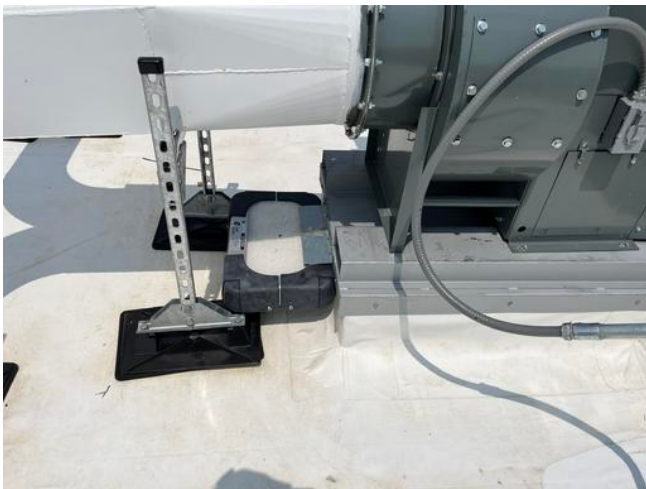
Exhaust fan drain is not properly installed, pitched, or routed to center of drip guard per detail. If gas piping is used, will need to be painted for rust protection.

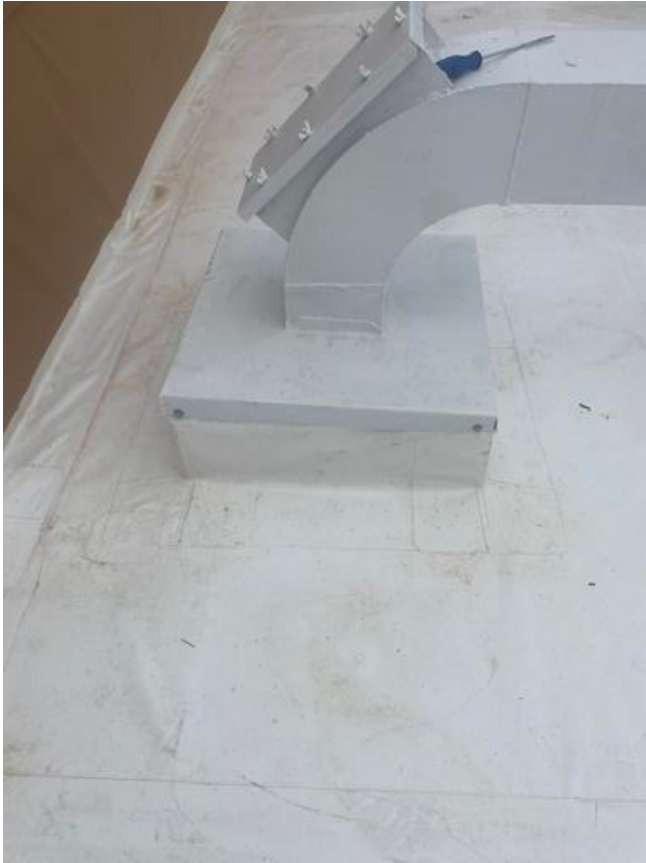
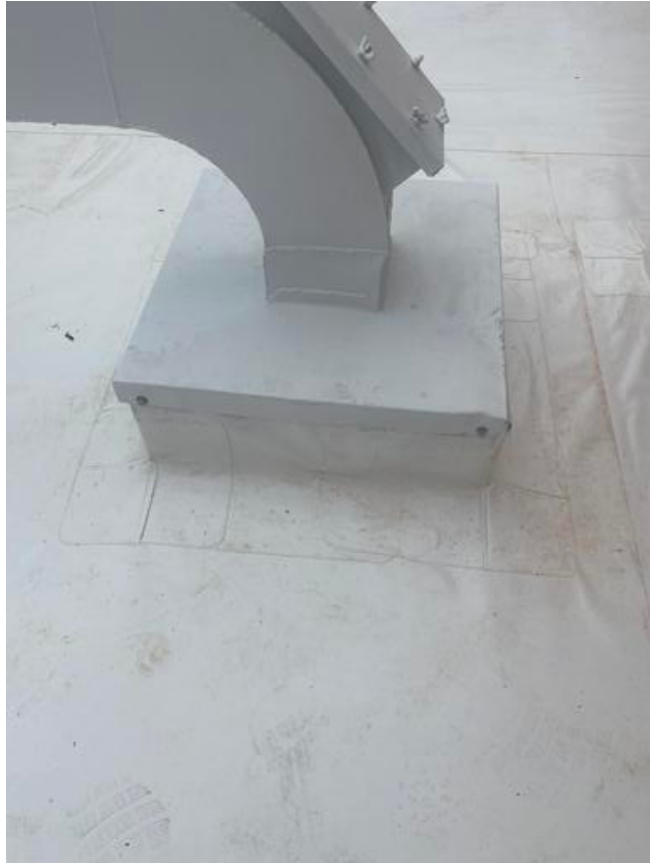
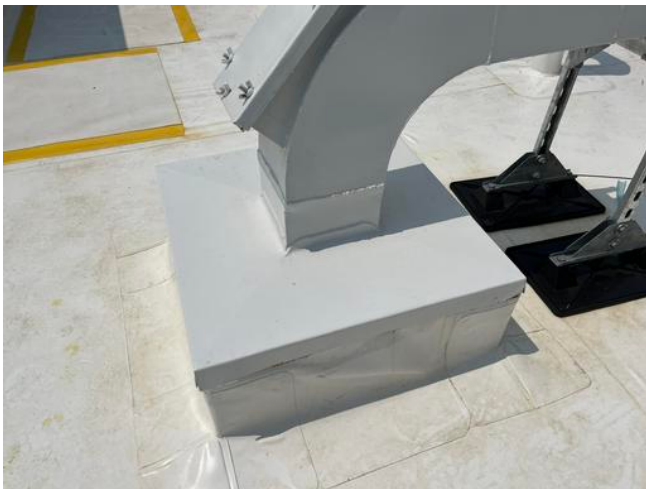
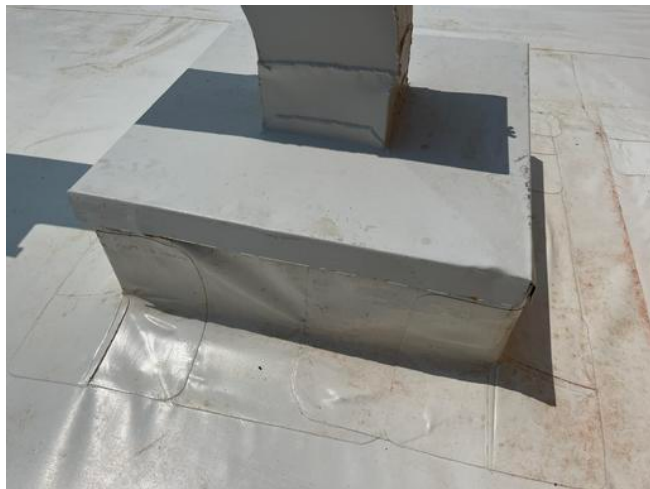
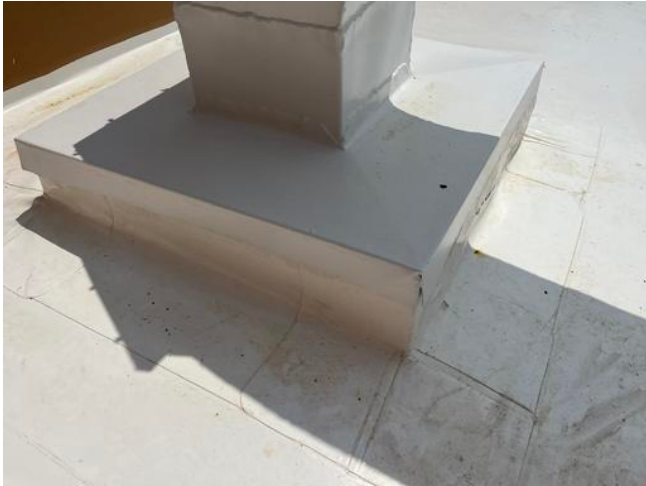
Grease duct curb cap is to be screwed at all corners along with a full perimeter weld between curb cap and duct.

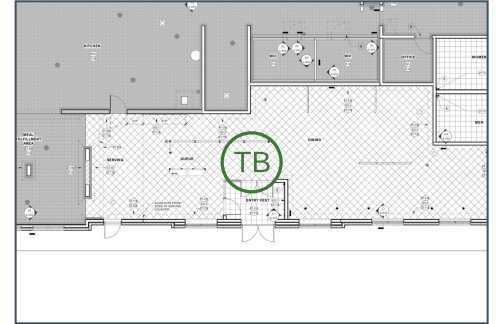
Label all sensors, humidistats, thermostats, smoke annunciators and remote space mounted OADs, MODs, VFD's for which piece of equipment they serve.

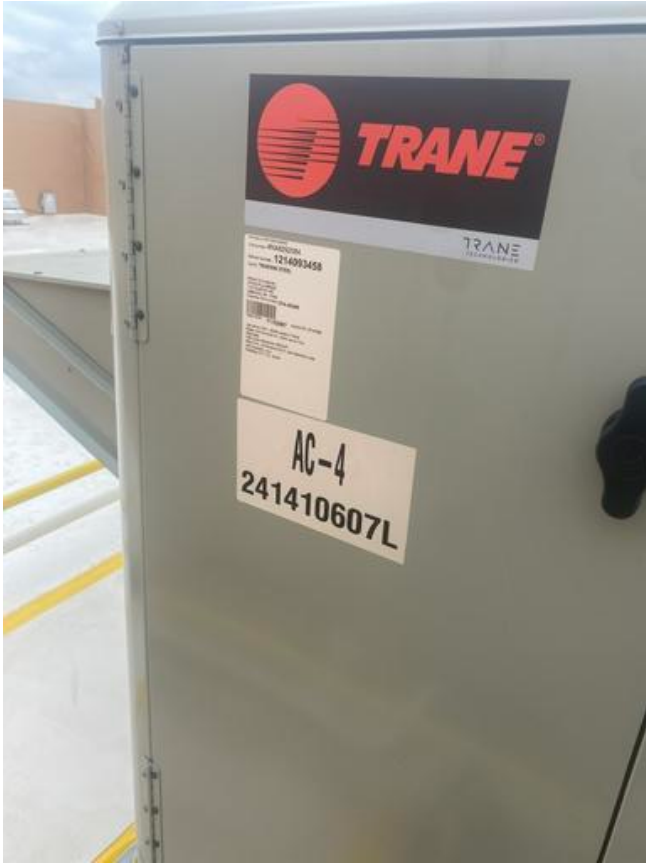
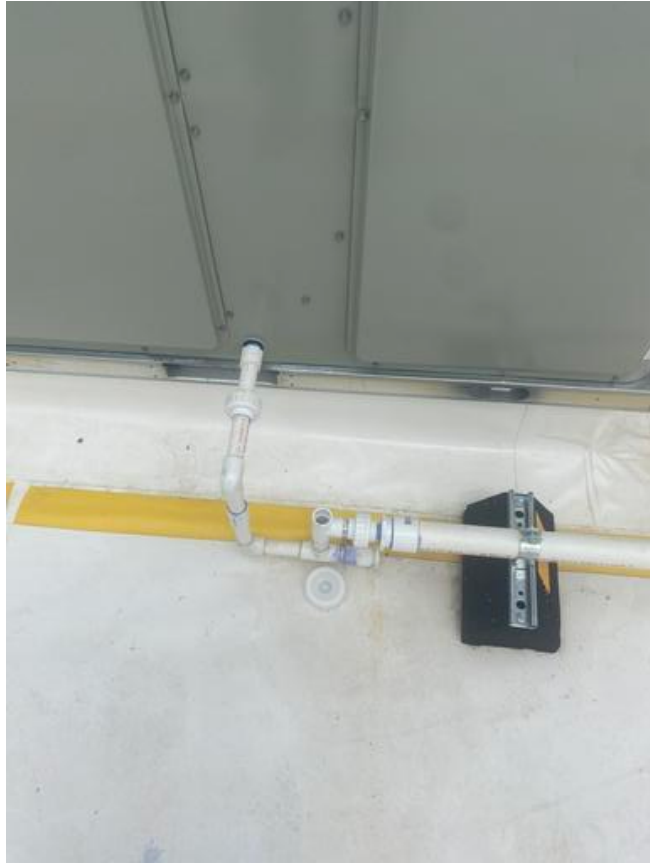
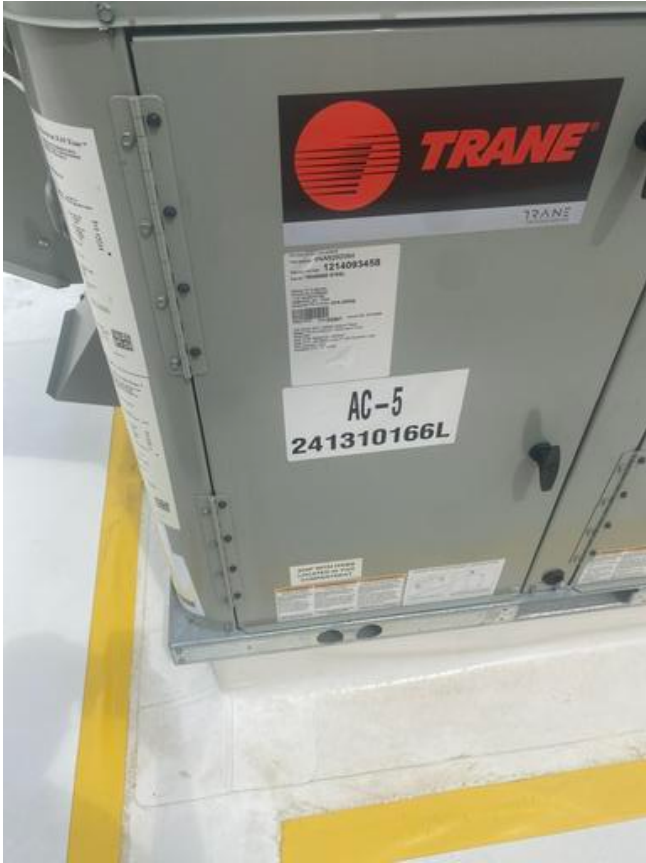
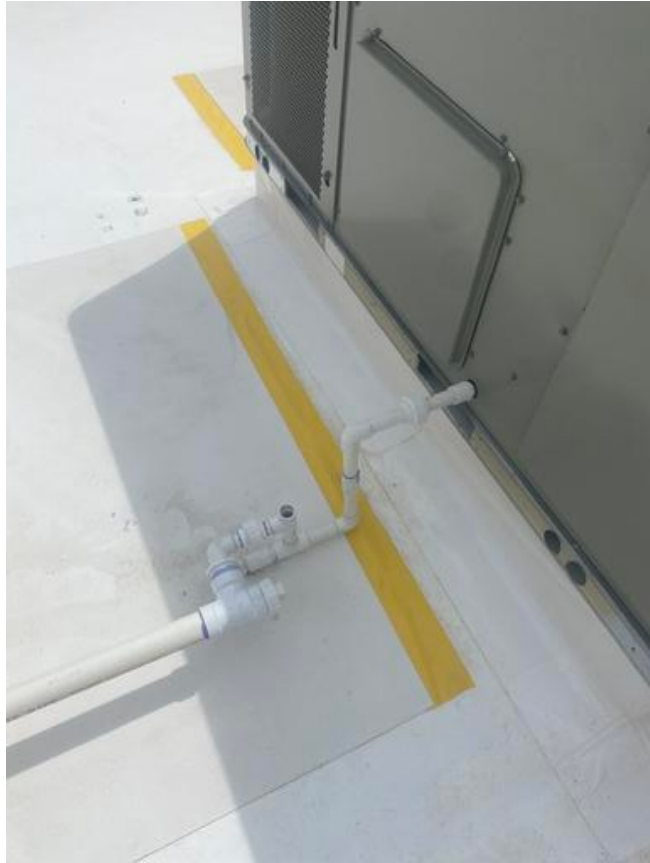
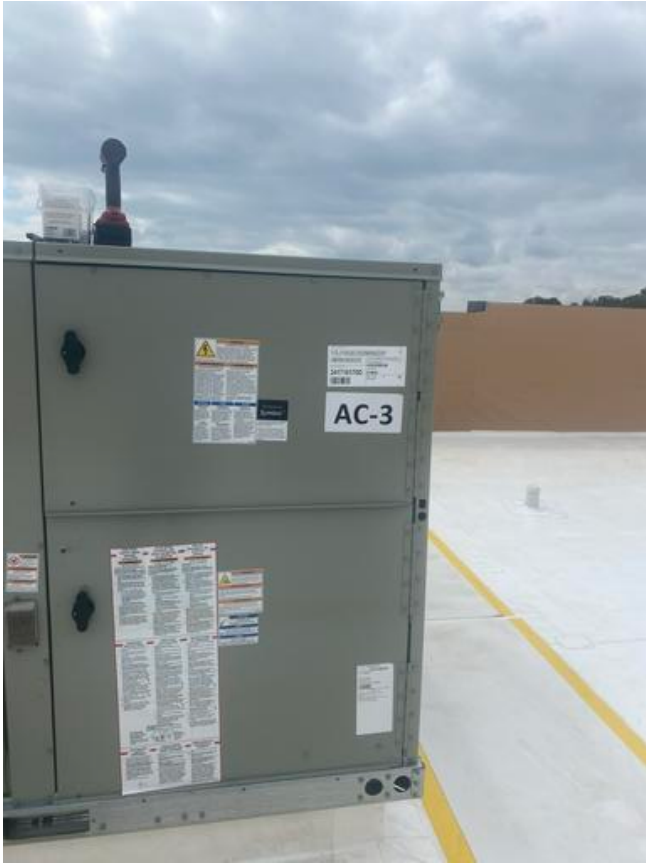
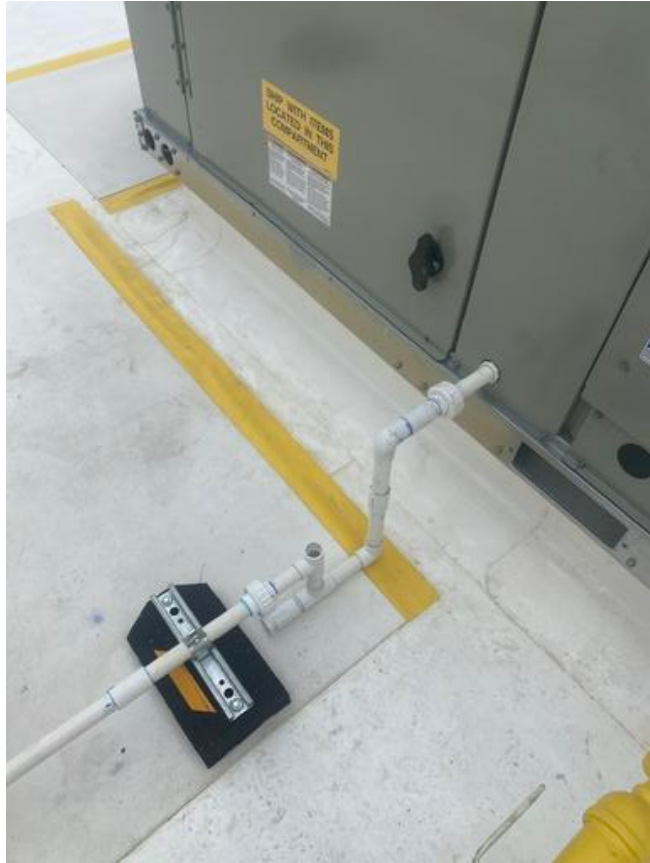
Equipment condensate piping or p-trap is not constructed per normal CFA specifications.
