Report: TAB Report
Function: Test, Adjust, & Balance
Date: 12/20/2022

PROJECT
11-21 CULVERS - PUNTA GORDA, FL

Project: 11-21 CULVERS - PUNTA GORDA, FL

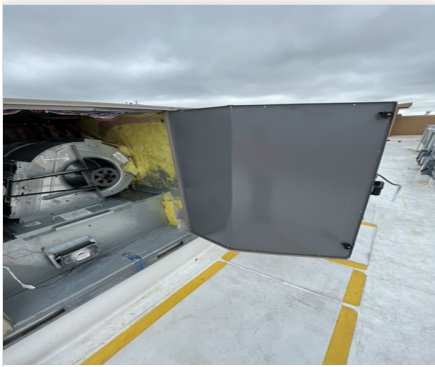
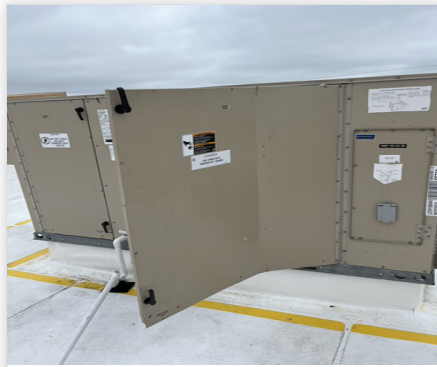
Doorinside.jpeg

Issue Name : RTU#2 motor access door is damaged.

Description : The door is bent and is starting to shear on sides. Mechanical has ordered replacement door, but it has not yet arrived.
