Report: TAB Report
Function: Test, Adjust, & Balance
Date: 12/20/2022

PROJECT
11-21 CULVERS - PUNTA GORDA, FL

Project: 11-21 CULVERS - PUNTA GORDA, FL

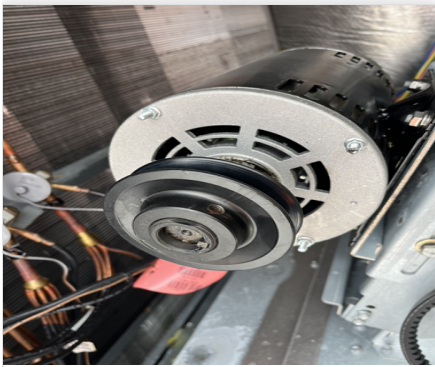
FuseIT3549d9df088541d...

Issue Name : AC2 is above designed cfm
Description : RTU2 is currently at 7328 out of a designed 5000 cfm. Cannot turn down due to motor sheave being stuck in place.
Created By : National TAB **Assigned To :** National TAB - Will Turnbough
Status : Closed
Originated Date : 11/23/2022 - Ian Fuller - National TAB

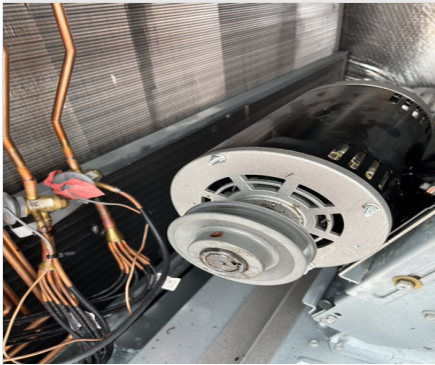
FuselTd9c3ba2ffc48479...

Issue Name : RTU#1 has high flow

Description : AC1 has 7649 cfm out of a designed 5200 cfm. Cannot turn down RTU cfm due to motor sheave stuck in place.

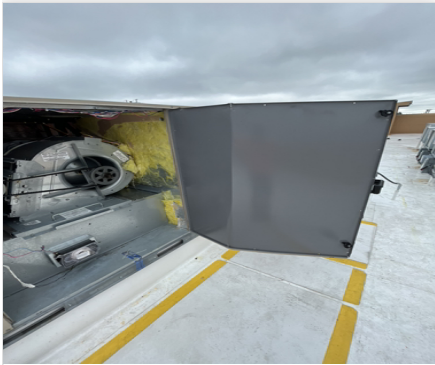
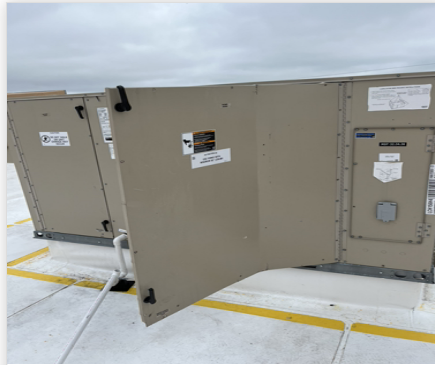
Issue Name : RTU#2 motor access door is damaged.

Description : The door is bent and is starting to shear on sides. Mechanical has ordered replacement door, but it has not yet arrived.

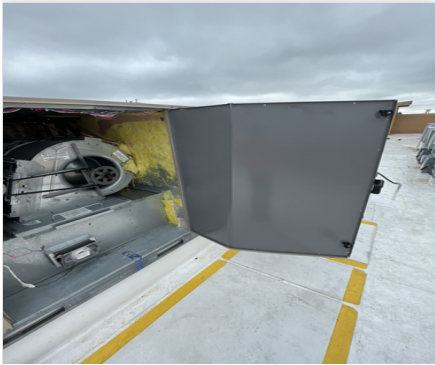
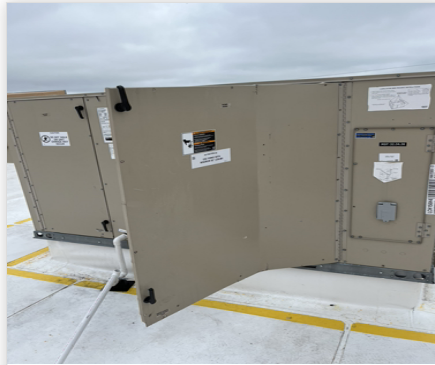
Issue Name : RTU2 motor access door is damaged.

Description : Door is bent and is starting to shear on the sides.

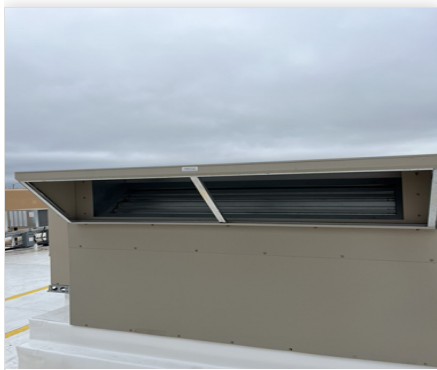
FuselTea3e59d302ae408...

Issue Name : RTUOA IS MISSING OA filters

Description : Recommend installing to prevent debris, moisture, and animals from entering the unit.
