Report: TAB

Function: Test, Adjust, & Balance

03-31-25 CHIPOTLE #5592 ASHLAND, OR

Project: 03-31-25 CHIPOTLE #5592 ASHLAND, OR

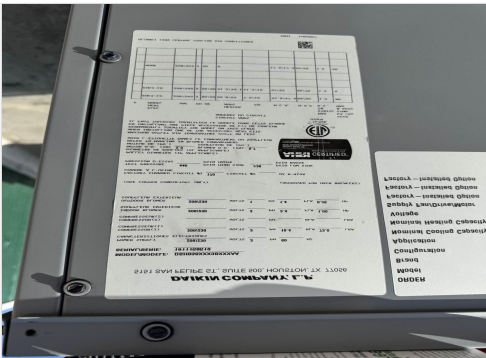
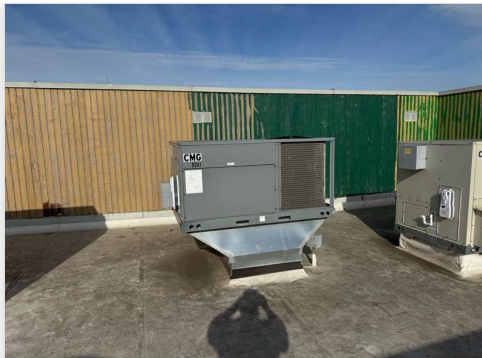
Unit Data - PHOTO LOG

Unit Data		
	Design	Actual
MFG	DAIKIN	DAIKIN
Serial Num	-	1911158519
Model Num	DSH036	DSH036
Type	RTU	RTU
Configuration	VERTICAL	Vertical
Num Final Filter 1	-	4
Final Filter Size 1	-	14x20x2

General		Actual
Fan Rotation Correct		Correct
Unit Filters Clean		Partially Loaded

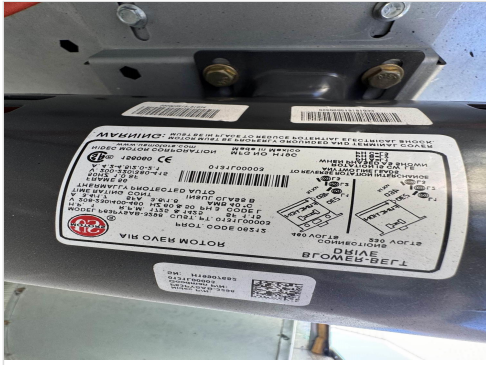
Motor Data - PHOTO LOG

Motor Data		
	Design	Actual
Motor MFG	-	US motors
Frame	-	56
Horsepower	3	1
Motor Rpm	Not Listed	1725
Phase	3	3
Rated Voltage	208	208
Rated Amperage	Not Listed	3.4

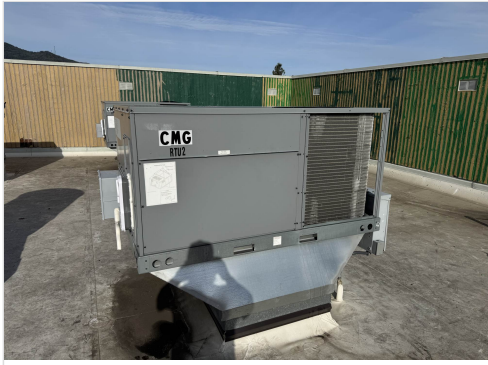
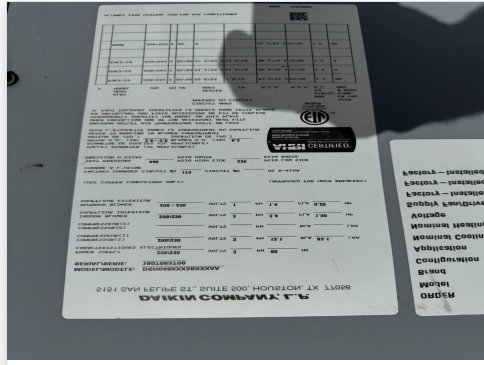
Unit Data - PHOTO LOG

Unit 2 has a missing piece of the blower wheel causing a bad vibration.

Unit Data		
	Design	Actual
MFG	DAIKIN	DAIKIN
Serial Num	-	1907063709
Model Num	DSH048	DSH048
Type	RTU	RTU
Configuration	VERTICAL	Vertical
Num OA Filters 1	-	-
OA Filter Size 1	-	-
Num Final Filter 1	-	4
Final Filter Size 1	-	14x20x2
Num Final Filter 2	-	-
Final Filter Size 2	-	-

General	
	Actual
Fan Rotation Correct	Correct
Unit Filters Clean	Partially loaded
Condensate Drain Installed	yes

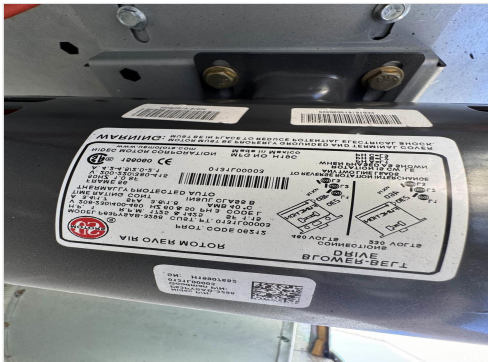
Motor Data - PHOTO LOG

Motor Data		
	Design	Actual
Motor MFG	-	US motos
Frame	-	56
Horsepower	3	1
Motor Rpm	-	1725
Phase	3	3
Rated Voltage	208	208
Rated Amperage	-	3.4

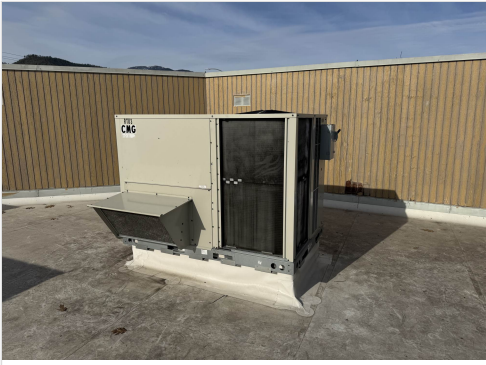
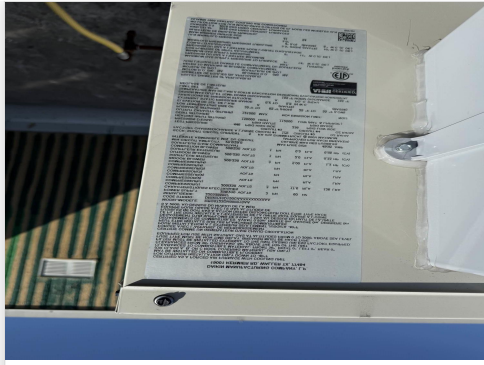
Unit Data - PHOTO LOG

Unit 1 & 2 do not have any. Unit 3 & 4 are not working.

Unit Data		
	Design	Actual
MFG	DAIKIN	DAIKIN
Serial Num	-	2204006877
Model Num	DRG072	DRG072
Type	RTU	RTU
Configuration	VERTICAL	Vertical
Num OA Filters 1	-	-
OA Filter Size 1	-	-
Num Final Filter 1	-	4
Final Filter Size 1	-	20x20x2
Num Final Filter 2	-	-
Final Filter Size 2	-	-

General	
	Actual
Fan Rotation Correct	Correct
Unit Filters Clean	PArtilly Loaded
Condensate Drain Installed	Yes

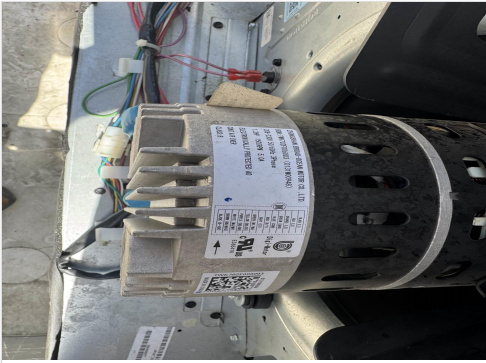
Motor Data - PHOTO LOG

Motor Data		
	Design	Actual
Motor MFG	-	Digi Motor
Frame	-	-
Horsepower	3	1.2
Motor Rpm	-	1500
Phase	3	3
Rated Voltage	208	208
Rated Amperage	-	5

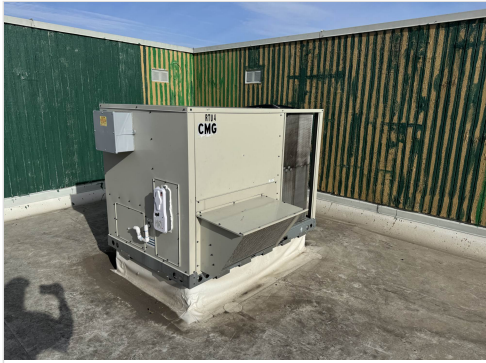
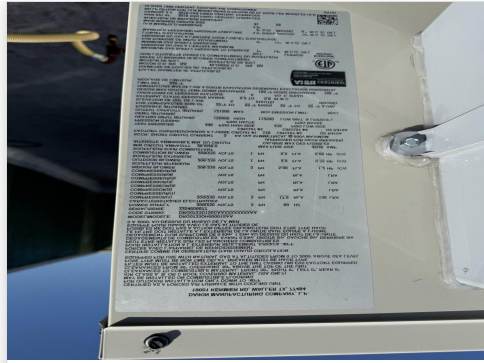
Unit Data - PHOTO LOG

Unit Data		
	Design	Actual
MFG	DAIKIN	DAIKIN
Serial Num	-	2203286667
Model Num	DRG072	DRG072
Type	-	RTU
Configuration	-	Vertical
Num OA Filters 1	-	-
OA Filter Size 1	-	-
Num Final Filter 1	-	4
Final Filter Size 1	-	20x20x2
Num Final Filter 2	-	-
Final Filter Size 2	-	-

General	
	Actual
Fan Rotation Correct	Correct
Unit Filters Clean	Partially Loaded
Condensate Drain Installed	Yes

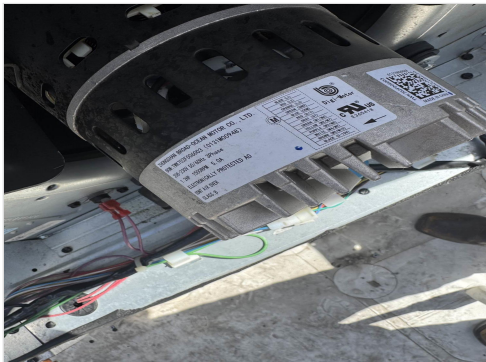
Motor Data - PHOTO LOG

Motor Data		
	Design	Actual
Motor MFG	-	Digi Motor
Frame	-	-
Horsepower	3	1.2
Motor Rpm	-	1500
Phase	3	3
Rated Voltage	208	208
Rated Amperage	-	5

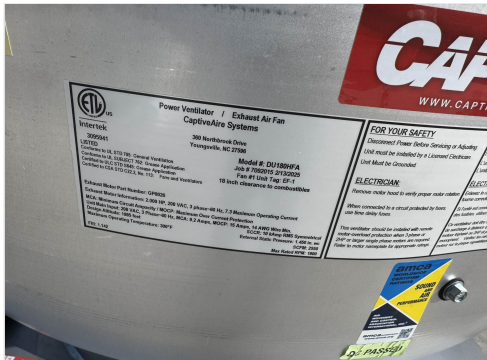
Unit Data - PHOTO LOG

Unit Data		
	Design	Actual
MFG	CAPTIVEAIRE	CAPTIVEAIRE
Model Num	DU180HFA	DU180HFA
Serial Num	-	7092015 2/13/2025
Type	UPBLAST	Upblast
Configuration	VERTICAL	Vertical

Test Data		
	Design	Actual
CFM	2550	2451
Fan RPM	-	43Hz
Fan Rotation	-	Correct
Motor RPM	-	43Hz
System SetPt	-	-
RL Voltage	-	73
RL Amperage	-	4.0
Total ESP	1.2"	
Fan Inlet SP	-	-0.50
Fan Discharge SP	-	0

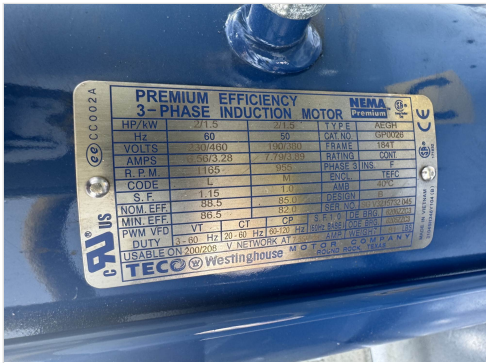
Motor Data - PHOTO LOG

Motor Data		
	Design	Actual
Motor MFG	-	Teco
Frame	-	184T
Horsepower	2	2
Motor Rpm	-	1165
Phase	3	3
Voltage (rated)	208	230
Amperage (rated)	-	6.56
Service Factor	-	1.15

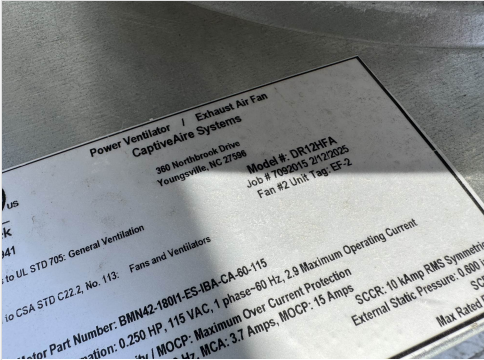
Unit Data - PHOTO LOG

Unit Data		
	Design	Actual
MFG	CAPTIVEAIRE	CAPTIVEAIRE
Model Num	DR12HFA	DR12HFA
Serial Num	-	7092015 2/12/2025
Type	DOWNBLAST	Downblast
Configuration	VERTICAL	Vertical

Test Data		
	Design	Actual
CFM	150	157
Fan RPM	-	732
Fan Rotation	-	Correct
Motor RPM	-	732
System SetPt	-	40
RL Voltage	-	121
RL Amperage	-	-
Total ESP	.6"	
Fan Inlet SP	-	-0.08
Fan Discharge SP	-	0

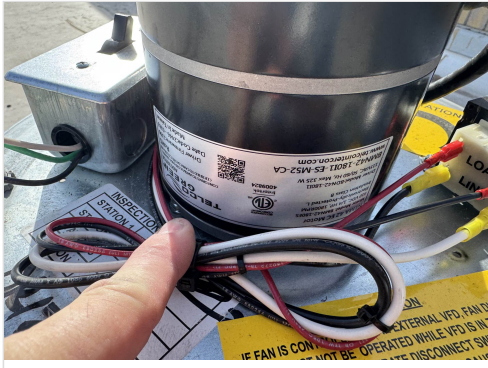
Motor Data - PHOTO LOG

Motor Data		
	Design	Actual
Motor MFG	-	Telco Green
Frame	-	-
Horsepower	.18	1/4
Motor Rpm	-	1800
Phase	1	1
Voltage (rated)	120	115
Amperage (rated)	-	-
Service Factor	-	-

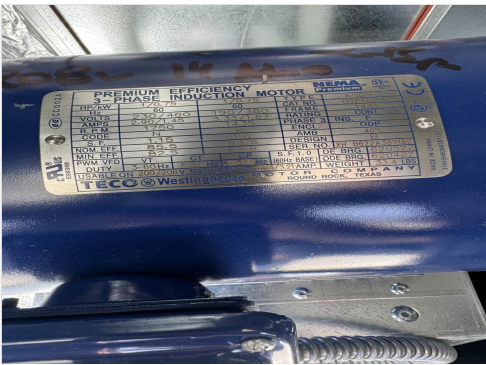
Motor Data - PHOTO LOG

Motor at max amps

Motor Data		
	Design	Actual
Motor MFG	-	Teco
Frame	-	143T
Horsepower	1	1
Motor Rpm	-	1750
Phase	3	3
Voltage (rated)	208	230
Amperage (rated)	-	2.9
Service Factor	-	1.15

Test Data		
	Design	Actual
CFM	1300	1056
SF RPM	-	60Hz
Motor RPM	-	1750
SF System SetPt	-	60Hz
RL Voltage	-	189
RL Amperage	-	2.8
Total ESP	-	
Fan Discharge SP	-	0.55

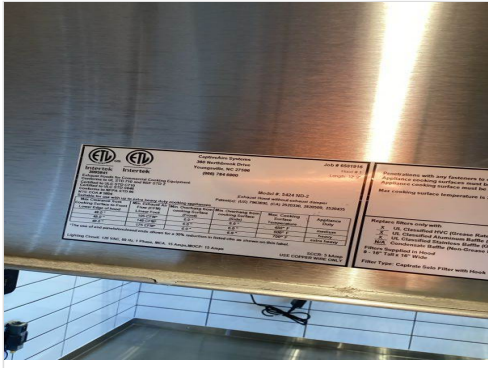
Unit Data - PHOTO LOG

Unit Data		
	Design	Actual
MFG	CAPTIVEAIRE	CAPTIVEAIRE
Model Num	5424 ND-2-ACPSP-F	5424 ND-2-ACPSP-F
Job / Serial Num	-	6501916
Type	TYPE 1 CANOPY	-
Hood length	153"	-
Hood Width	54"	-
Supply Plenum Type	-	perforated
Supply Plenum Width	9"	9
Supply Plenum Length	165"	159

Test Data Exhaust		
	Design	Actual
Filter Type	CAPTRATE SOLO	-
Filter Size 1	16X16	16x16
Filter Qty 1	9	9
Filter AK factor size 1	1.62	1.62
Filter Total AK Area	14.58	14.58
Filter1 FPM	-	157
Filter2 FPM	-	161
Filter3 FPM	-	175
Filter4 FPM	-	192
Filter5 FPM	-	179
Filter6 FPM	-	173
Filter7 FPM	-	172
Filter8 FPM	-	160
Filter9 FPM	-	144
Filter10 FPM	-	
Filter11 FPM	-	
Filter12 FPM	-	
Filter Ave FPM(corr)	-	
CFM	2550	0
