Report: TAB REPORT
Function: Test, Adjust, & Balance
Date: 05/03/2024

PROJECT
04-29-24 ARBYS #10078 - BIXBY, OK

Project: 04-29-24 ARBYS #10078 - BIXBY, OK

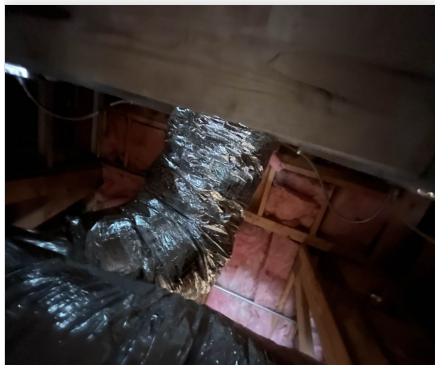
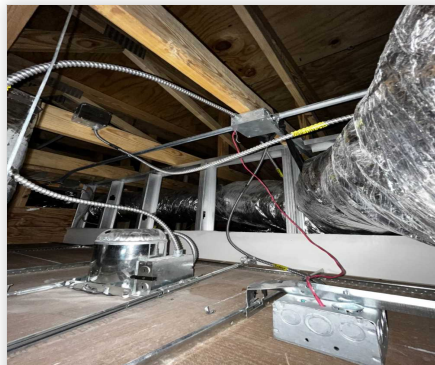
Issue Name : RTU-1 Diffuser 10,12 are low on flow
Description : Diffuser 10,12 side door vestibule and men’s RR are low on flow. Unable to force air to diffusers. Noticed that these diffusers are flex ducted into another flex duct run and do not have individual dampers. See pictures attached.

[1] Diffusers 10,11,12 are low on flow. Issue created.

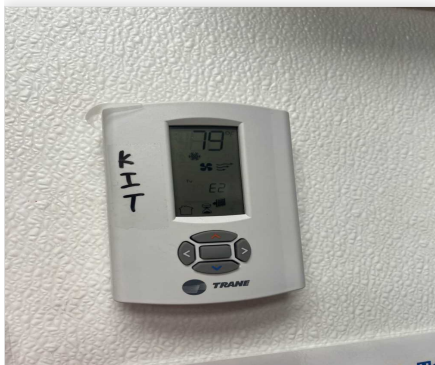
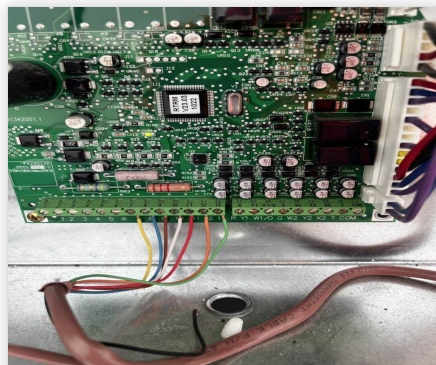
Issue Name : RTU-1/RTU-2 heating/cooling
Description : RTU-2 dining room unit only runs in cooling or fan only. No alarms on thermostat. RTU-1 kitchen unit only runs in heating or fan only. Alarm showing E2, per trane manual E2 references a cooling fault. Significant temperature change when Walking between the two spaces. Temperatures on thermostats reading the same at 72 degrees. Recommend MC Service

Dining unit only runs in cooling Kitchen unit only runs in heating or fan only modes. MC is scheduled to correct.

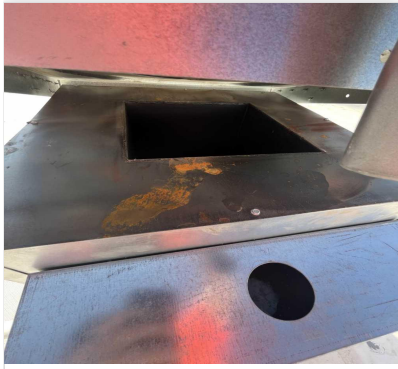
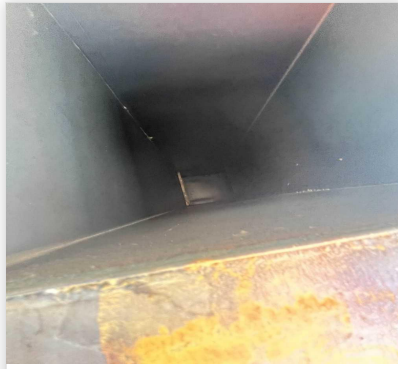
Lean fan back. Is grease duct installation adequate and is duct ran all the way to the base of the fan?

Yes

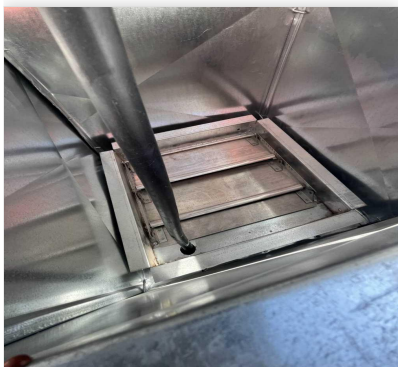
For restroom fan(s) is the back draft damper installed and can it fully open?

Yes
