Report: TAB Report
Function: Test, Adjust, & Balance
Date: 03/23/2026
Completed By: National TAB

PROJECT
03-16-26 QT #1138 SIMPSONVILLE, SC

Project: 03-16-26 QT #1138 SIMPSONVILLE, SC

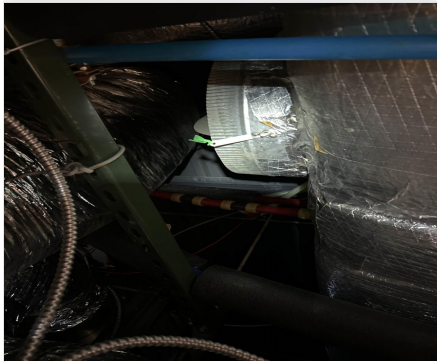
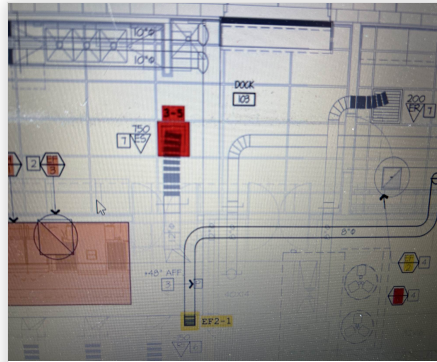
Issue Name : RTU 3 missing ductwork
Description : Missing ductwork for SGRD 3-5. Closed damper 100% but still has air leakage.
Created By : National TAB **Assigned To :** National TAB - Dan Hertenstein
Status : Open
Priority : High **Asset Tag :** SGRD5
Originated Date : 03/18/2026 - Jearod Ferrette - National TAB

Asset	Notes	Date	Written By
SGRD5	MISSING DUCTWORK	03/18/2026	Jearod Ferrette

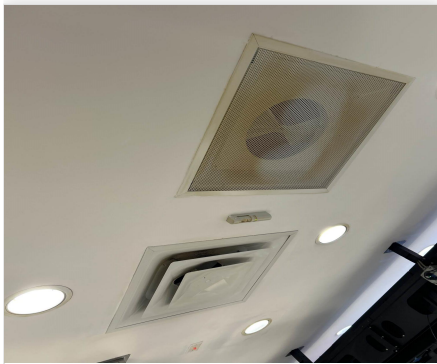
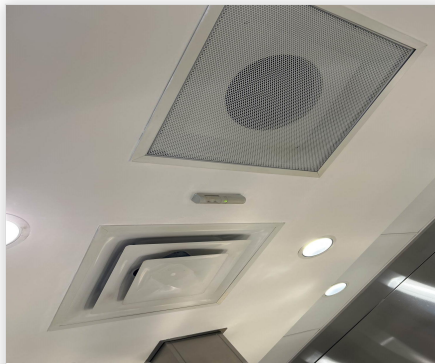
Issue Name : Specified diffusers not installed
Description : Specified diffusers not installed
Created By : National TAB **Assigned To :** National TAB - Dan Hertenstein
Status : Open
Priority : **Medium** **Asset Tag :** RT-3
Originated Date : 03/18/2026 - Jearod Ferrette - National TAB

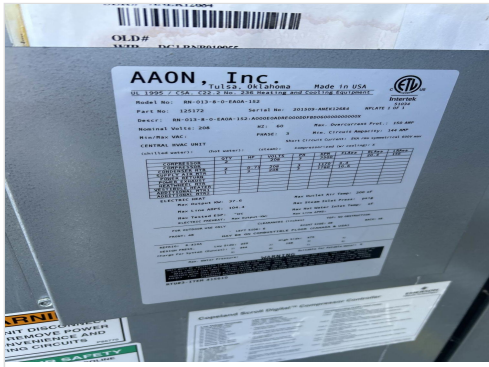
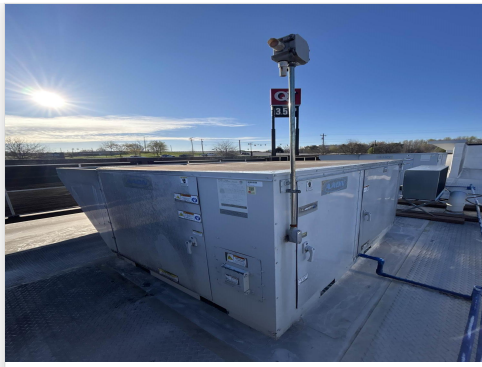
Asset: RT-3

Test Data		
	Design	Actual
SF CFM	4200	3029
SF RPM	-	DD/ 52 HZ
OA CFM (Hoods On)	800	843
OA CFM (Hoods Off)	350	365
RL Voltage	-	164.8 VFD
RL Amperage	-	11.7 VFD
VFD Max SetPt	-	52 HZ
OA Damper Position (Hoods On)	-	46%
OA Damper Position (Hoods Off)	-	26%

Performance Data		
	Design	Actual
MA Plenum SP	-	-0.46"
Fan Suction SP	-	-0.62"
Fan Discharge SP	-	2.13"
Total ESP	-	2.59"
Fan Total SP	-	2.75"

Notes:
HIGH DISCHARGE STATIC PRESSURE

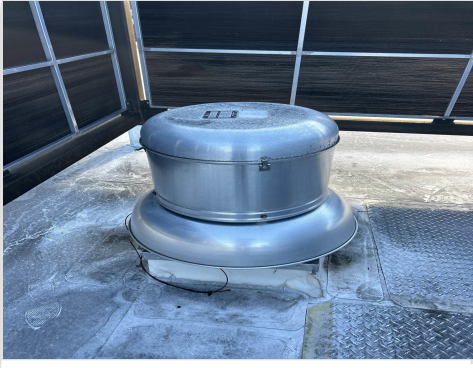
Asset: EF2

Test Data		
	Design	Actual
CFM	375	466
Fan RPM	-	DD
Fan Rotation	-	CCW
Motor RPM	-	DD
System SetPt	-	ON
RL Voltage	-	NA
RL Amperage	-	NA
Total ESP	-	0.19"
Fan Inlet SP	-	-0.19"
Fan Discharge SP	-	ATMO

Notes:
SEE ISSUES
